# **Port Authority Facility Condition Survey Program**

**George Washington Bridge  
Main Span Lower Level  
2011 Biennial Inspection**

**December 2011**

**2011 FINAL Condition Survey Report / GWB Lower Level**

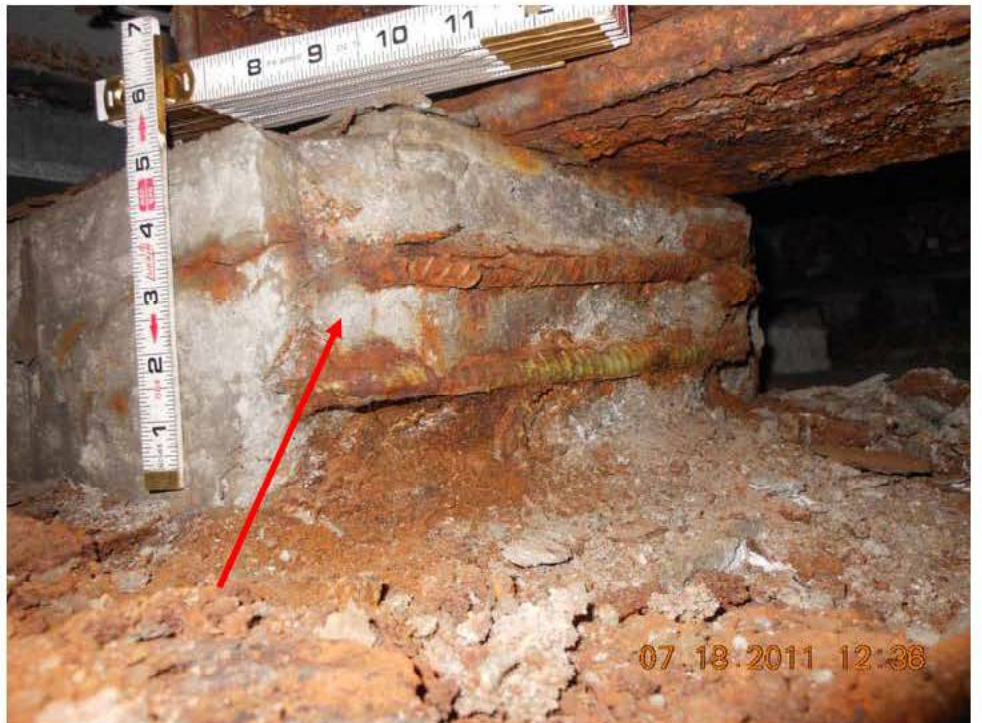
**Location:** Span 11, the concrete pedestal at the east end of Stringer 11.

**Description:** The pedestal exhibits a large spall with exposed and corroded rebar at the west end with minor undermining of the bearing.

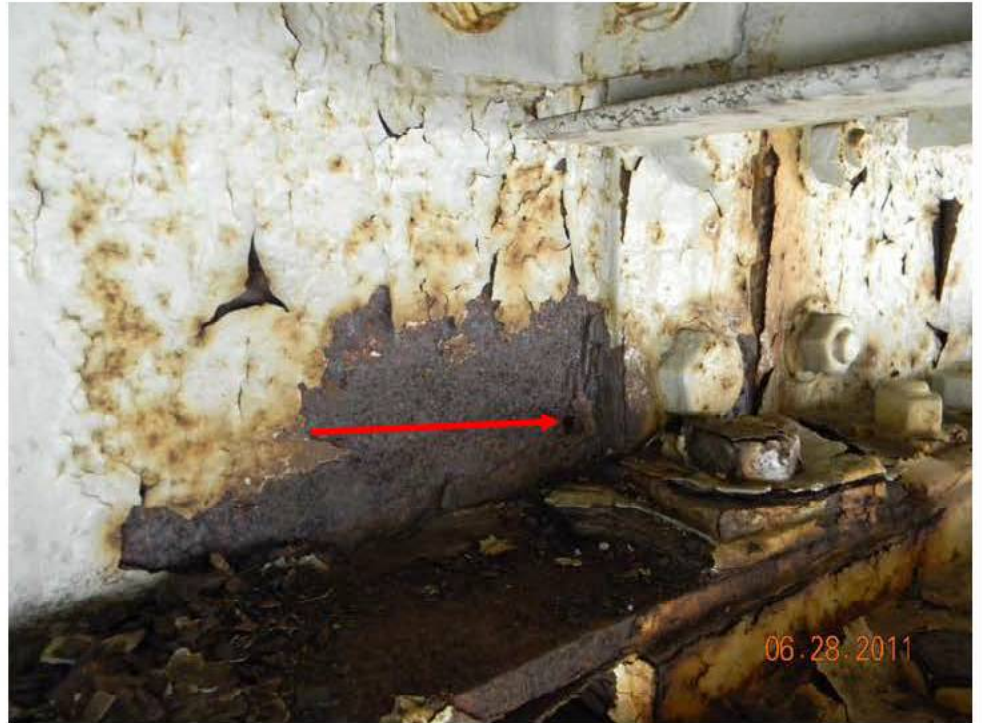
**Description:** The bottom of web exhibits severe corrosion with a 1/2" diameter hole at Floorbeam 38E.

<b>GWB-BR001-022</b>	Repair ½" diameter hole in the bottom of web of stringer S4 at panel point 38E (1 location).	Outstanding	Repair ½" diameter hole in the bottom of web of stringer S4 at panel point 38E (1 location).	SDU-5 (Photo 7)
<b>GWB-BR001-024</b>	Repair spalled and cracked concrete pedestal causing minor undermining of the bearing under stringer S10 at the east end of span 10. One anchor bolt is partially exposed (1 location).	Outstanding	Repair spalled and cracked concrete pedestal causing minor undermining of the bearing under stringer S10 at the east end of span 10. Anchor bolts are partially exposed (1 location).	SDU-7 (Photo 8)

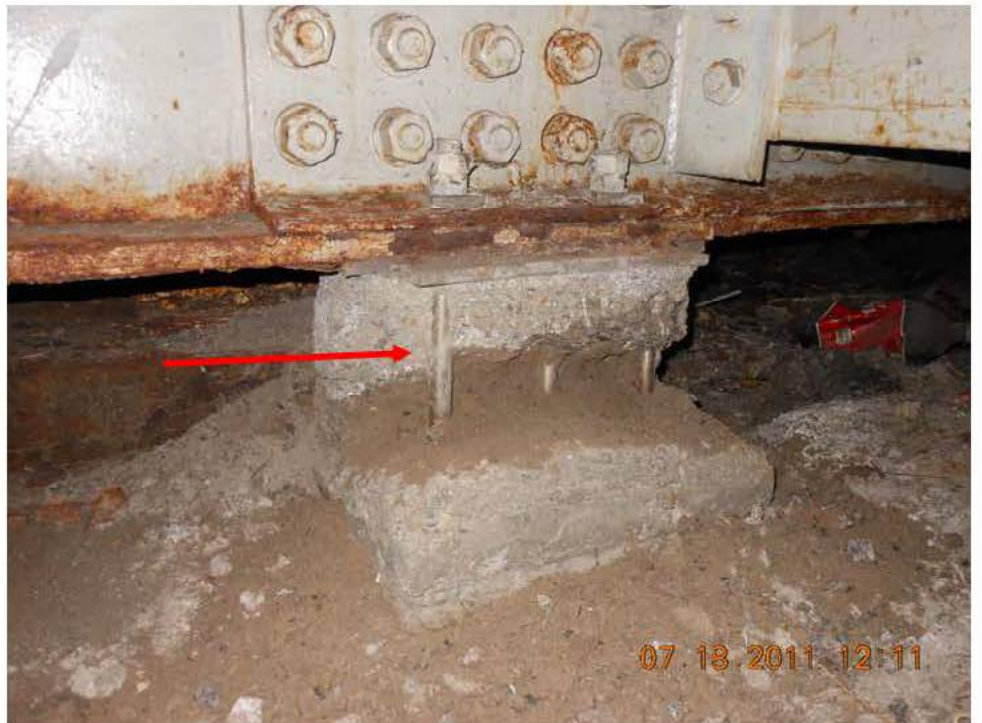
**Photo No.:** 8.

**Location:** Span 10, concrete pedestal at the east end of Stringer S10.

**Description:** The concrete pedestal is spalled and cracked undermining the bearing. The remaining concrete exhibits severe scaling. Anchor bolts are partially exposed but in good condition.

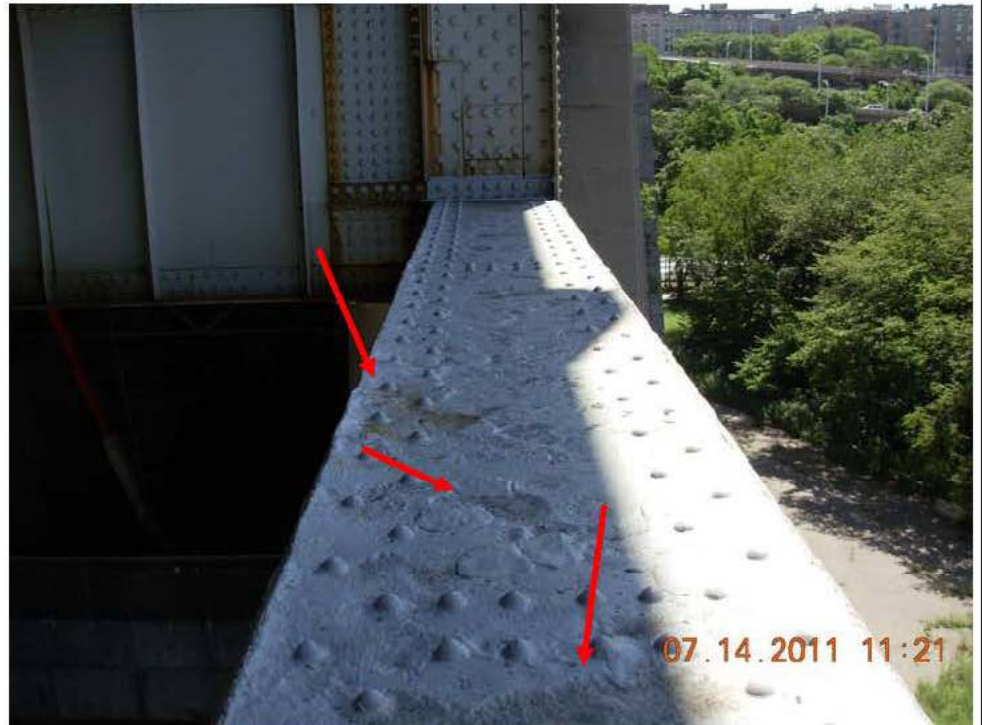
**Photo No.:** 9.

**Location:** Span 3, top of bottom chord between Panel Points 3E\* and 3E of the south stiffening truss.

**Description:** The top plate is severely pitted with twelve (12) holes up to 6" long x 2" wide and water ponding throughout. Note the temporary repair performed by filling holes with caulk and repainting.

QAD Repair Reference Number	Repair Recommendation 2009 Inspection	Current Status	Repair Recommendation 2011 Inspection	Dwg. No. (Photo No.)
<b>GWB-BR001-025</b>	Repair twelve (12) up to 6" x 2" holes in the top plate of the south bottom truss chord between panel points 3E* and 3E (1 location).	Outstanding	Repair twelve (12) up to 6" x 2" holes in the top plate of the south bottom truss chord between panel points 3E* and 3E (1 location). Temporary repair performed by filling holes with caulk and repainting.	SDU-7 (Photo 9)
<b>GWB-BR001-033</b>	Replace the severely corroded end diaphragms with holes in span 3 between stringers S6 – S7, S11 – S12, S15 – S16 over floorbeam 1E (3 locations).	Completed	-----	-----
<b>GWB-BR001-034</b>	Repair severely corroded stringer webs with holes above the bearings at all stringers above panel point 1E (16 locations).	Partially Completed	Repair severely corroded stringer webs with holes above the bearings at stringers S6 and S14 above panel point 1E (2 locations).	SDU-7 (Photo 10)

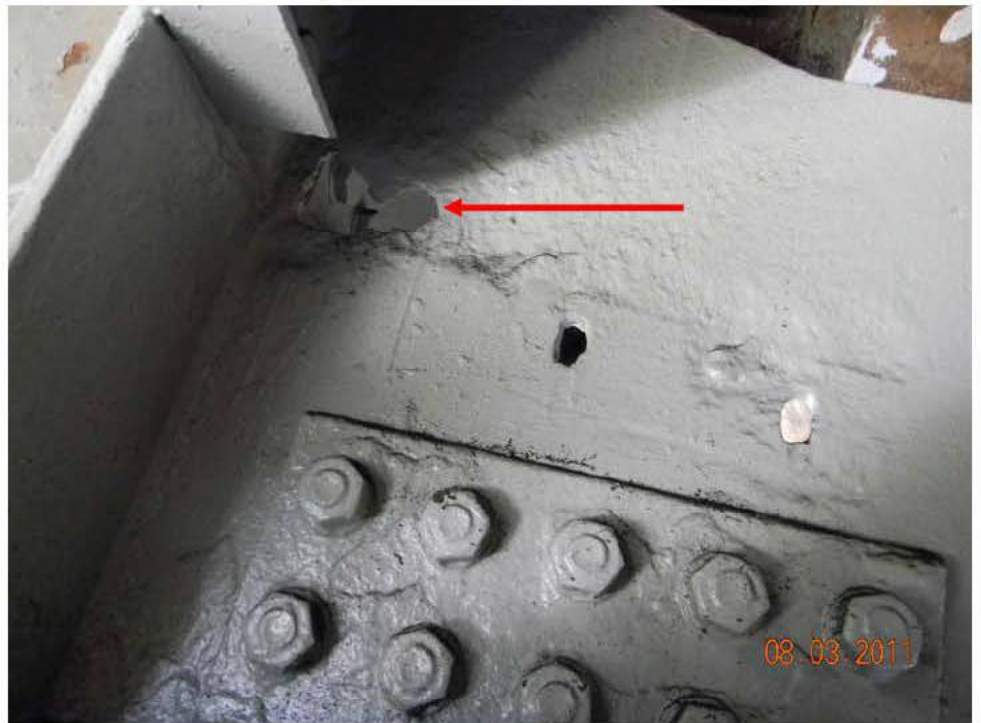
**Photo No.:** 10.

**Location:** Span 3, east end of Stringer S14 at Floorbeam 1E.

**Description:** The web at the end of stringer exhibits severe corrosion with holes, including a 3" x 1" hole near the top of the web.

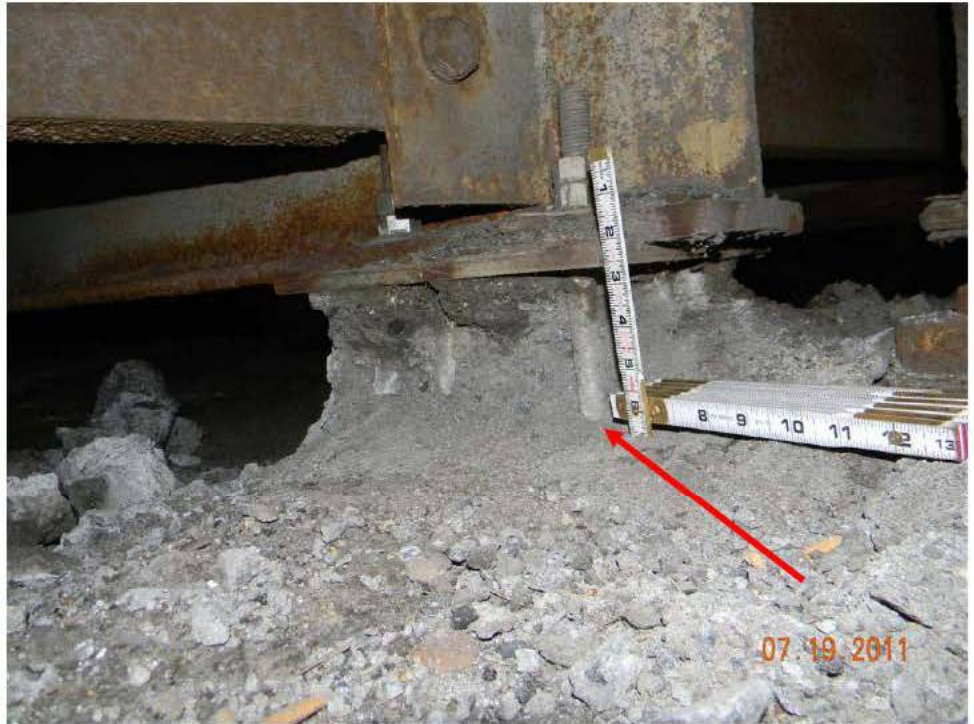
**Description:** The pedestal is severely spalled with exposed anchor bolts causing undermining of the bearing plate under the stringer. The remaining concrete exhibits severe scaling.

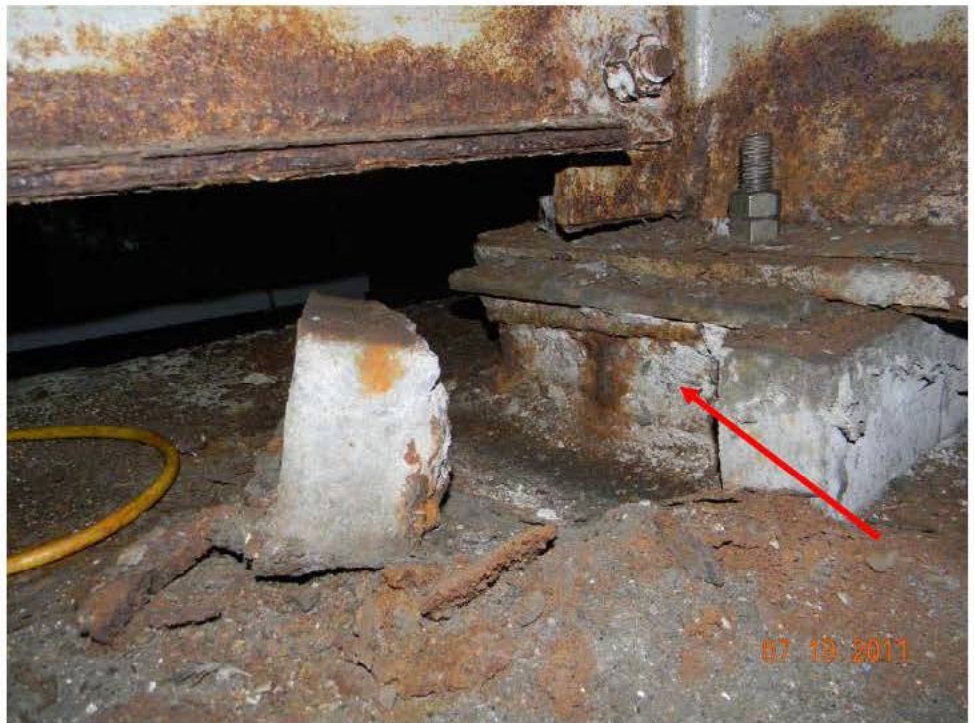
**Photo No.:** 12.

**Location:** Span 11, concrete pedestal at the east end of Stringer S14.

**Description:** The pedestal exhibits spalled concrete with exposed rusted rebar causing minor undermining of the bearing plate under the stringer.

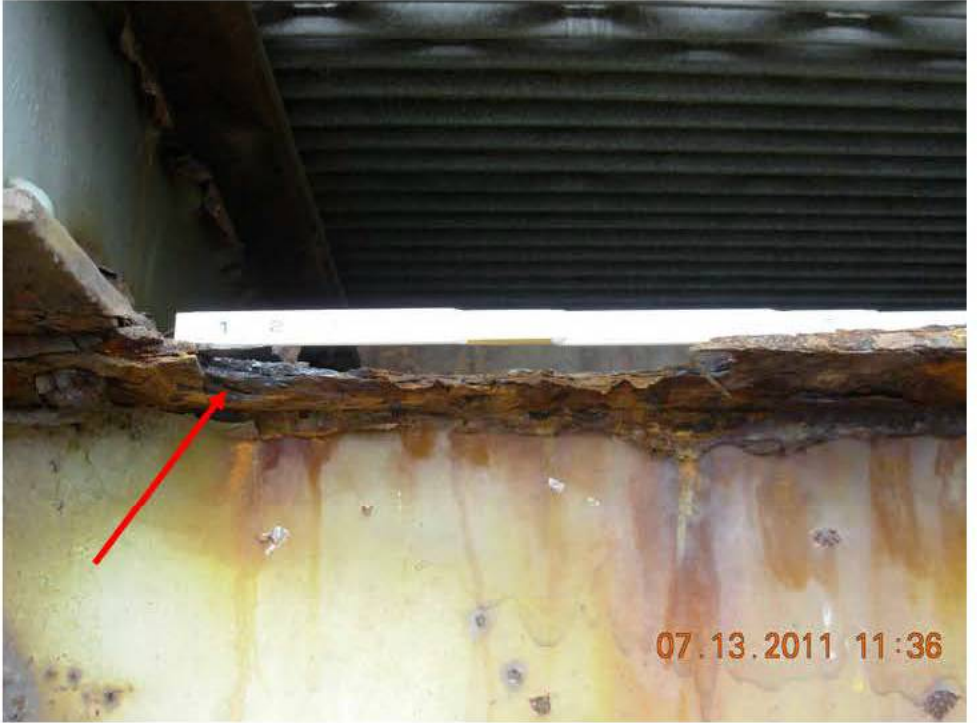
<p><b>Photo No.:</b> 13.</p> <p><b>Location:</b> Span 3, Stringer S1 between Panel Points 8E and 7E*</p> <p><b>Description:</b> The top flange exhibits severe corrosion with a 2" x 10" hole near the quarter point from Floorbeam 7E*.</p> <p><b>(Priority Repair 7)</b></p>

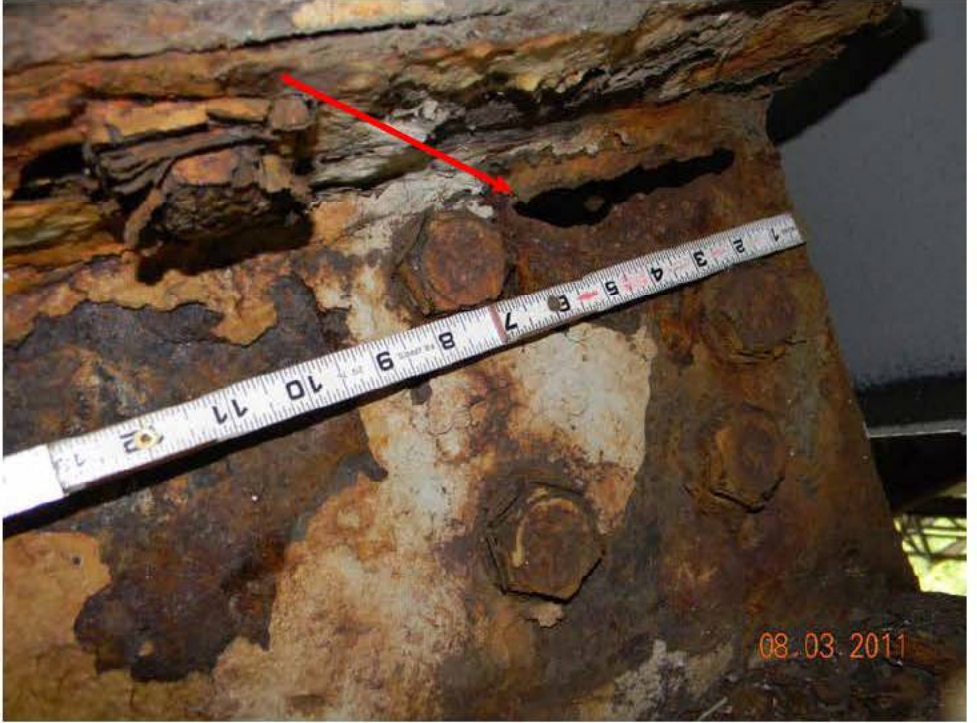
<p>07.13.2011 11:36</p>
<p><b>Photo No.:</b> 14.</p> <p><b>Location:</b> Span 4, end of Stringer S10 over Floorbeam 1E.</p> <p><b>Description:</b> The web and top flange are severely corroded with large holes including a 1" high x 6" wide hole in the top of the web.</p> <p><b>(Priority Repair 8)</b></p>

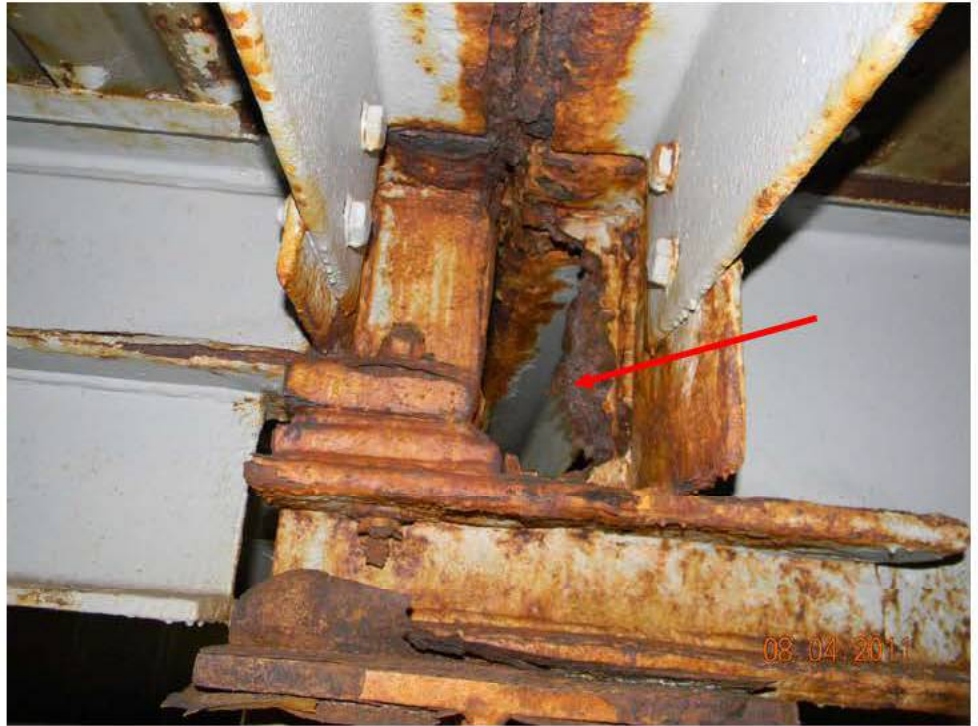
**Description:** The end of stringer exhibits severe corrosion with a 4" x 11" hole (arrow) in the web above the bearing.

<b>QAD Repair Reference Number</b>	<b>Repair Recommendation 2009 Inspection</b>	<b>Current Status</b>	<b>Repair Recommendation 2011 Inspection</b>	<b>Dwg. No. (Photo No.)</b>
<b>GWB-BR001-038</b>	Repair the severely corroded top flange and web with holes in the web at the bearings of stringers S2, S3, S4, S6, S7, S10 and S11, located at the east side of floorbeam 1E (7 locations).	Outstanding	Repair the severely corroded top flange and web with holes in the web at the bearings of stringers S2, S3, S4, S6, S7, S10 and S11, located at the east side of floorbeam 1E (7 locations).	SDU-7 <i>(Photo 14)</i>
<b>GWB-BR001-039</b>	Repair the severely corroded webs, with hole near the bearing, of stringers S1, S5 and S8 located at the west end of span 7 and stringers S13, S14 and S15 located at the east end of span 9 (6 locations). (Holes exist in webs of S11, S12 and S13 in Span 9 incorrectly labeled S13, S14 and S15).	Outstanding	Repair the severely corroded webs, with hole near the bearing, of stringers S1, S5 and S8 located at the west end of span 7 and stringers S11, S12 and S13, including an adjacent corrosion crack at stringer S12, located at the east end of span 9 (6 locations).	SDU-7 <i>(Photo 15 &amp; 16)</i>

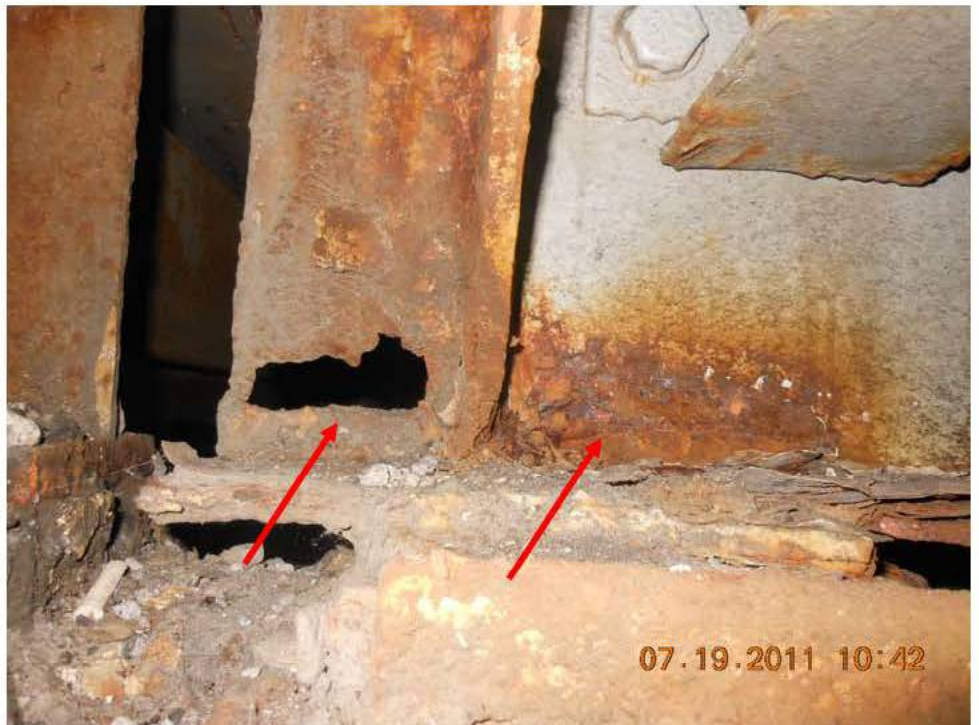
**Photo No.:** 16.

**Location:** Span 9, east end of Stringer S12.

**Description:** The bottom of the web exhibits severe corrosion with a 1.5" x 4" hole and an adjacent 5" long corrosion crack above the bearing.

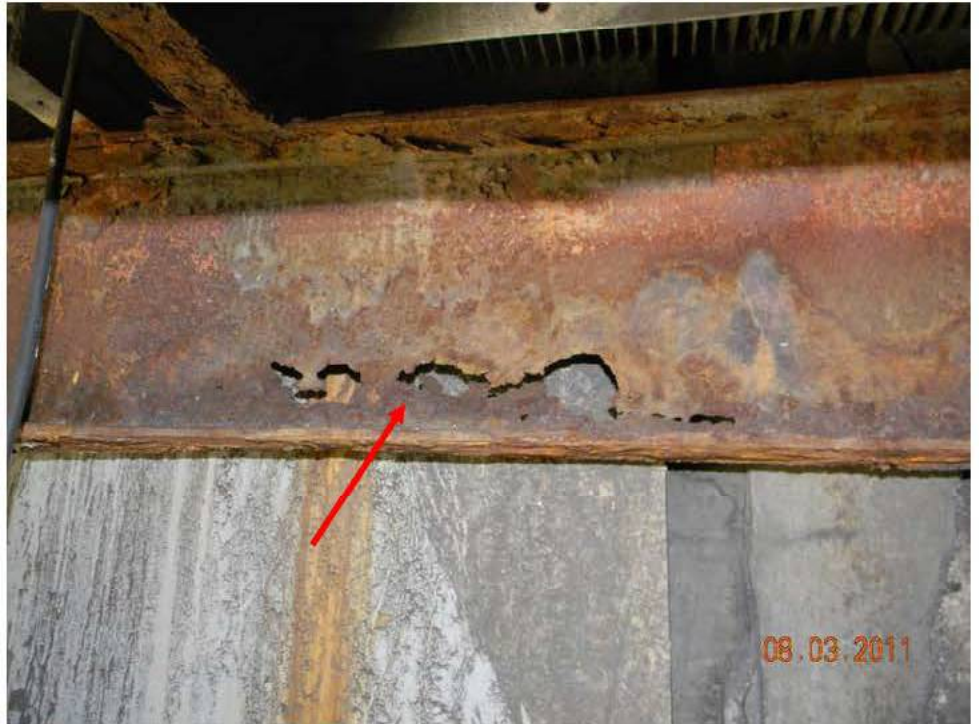
**Photo No.:** 17.

**Description:** Fascia stringer S18, which does not support traffic loads, exhibits 50% section loss of both flanges along with large holes at the bottom of the web near mid-span.

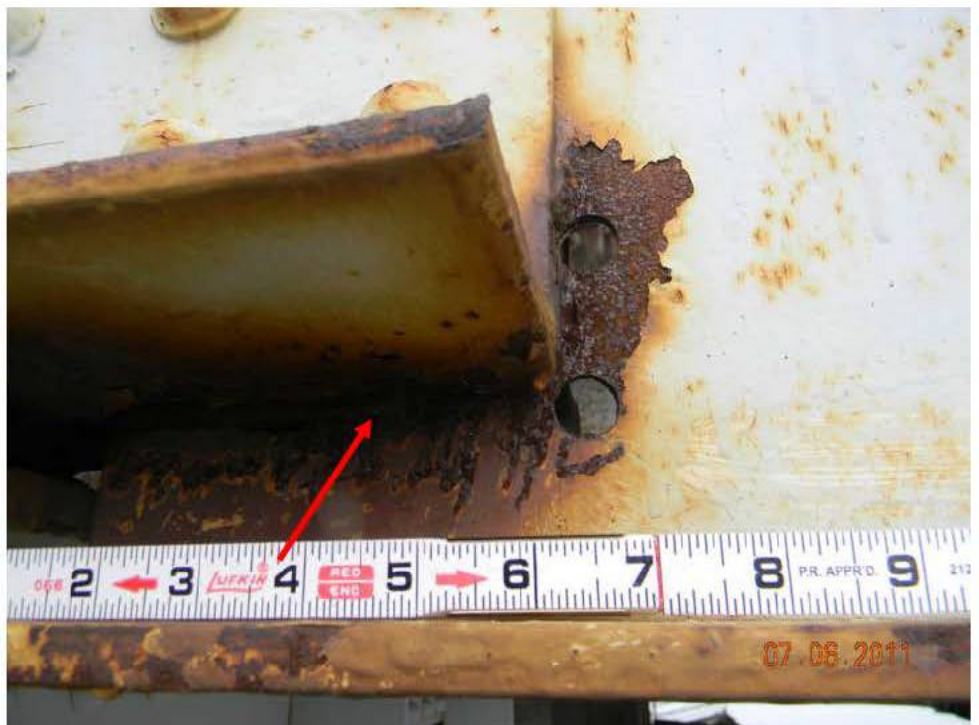
**Photo No.:** 18.

**Location:** Span 2, fascia Stringer S1 at the east side of Floorbeam 26W\*.

**Description:** The stringer web exhibits severe corrosion with section loss and holes along the bearing stiffening angle at the floorbeam connection. Two 3/4" crack arrestor holes were drilled at this location.

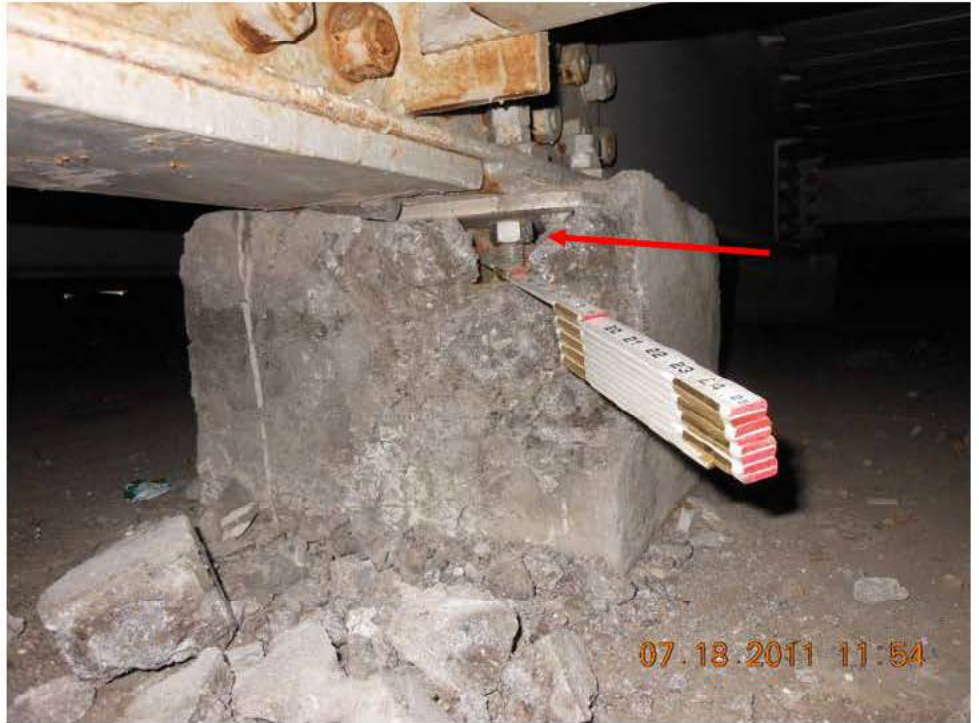
**Photo No.:** 19.

**Location:** Span 10, concrete pedestal at the west end of Stringer S16.

**Description:** The pedestal exhibits spalled concrete with voids, causing minor undermining of the bearing plate under the stringer.

<b>GWB-BR001-040</b>	Repair the severely corroded stringers S1 and S18 with web holes and 50% section loss of bottom flange near the 1/3 span between panel points 1E* and 1E (2 locations).	Outstanding	Repair the severely corroded stringers S1 and S18 with web holes and 50% section loss of bottom flange near the 1/3 span between panel points 1E* and 1E (2 locations).	SDU-7 <i>(Photo 17)</i>
<b>GWB-BR001-041</b>	Repair the severely corroded web, with holes around the bearing stiffening angles, of stringer S1 at the east side of panel point 26W* (1 location).	Outstanding	Repair the severely corroded web, with holes around the bearing stiffening angles, of stringer S1 at the east side of panel point 26W* (1 location).	SDU-4 <i>(Photo 18)</i>
<b>GWB-BR001-042</b>	Repair cracked and spalled concrete pedestals causing undermining of the bearing under stringer S13, S15 and S16 at the west end of span 10 and under stringer S4, S7, S8, S10, S15 and S18 at the east end of span 11 (9 locations).	Outstanding	Repair cracked and spalled concrete pedestals causing undermining of the bearing under stringer S13, S15 and S16 at the west end of span 10 and under stringer S4, S7, S8, S10, S15 and S18 at the east end of span 11 (9 locations).	SDU-7 <i>(Photo 19 &amp; 20)</i>

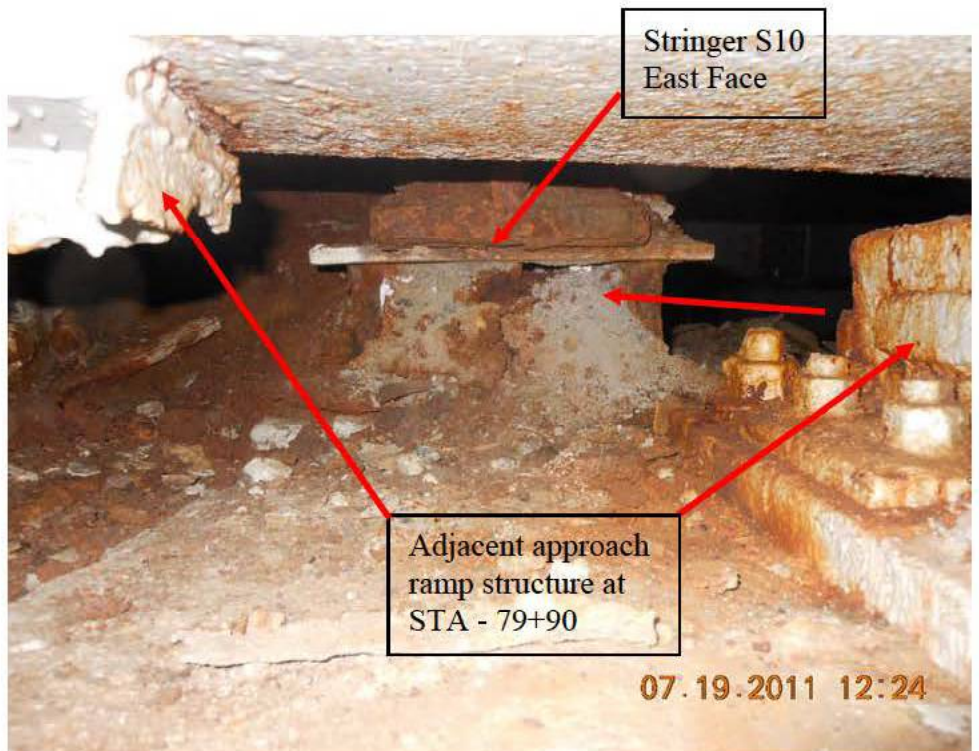
**Photo No.:** 20.

**Location:** Span 11, concrete pedestal at the east end of Stringer S10.

**Description:** The pedestal exhibits spalled and cracked concrete causing minor undermining of the bearing plate under the stringer.

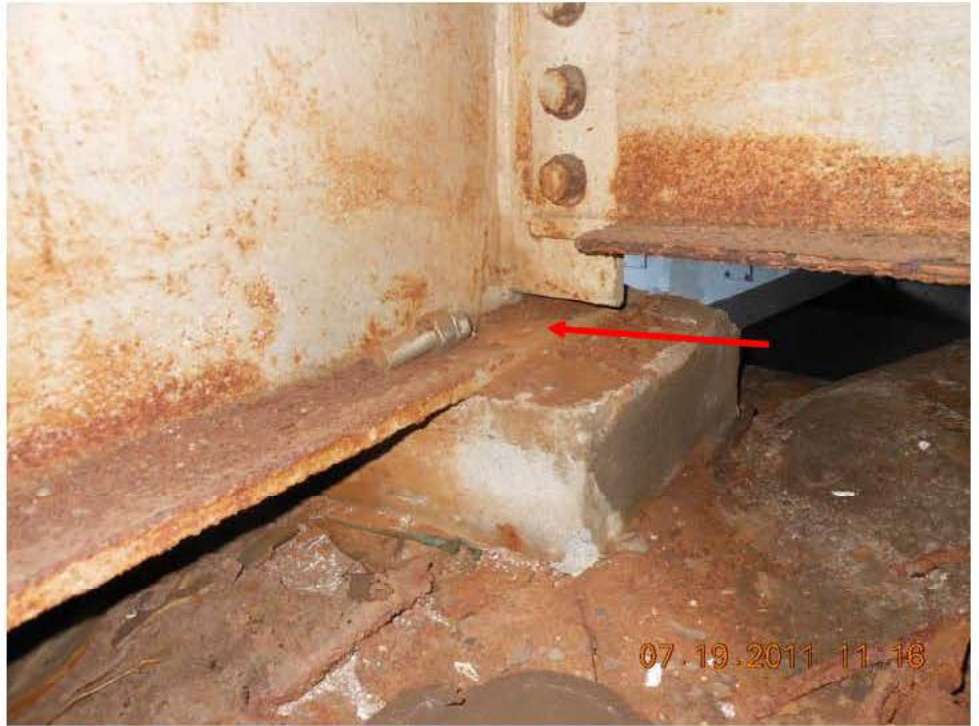
**Description:** One out of two anchor bolts is sheared off on the south side of stringer. Also, one out of two anchor bolts is sheared off on the north side (not shown).

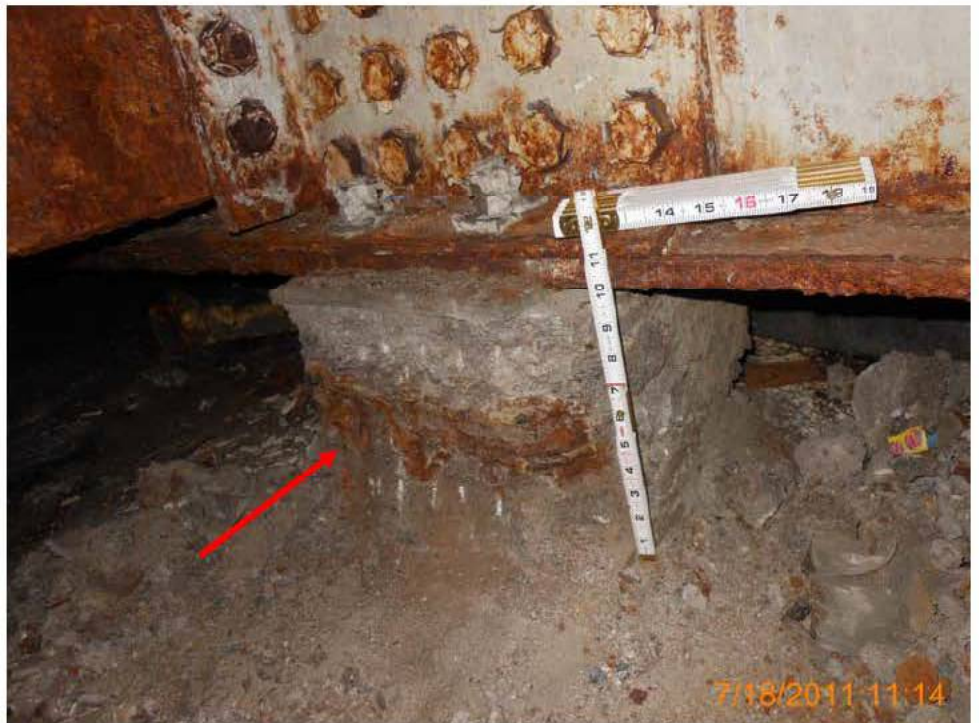
**Photo No.:** 22.

**Location:** Span 10, concrete pedestal for Stringer 9 bearing at Pedestal 3 from west.

**Description:** Spalled concrete pedestal below stringer bearing with exposed rusted rebar.

<b>QAD Repair Reference Number</b>	<b>Repair Recommendation 2009 Inspection</b>	<b>Current Status</b>	<b>Repair Recommendation 2011 Inspection</b>	<b>Dwg. No. (Photo No.)</b>
<b>GWB-BR001-043</b>	Repair the 2 of 4 broken anchor bolts at the bearing of stringer S16 located at the east end of span 11 (1 location).	Outstanding	Repair the 2 of 4 broken anchor bolts at the bearing of stringer S16 located at the east end of span 11 (1 location).	SDU-7 (Photo 21)
<b>GWB-BR001-044</b>	Repair the severely corroded end diaphragms with holes between stringers S16 and S17 over floorbeam 1E in span 3 (1 location).	Completed	-----	-----
<b>GWB-BR001-047</b>	-----	New	Repair spalled and cracked concrete pedestals, with or without exposed anchor bolts and/or rebar, causing minor undermining of the bearing under stringers S9 and S15 of span 10, under stringer S9 at the east end of span 11, and at 3 locations under stringer S12 in span 11 (6 locations).	SDU-7 (Photos 22 & 23)

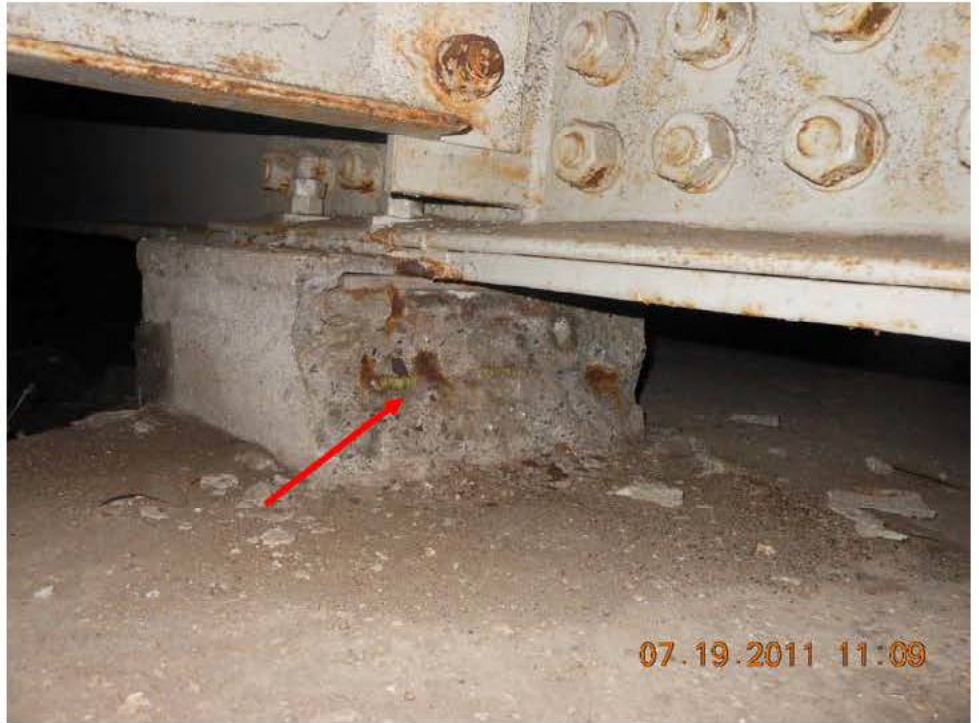
**Photo No.:** 23.

**Description:** Spalled concrete pedestal below stringer bearing with exposed rusted rebar.

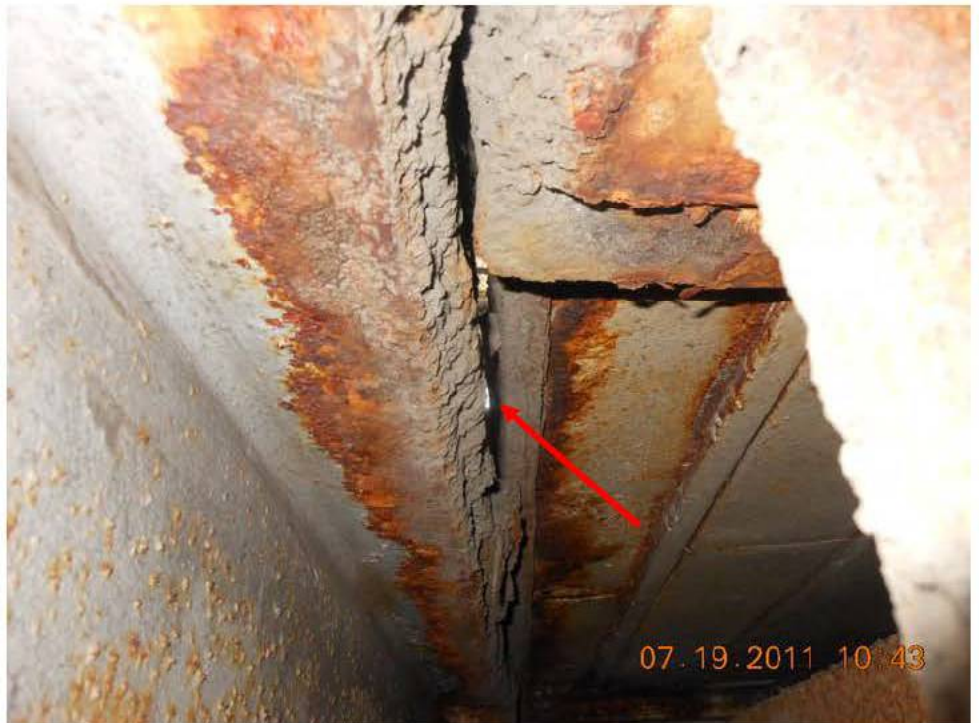
**Photo No.:** 24.

**Location:** Span 9, expansion joint below westbound roadway at the east end of the span between Stringers S13 and S14.

**Description:** The joint filler material is missing for nearly the entire width of both roadways.

<b>GWB-BR001-023</b>	Repair/Replace missing expansion joint filler material at span 9 (1 location).	Outstanding	Repair/Replace missing expansion joint filler material at span 9 (1 location).	TD-6 (Photo 24)
<b>GWB-BR001-045</b>	Repair the jammed finger joint plates at panel point 1E (1 location).	Outstanding	Repair the jammed finger joint plates at panel point 1E (1 location).	TD-6 (Photo 25)
<b>GWB-BR001-026</b>	New Jersey and New York Main Span Travelers - repair greater than 50% section loss in vertical stem of connection tee for south traveler hanger at panel point 40W that supports the track for the Main Span Travelers (1 location).	Outstanding	New Jersey and New York Main Span Travelers - repair greater than 50% section loss in vertical stem of connection tee for south traveler hanger at panel point 40W that supports the track for the Main Span Travelers (1 location).	SDU-5 (Photo 26)

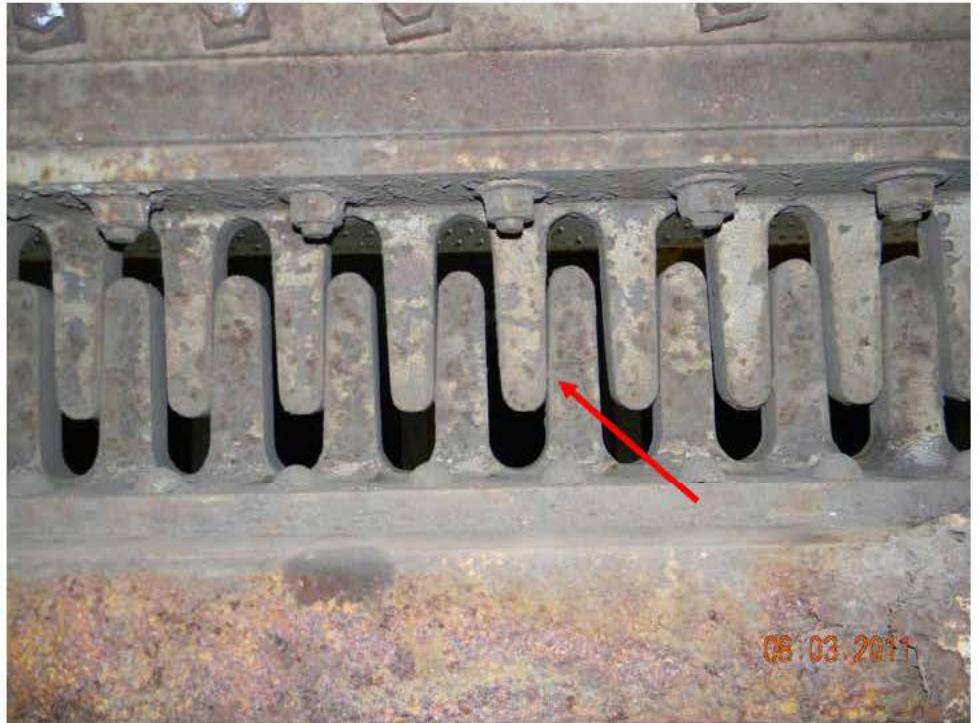
**Photo No.:** 25.

**Description:** The finger joint plates are shifted and jammed against each other (arrow), restricting movement.

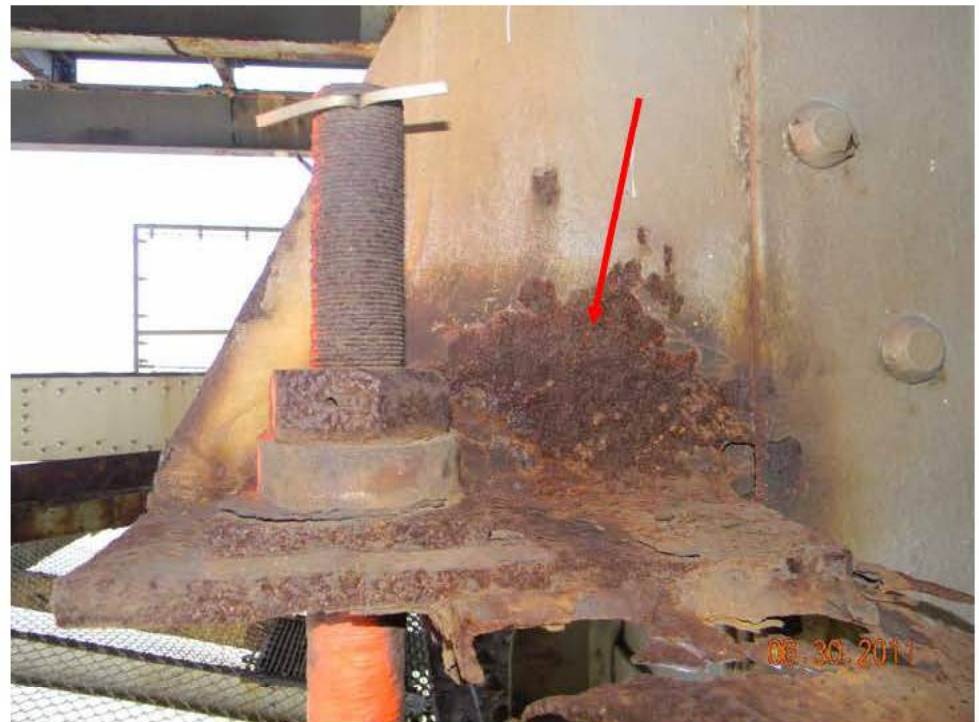
**Photo No.:** 26.

**Description:** The stem of tee shape hanger support exhibits greater than 50% section loss due to active severe corrosion.

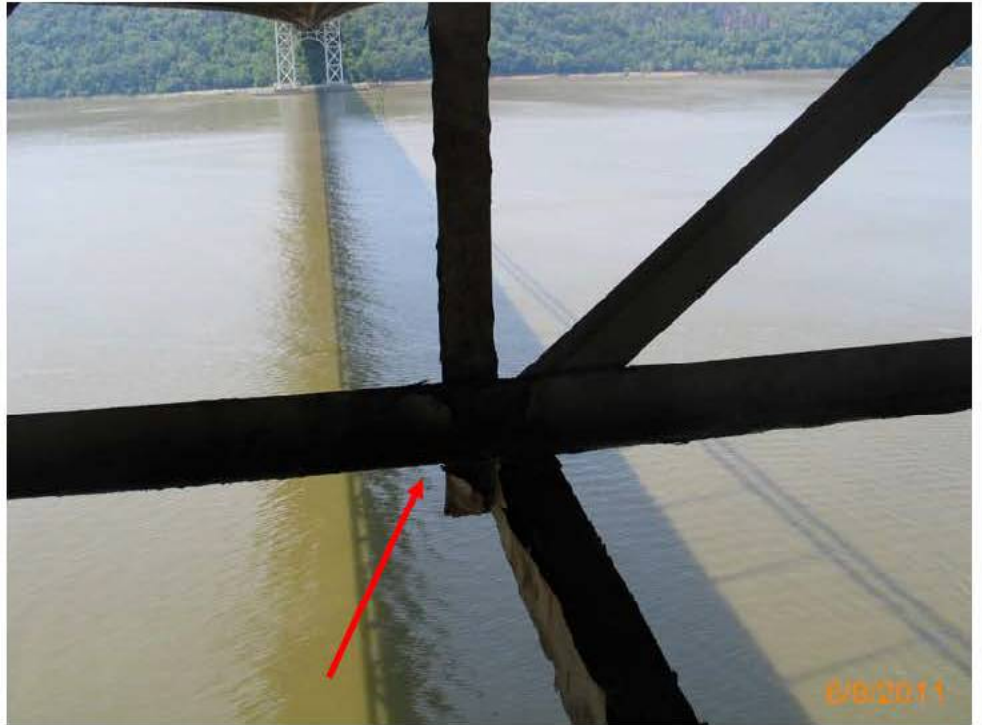
**Description:** Severe corrosion to the west bottom member of the traveler support truss.

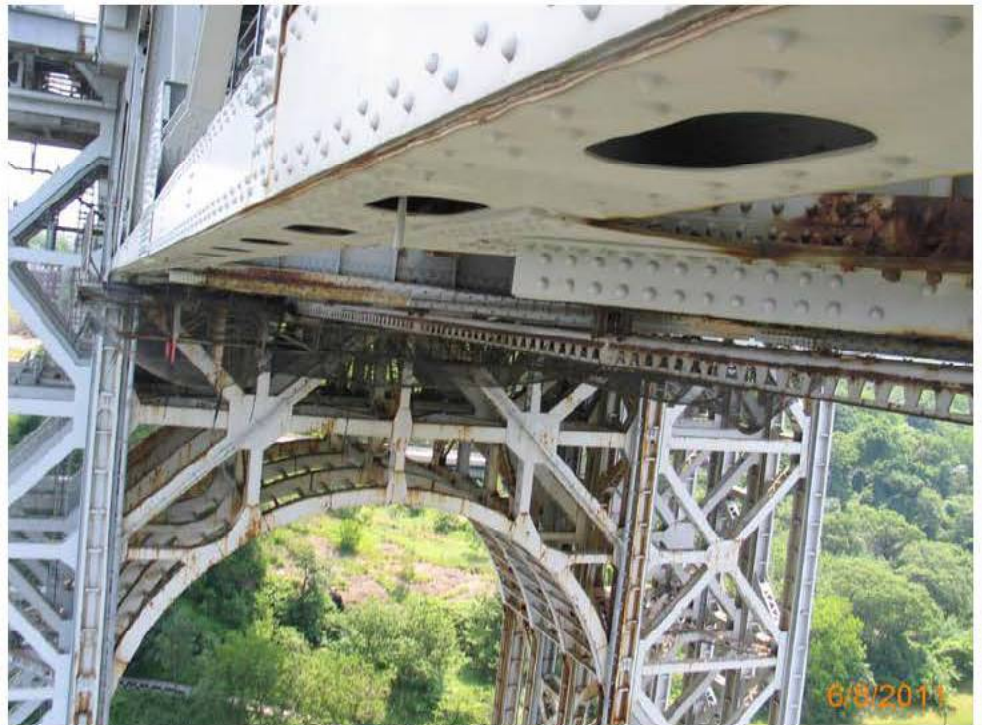
**Photo No.:** 28.

**Description:** General View. The traveler is not operational and is enclosed by netting to prevent falling debris. The traveler exhibits moderate to severe corrosion to main support truss members.

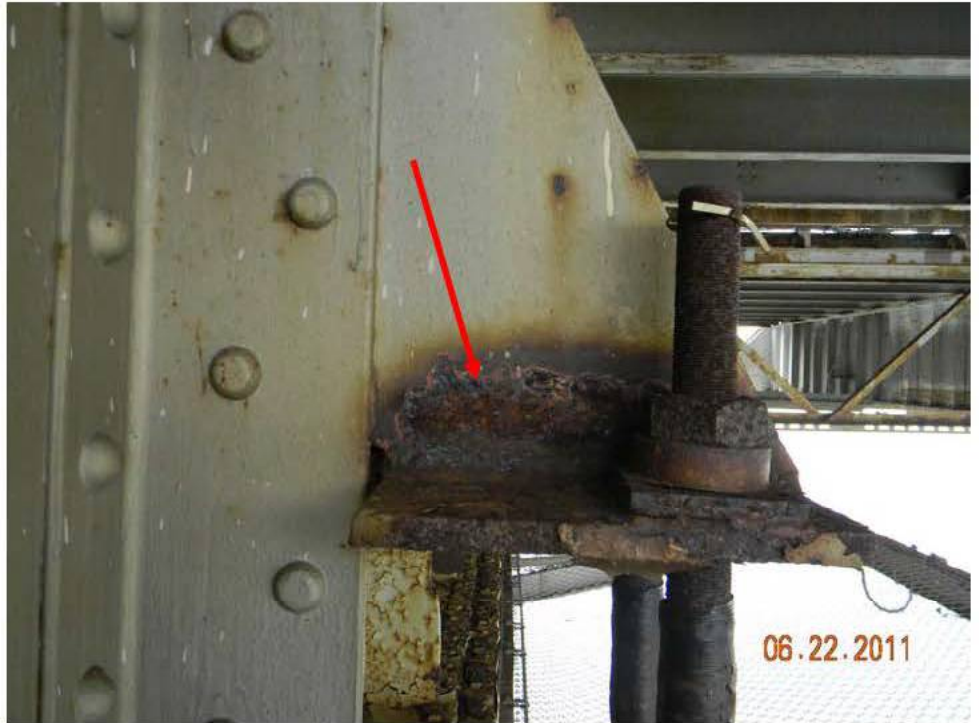
**Description:** The stem of the hanger tee support for the traveler exhibits greater than 50% section loss due to active severe corrosion.

<b>QAD Repair Reference Number</b>	<b>Repair Recommendation 2009 Inspection</b>	<b>Current Status</b>	<b>Repair Recommendation 2011 Inspection</b>	<b>Dwg. No. (Photo No.)</b>
<b>GWB-BR001-030</b>	New Jersey Main Span Traveler – repair moderate to severe section loss at main support truss members (12 locations).	Outstanding	New Jersey Main Span Traveler – repair moderate to severe section loss at main support truss members. One new location added. (13 locations).	T-3 (Photo 27)
<b>GWB-BR001-028</b>	New York Main Span Traveler – repair moderate to severe section loss at main support truss members (90 locations).	Outstanding	New York Main Span Traveler – repair moderate to severe section loss at main support truss members. Additional 5 new locations added (Total 95 locations).	T-4 (Photo 28)
<b>GWB-BR001-031</b>	New Jersey and New York Main Span Travelers - repair 50% section loss in vertical stem of connection tee that supports the south track at panel point 23E and the north track at Panel Point 42W for the Main Span Travelers (2 locations).	Outstanding	New Jersey and New York Main Span Travelers - repair 50% section loss in vertical stem of connection tee that supports the south track at panel point 23E and the north track at Panel Point 42W for the Main Span Travelers (2 locations).	SDU-5 & 6 (Photos 29 & 30)

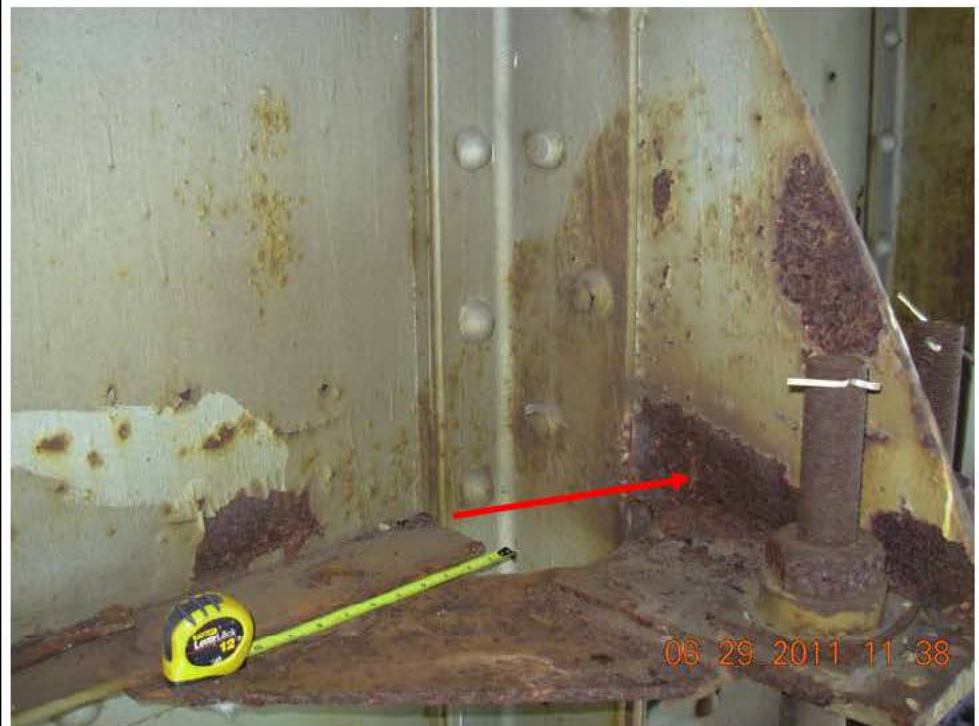
**Photo No.:** 30.

**Description:** The stem of the hanger tee support for the traveler exhibits greater than 50% section loss due to active severe corrosion.

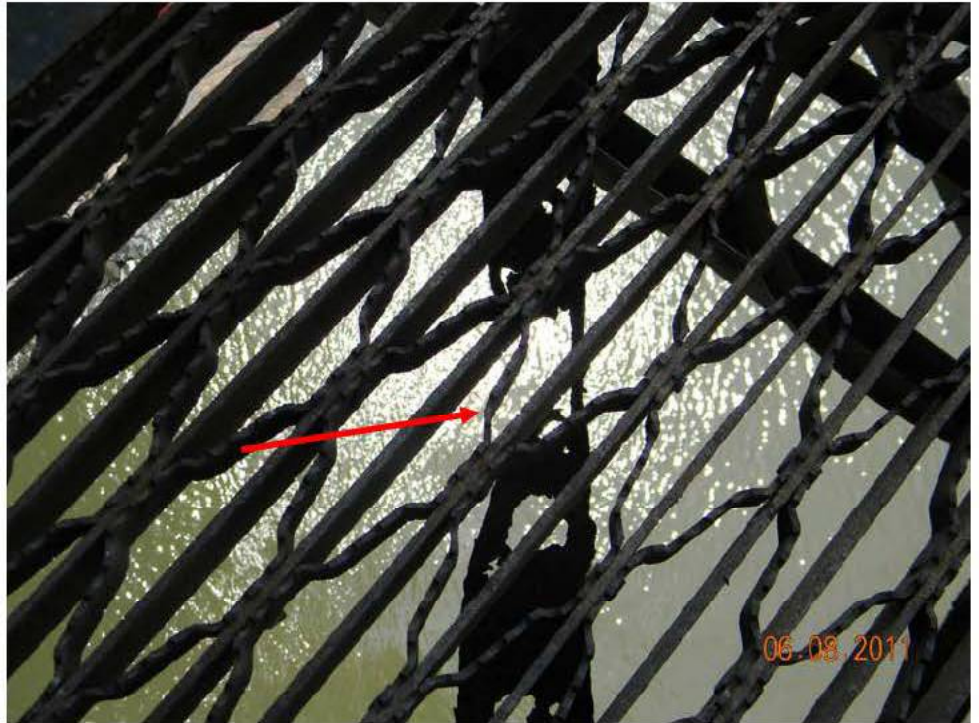
**Description:** The bracing angle for the top chord of the traveler truss is severely corroded with large holes.

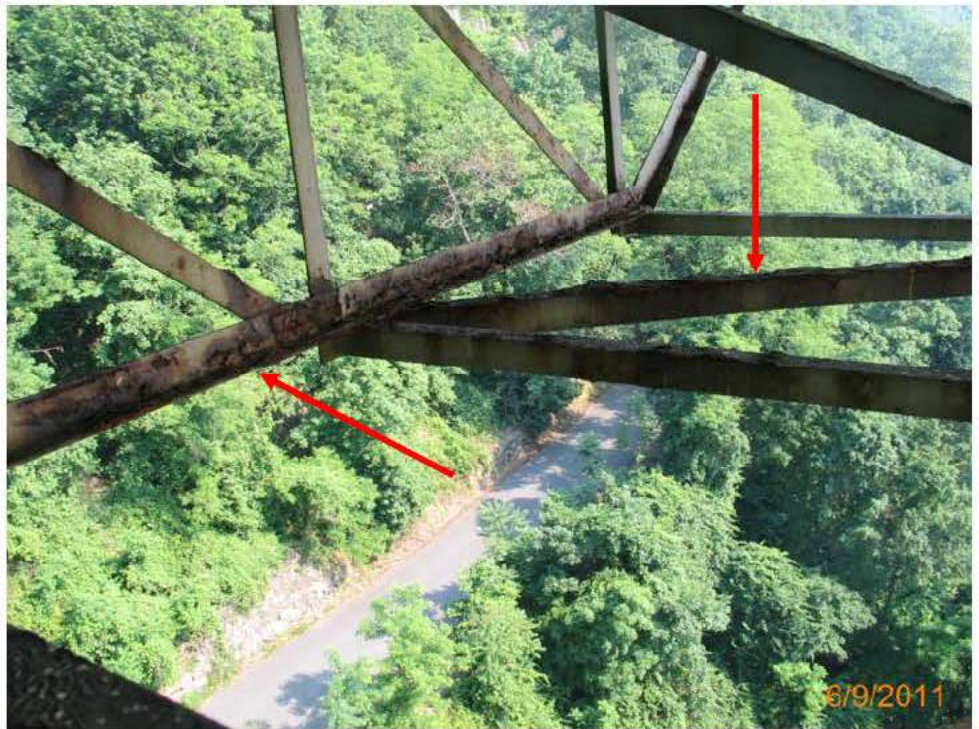
**Photo No.:** 32.

**Description:** Moderate to severe section loss at main support truss members.

<b>GWB-BR001-046</b>	New Jersey Main Span Traveler – repair moderate to severe section loss at cross bracings between main support truss top chords (6 locations).	Outstanding	New Jersey Main Span Traveler – repair moderate to severe section loss at cross bracings between the main support truss top chords (6 locations).	T-3 (Photo 31)
<b>GWB-BR001-048</b>	-----	New	New Jersey Back Span Traveler – repair moderate to severe section loss at main support truss members (5 locations).	T-2 (Photo 32)
