# **Port Authority Facility Condition Survey Program**

**George Washington Bridge  
Main Span Lower Level  
2011 Biennial Inspection**

**December 2011**

**2011 FINAL Condition Survey Report / GWB Lower Level**

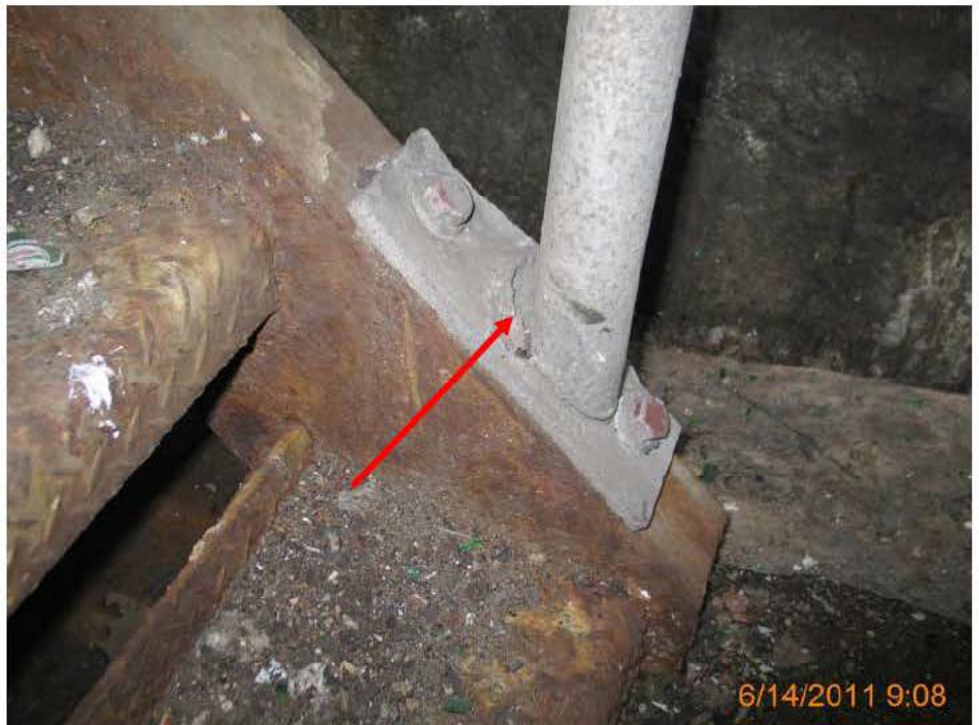
**Photo No.:** 34.

**Location:** Span 1, bottom of north safety walk staircase near New Jersey abutment.

2. Repair the broken weld at the base of the west handrail of the north safetywalk stairs and broken base at the east handrail of the south safety walk stairs at the New Jersey abutment (2 locations).	SDU-3 <i>(Photo 34)</i>

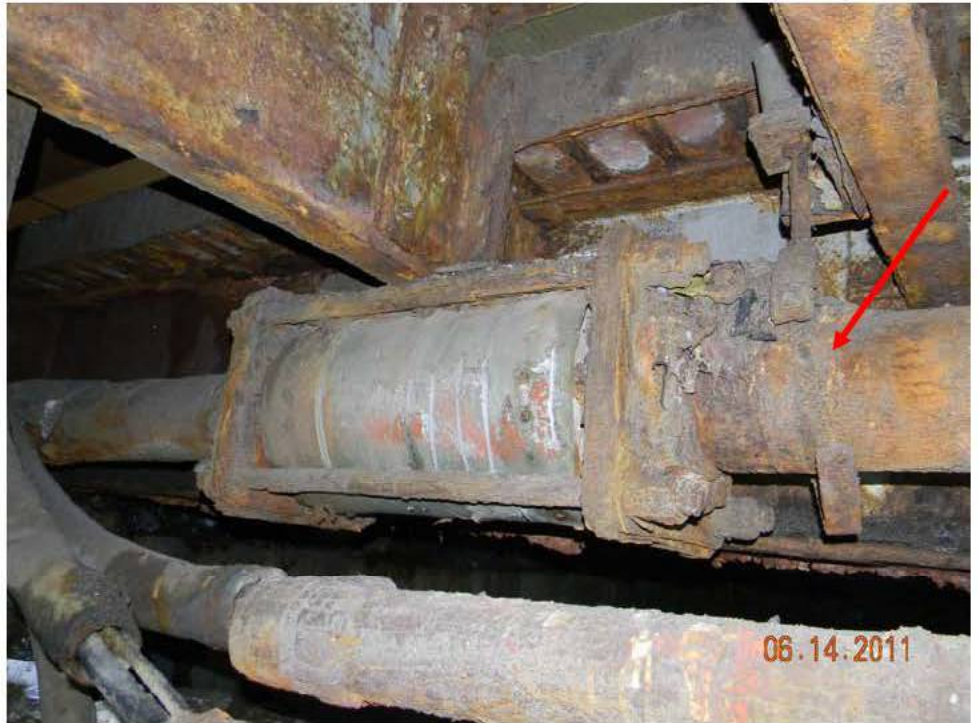
**Photo No.:** 35.

**Description:** The clevis hanger for the water main is severely deteriorated and the adjacent strap is broken.

3. Remove section of abandoned 8-inch diameter water main with deteriorated clevis hanger at the New Jersey abutment (1 location).	SDU-3 <i>(Photo 35)</i>

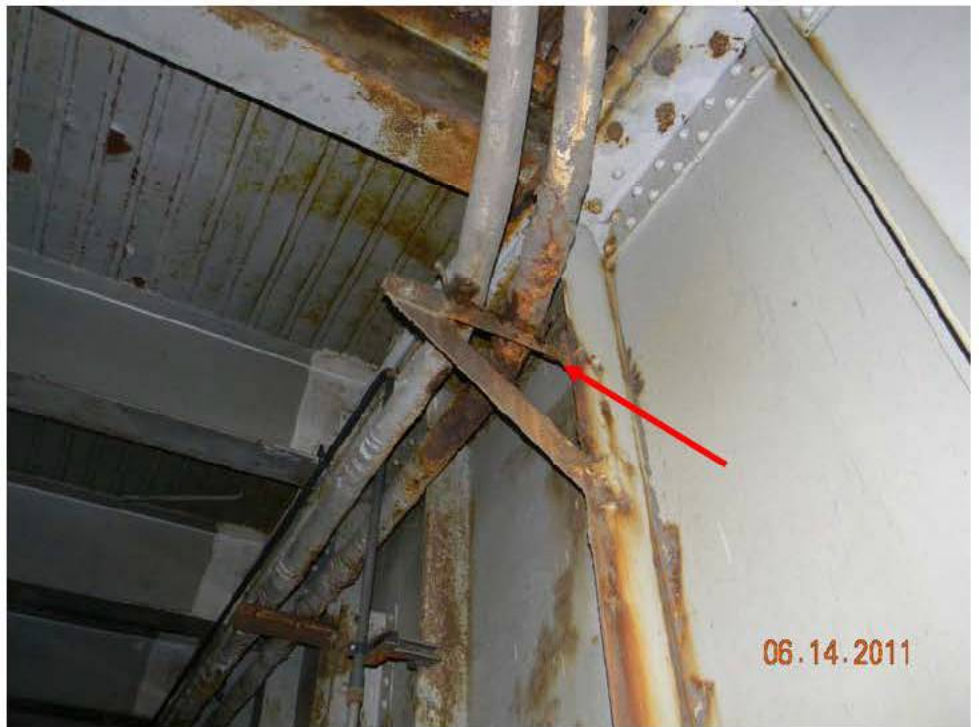
**Photo No.:** 36.

**Description:** The conduit knee brace support exhibits severe corrosion with up to 90% section loss to the horizontal support member and one of the conduits is severely corroded.

4. Replace severely deteriorated steel knee brace support bracket for two 3-inch diameter electrical conduits at stringer S2, west of Floorbeam 3W at span 1 (1 location).	SDU-3 <i>(Photo 36)</i>

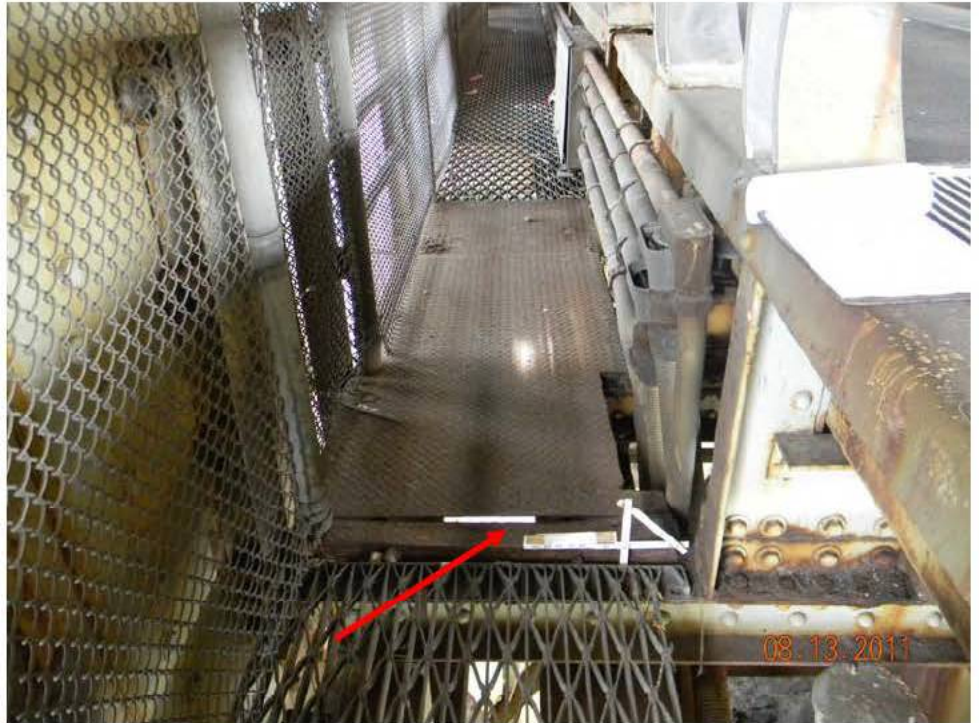
**Photo No.:** 41.

**Description:** The west edge of the safety walk diamond plate is uplifted 1.5" causing a tripping hazard.

9. Repair or replace the diamond plate safety walk uplifted 1.5 inches creating a tripping hazard at the New York tower (1 location).	TD-5 <i>(Photo 41)</i>

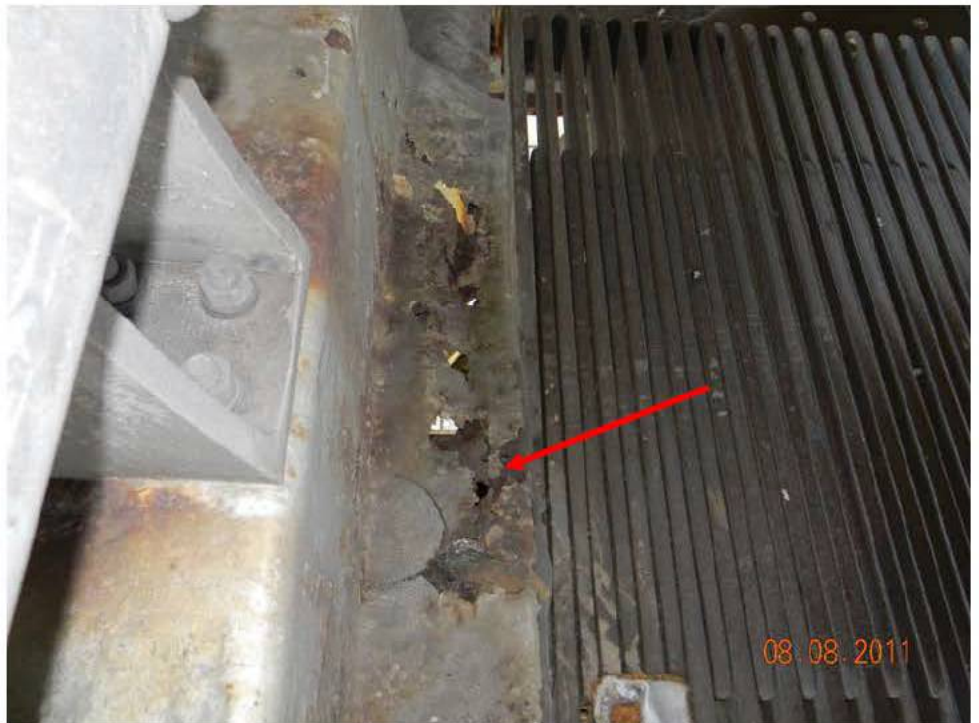
**Photo No.:** 42.

**Description:** A four feet long section of steel curb remains collapsed and is severely corroded with numerous holes.

10. Repair the severely deteriorated and collapsed section of steel curb at the south side of the eastbound roadway (1 location).	TD-2 <i>(Photo 42)</i>

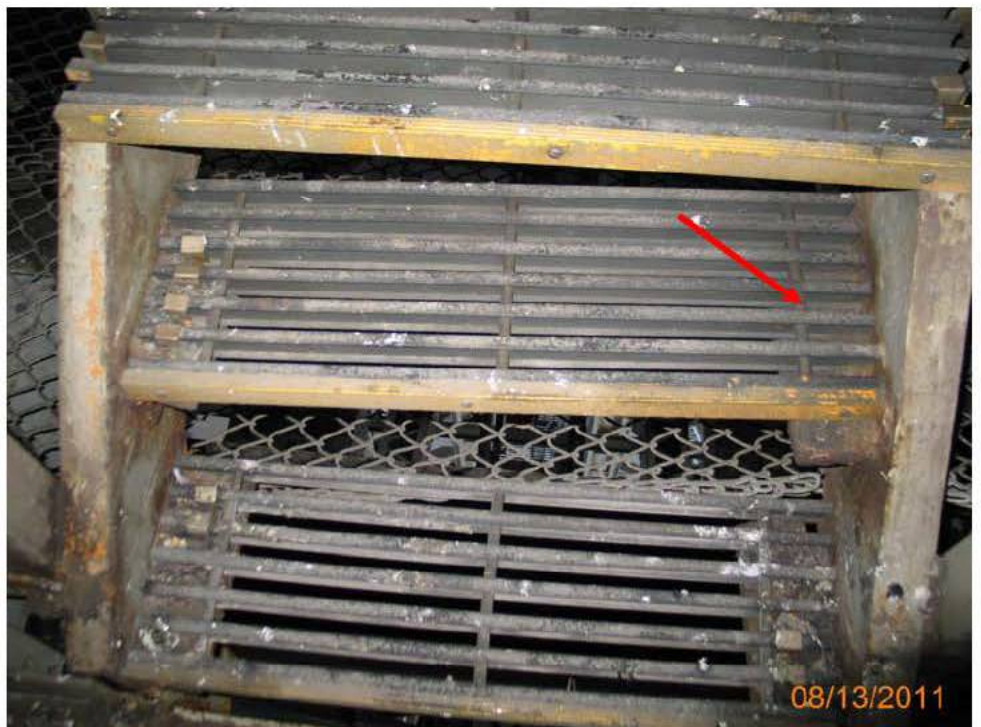
**Photo No.:** 44.

**Location:** Span 2, median catwalk step at New Jersey Tower.

12. Replace the missing stair grate connection clip at the median catwalk at the New Jersey tower (accessible to the public / stranded motorist) (1 location).	TD-2 <i>(Photo 44)</i>

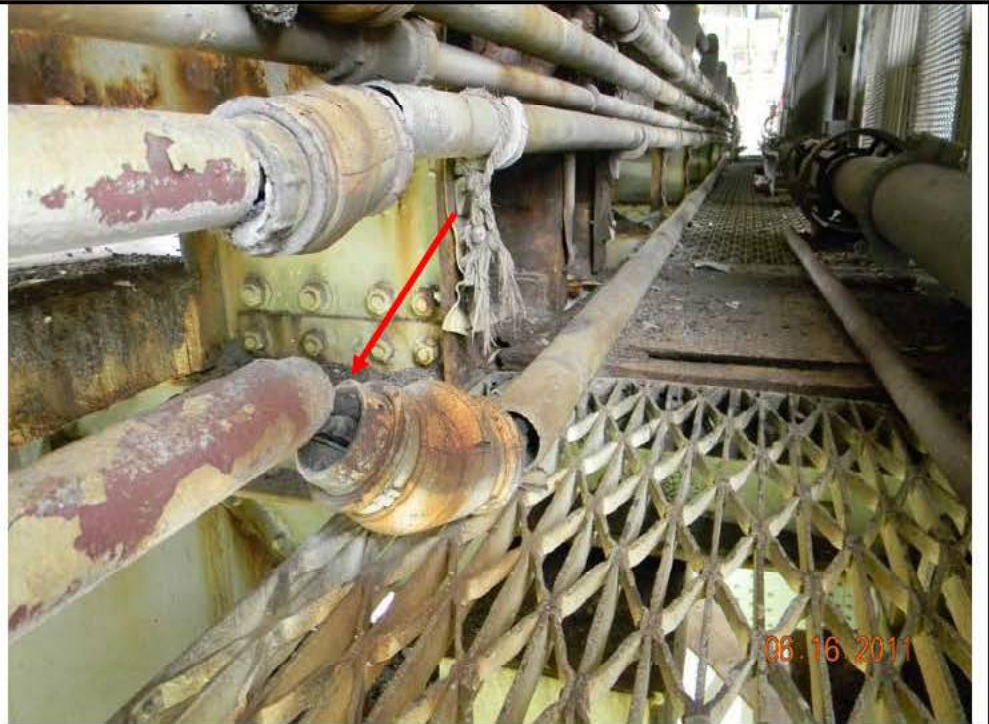
**Photo No.:** 45.

**Description:** Broken conduit coupling connection with exposed wires along the safety walk (Accessible to public / stranded motorists).

13. Repair the broken conduit at the south safety walk at the New Jersey tower (Accessible to the public / stranded motorists) (1 location).	TD-2 <i>(Photo 45)</i>

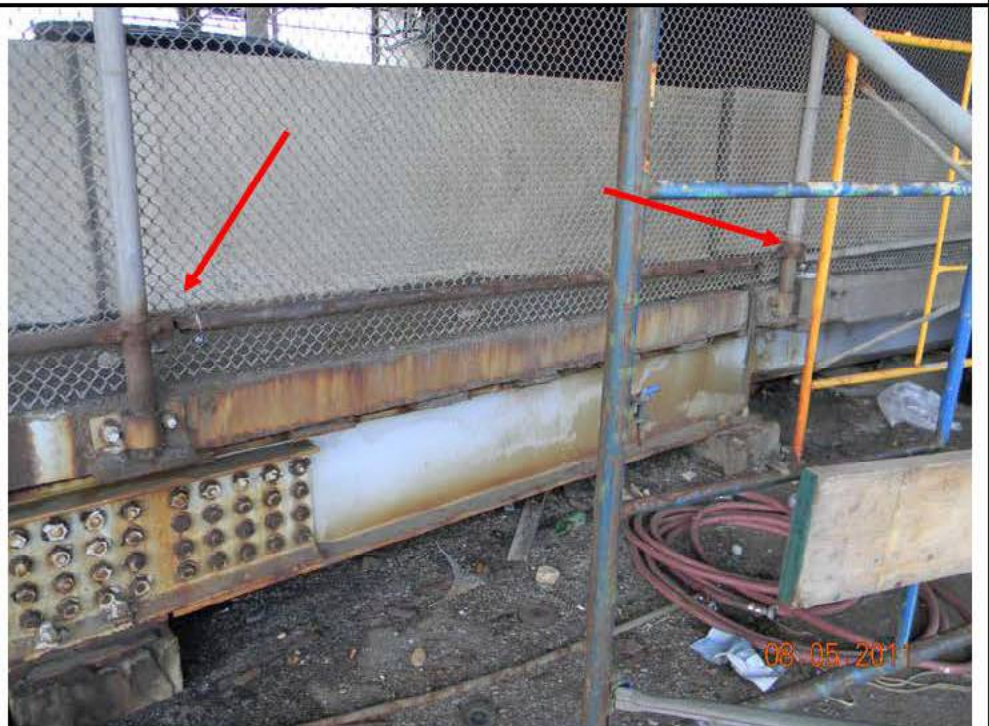
**Photo No.:** 46.

**Description:** The bottom rail of the fence panel is severely corroded and broken at both ends at the post connections.

14. Replace the broken bottom rail of the chain link fence panel at the west end of Span 10 along the westbound roadway and east end of Span 11 along the eastbound roadway (2 locations).	TD-6 <i>(Photo 46)</i>

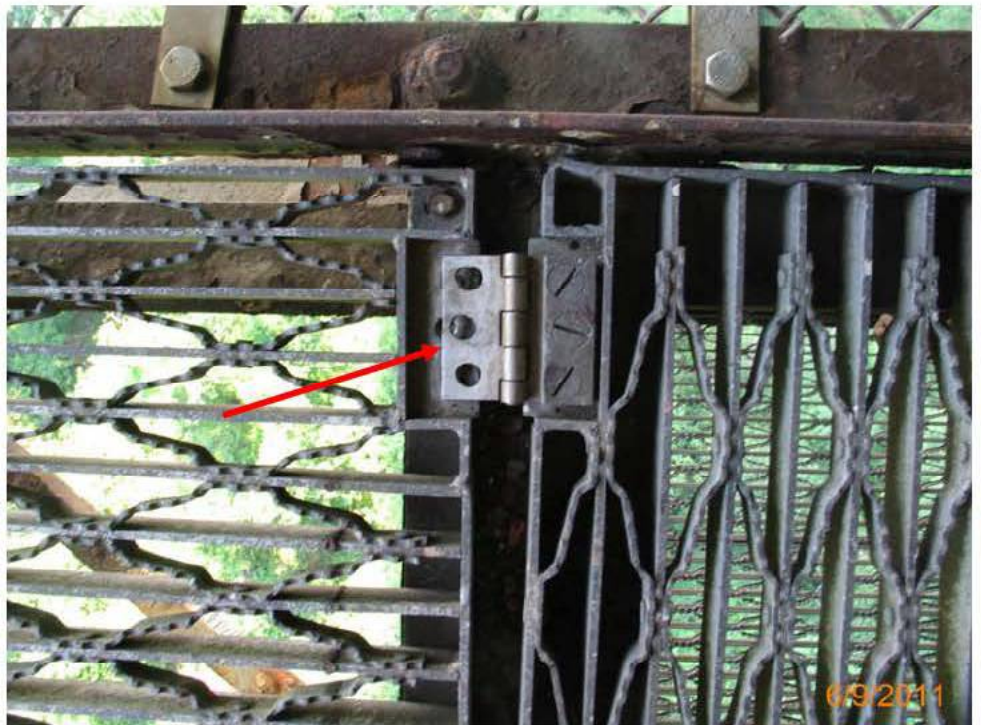
**Photo No.:** 50.

**Location:** East side of New Jersey Back Span Traveler.

18. Replace the missing or broken hinges or hinge screws at access doors in grate floor of the travelers (5 locations).	T-2, T-3 & T-4 <i>(Photo 50)</i>

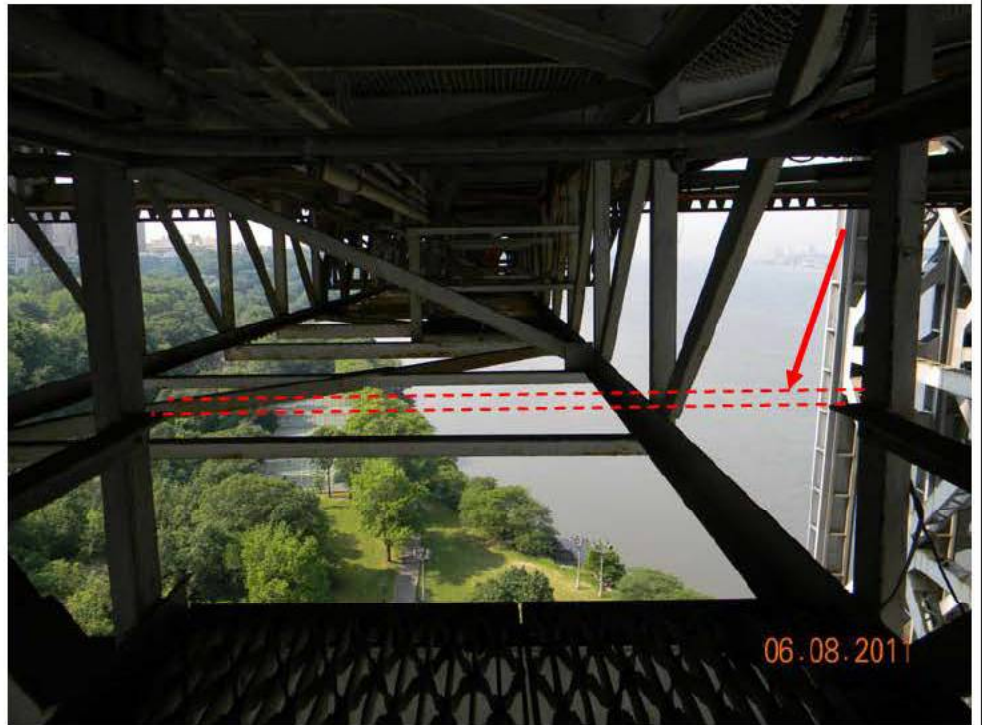
**Photo No.:** 53.

**Description:** Missing horizontal rail angle for platform below traveler floor access hatch.

<b>Repair Recommendation - 2011 Inspection</b>	<b>Dwg. No. (Photo No.)</b>
21. Replace the missing horizontal rail angle at the New York back span traveler truss platform below the floor access hatch (1 location).	T-5 <i>(Photo 53)</i>
22. Tighten or replace the loose or missing bolts for safety netting straps and replace the missing safety netting straps and bolts (169 locations).	T-2, 3, 4 & 5 <i>(Photo 54)</i>

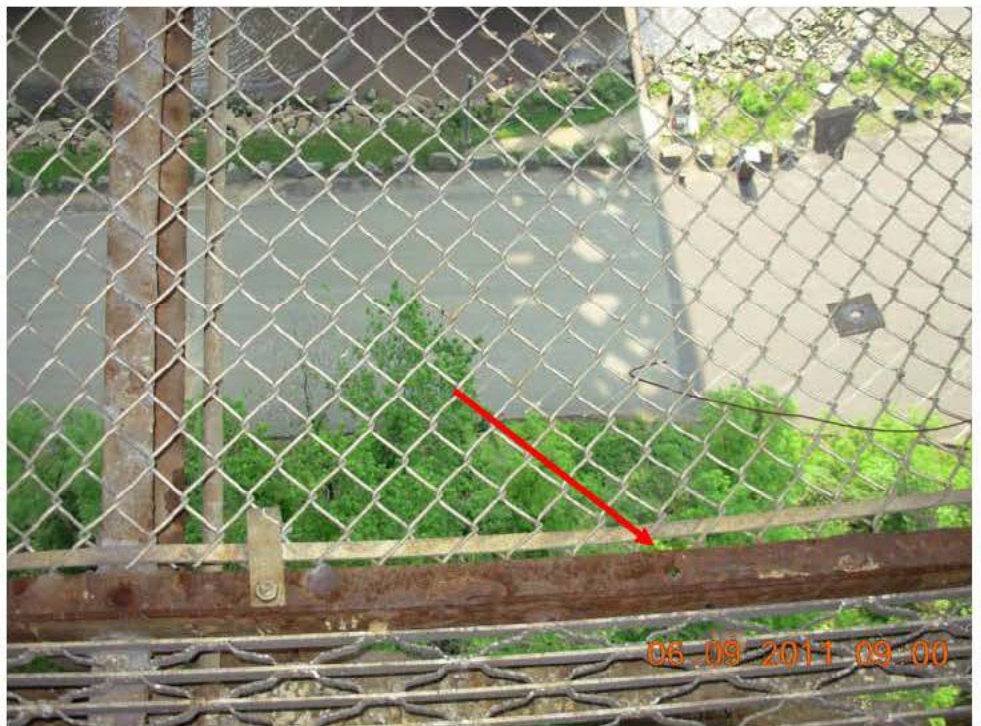
**Photo No.:** 54.

**Description:** Missing strap attachment (arrow) connecting traveler floor to safety netting fence fabric.
