Port Authority Facility Condition Survey Program

**George Washington Bridge
Main Span Lower Level
2013 Biennial Inspection**

December 2013

**Re: Expert Professional Services for the Performance
of Biennial Inspection of the George Washington
Bridge Upper & Lower Levels
PA Agreement No. 405-13-005; P.O. 4900009127**

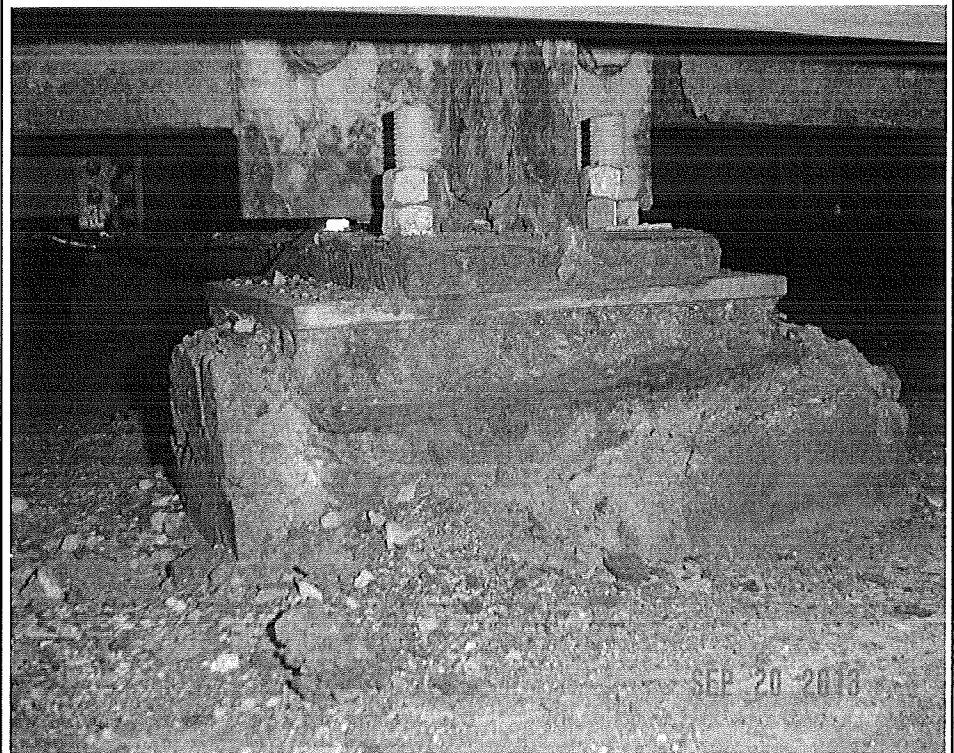
(Priority Repair 1)

Description: Pedestal exhibits a large spall with exposed and corroded rebar causing minor undermining of the bearing.

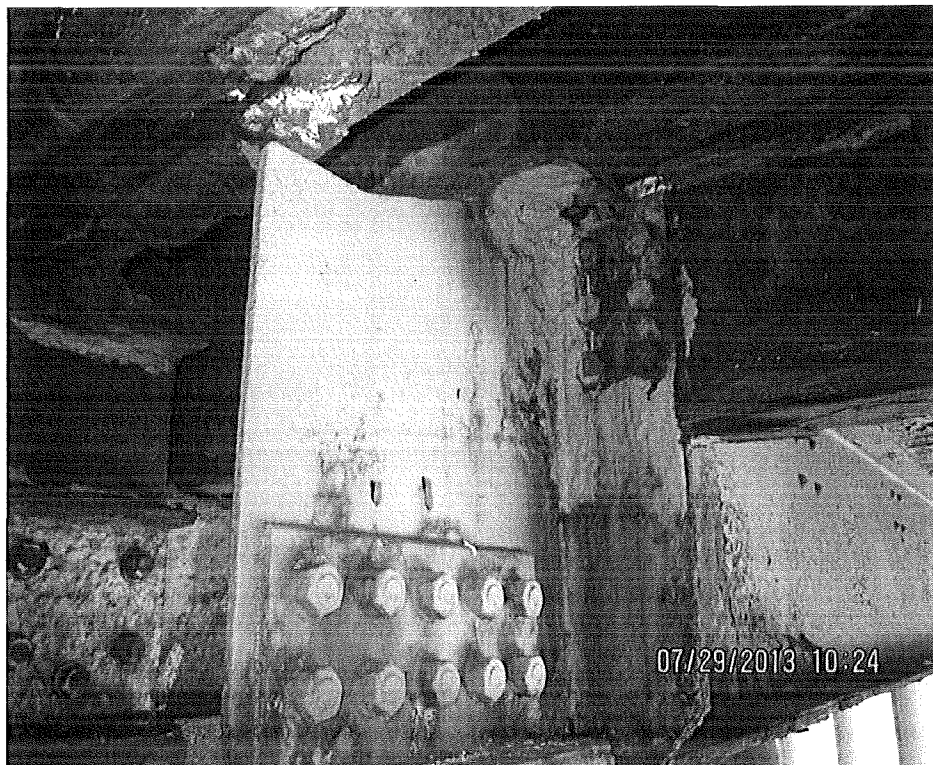
(Priority Repair 3)

Description: The end of the stringer exhibits severe corrosion with two 1" holes in the middle of the web.

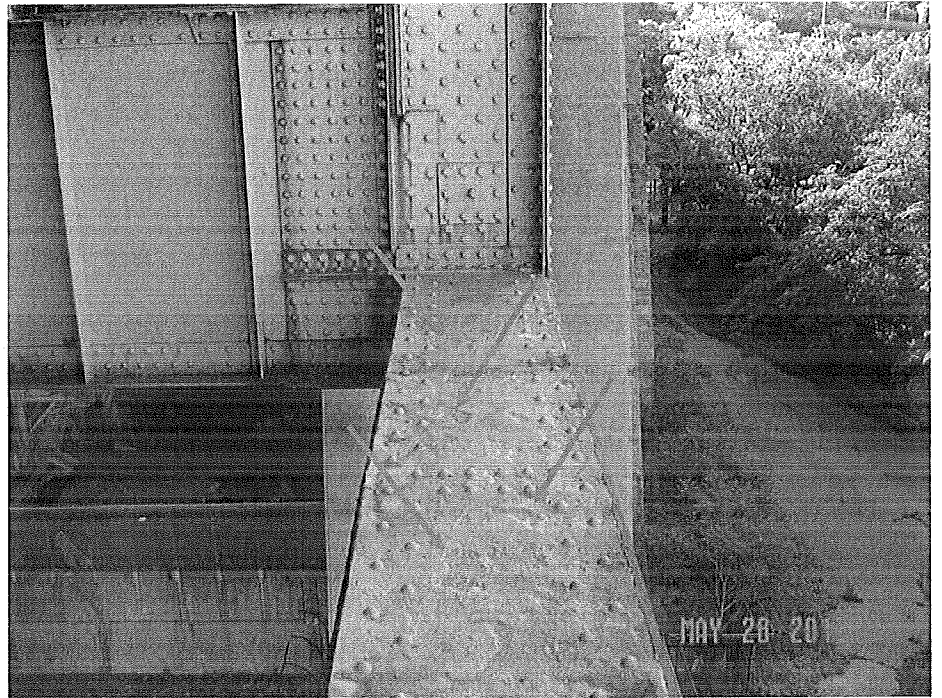
(Priority Repair 4)

Description: The top plate is severely pitted with twelve (12) holes up to 6" long x 2" wide filled by caulking.

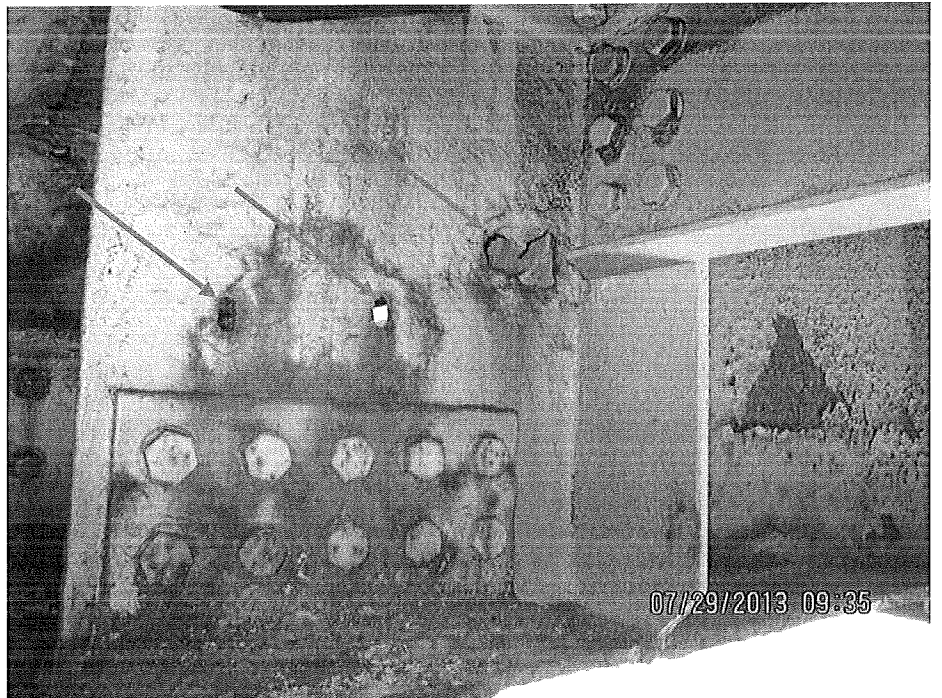
(Priority Repair 5)

Description: The web at the end of stringer exhibits severe corrosion with holes, including a 3" x 1" hole near the top of the web.

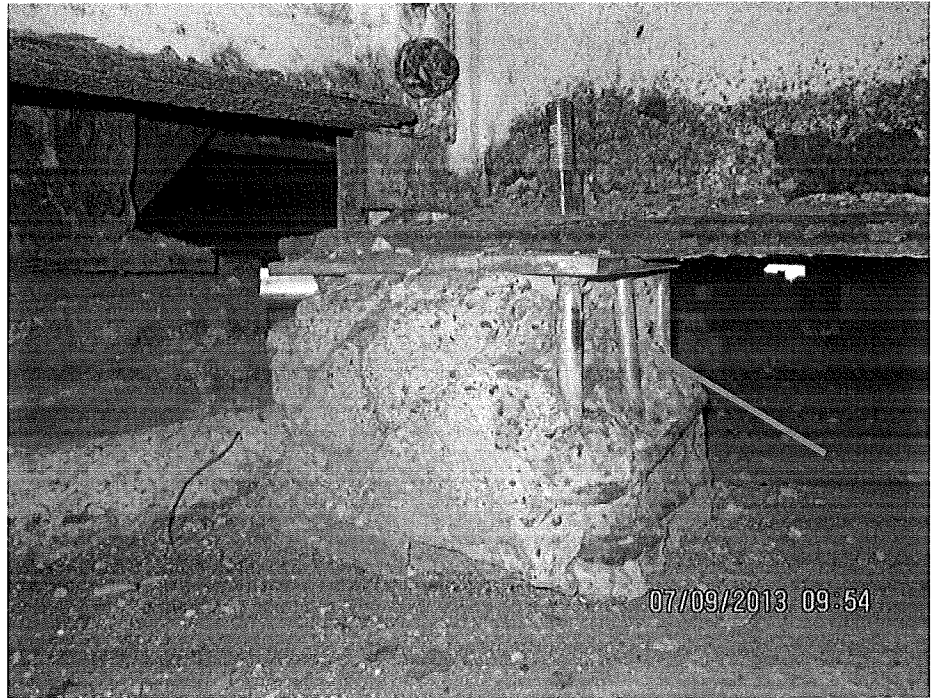
(Priority Repair 6)

Description: The pedestal is severely cracked and spalled exposing bearing anchor bolts causing undermining of the bearing plate.

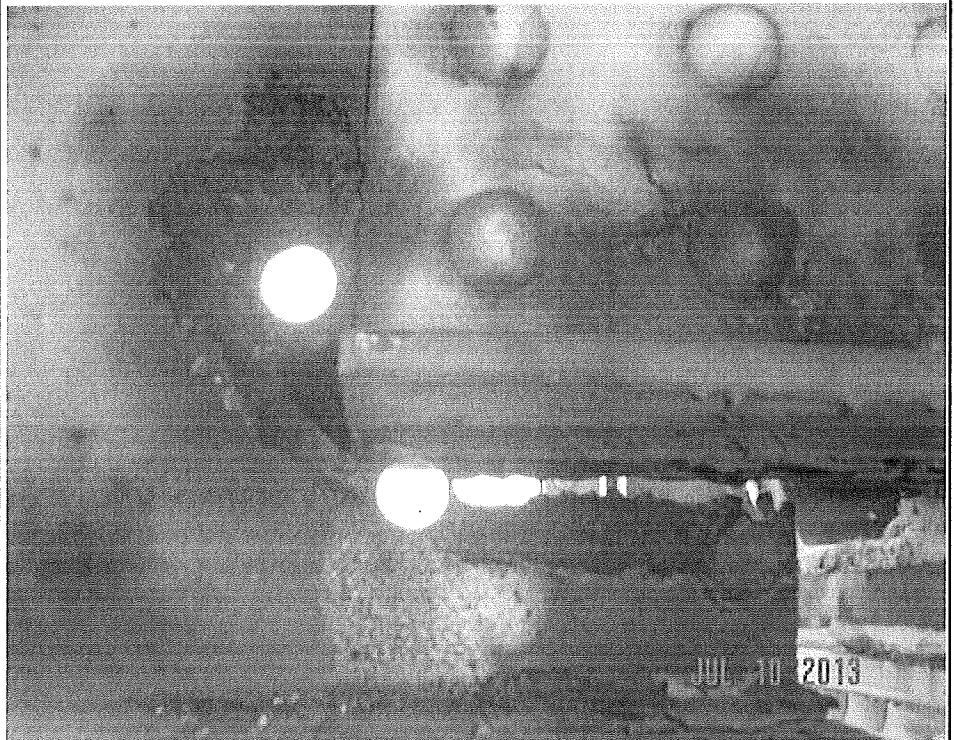
(Priority Repair 7)

Description: The stringer web exhibits severe corrosion with section loss and holes along the bearing stiffening angle at the floorbeam connection. Two 3/4" crack arrestor holes were drilled at this location.

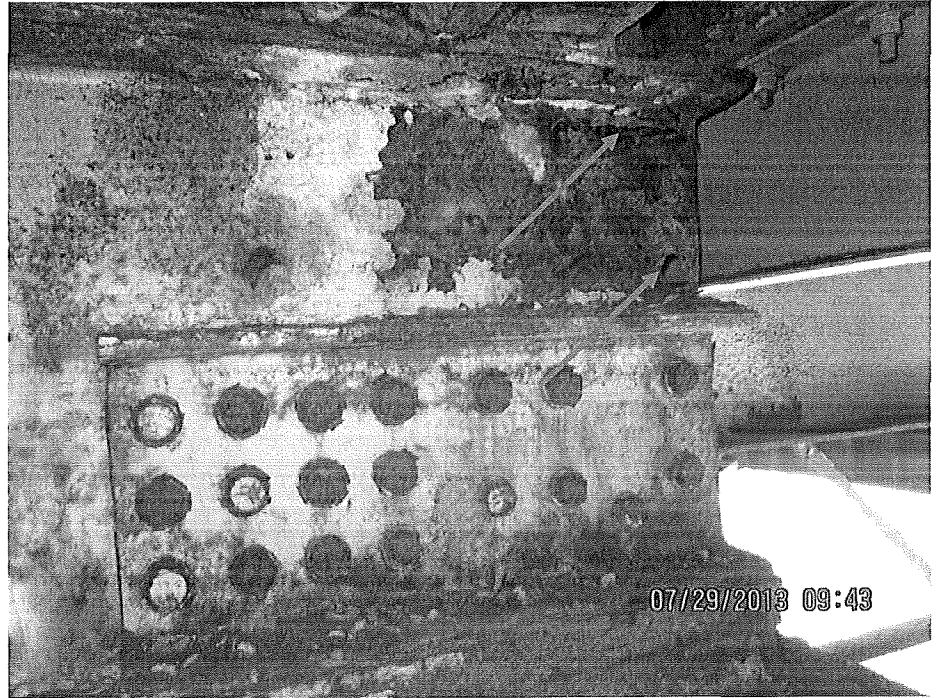
(Priority Repair 8)

Description: The web and top flange are severely corroded with large holes including a 1" high x 6" wide hole in the top of the web and a 2" diameter hole near the middle of the web.

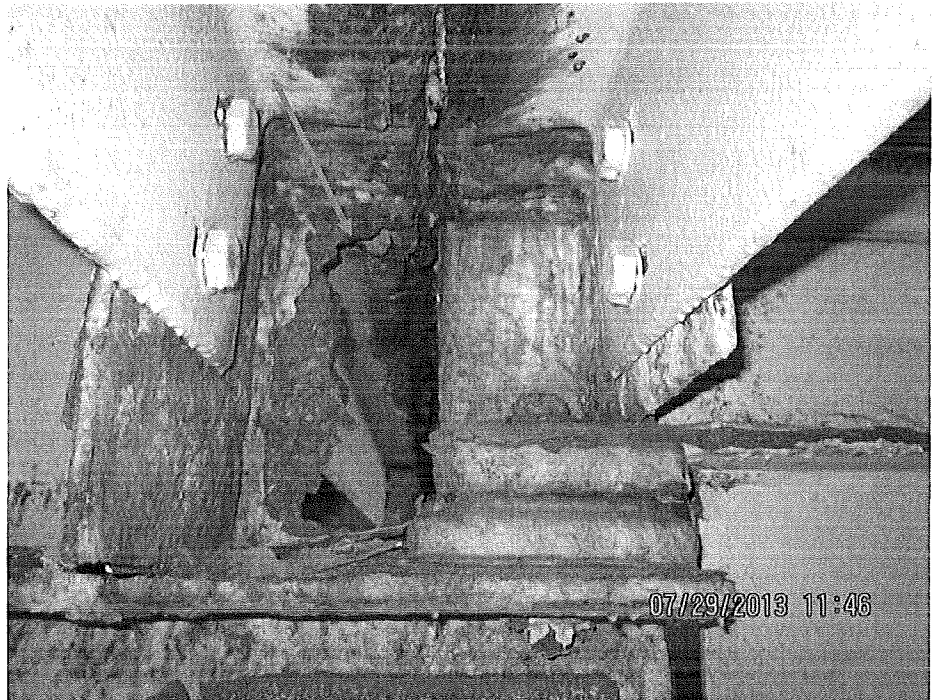
(Priority Repair 9)

Description: The end of stringer exhibits severe corrosion with a 4" x 11" hole in the web above the bearing.

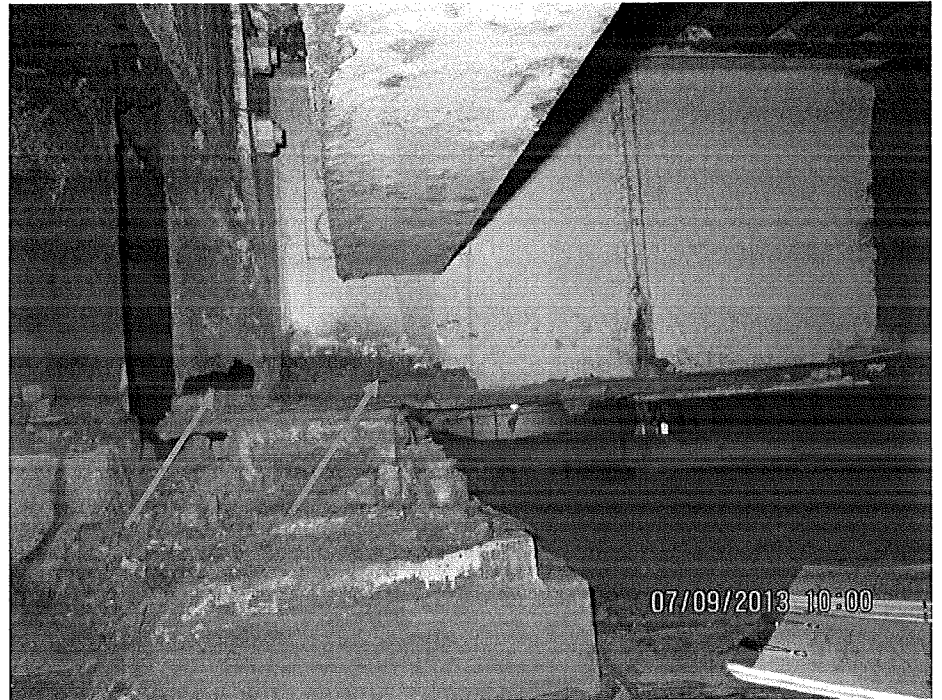
(Priority Repair 9)

Description: The bottom of the web exhibits severe corrosion with a 2" x 4" hole and an adjacent 5" long corrosion crack above the bearing.

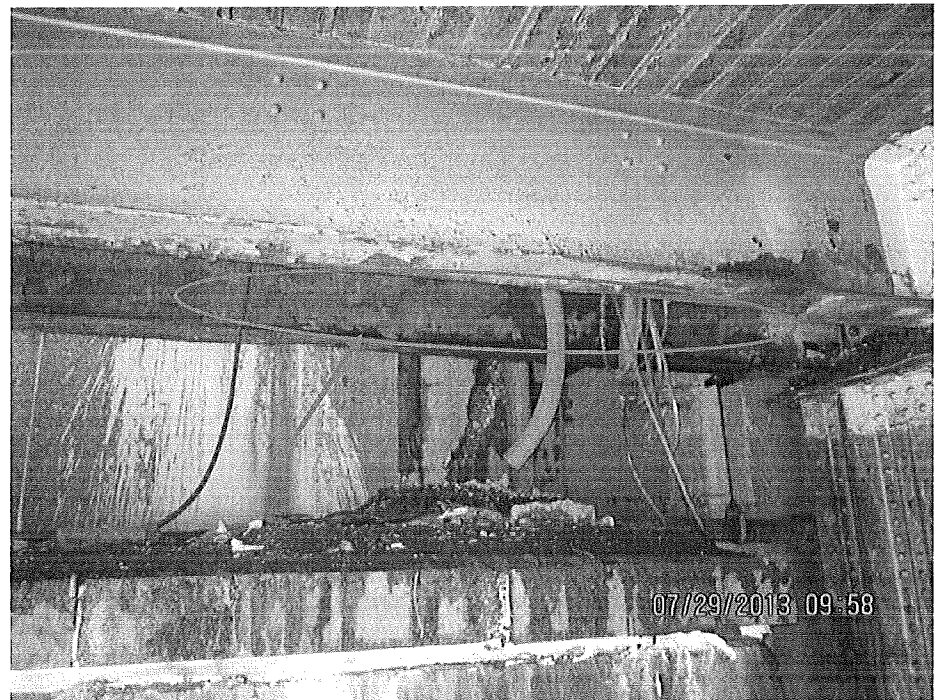
(Priority Repair 10)

Description: Fascia stringer S18 exhibits 50% section loss of both flanges along with large holes at the bottom of the web.

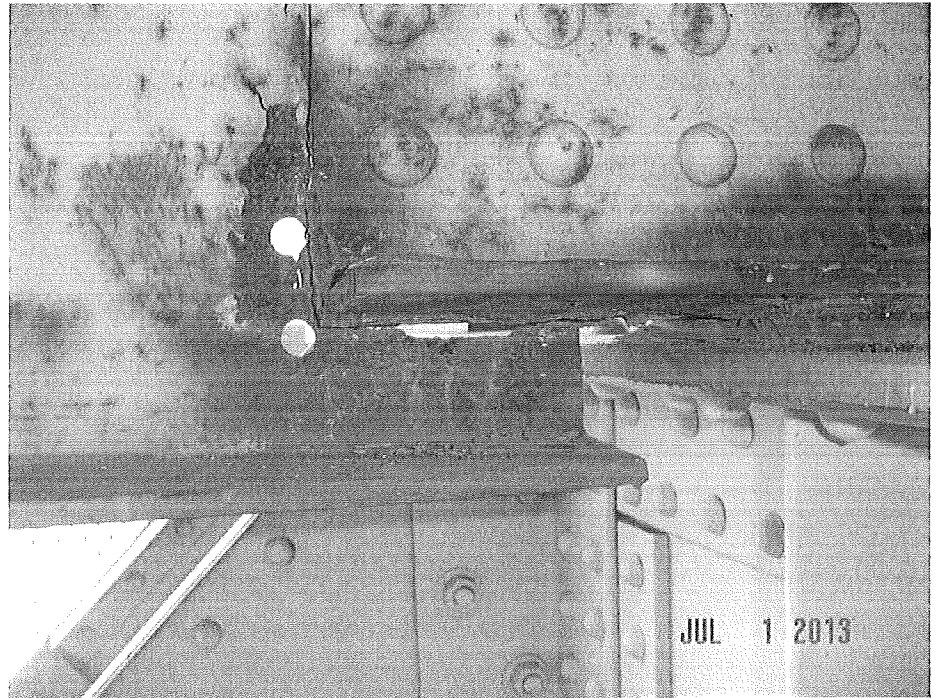
(Priority Repair 11)

Description: The stringer web exhibits severe corrosion with section loss and holes along the bearing stiffening angle at the floorbeam connection. Two 3/4" crack arrestor holes were drilled at this location.

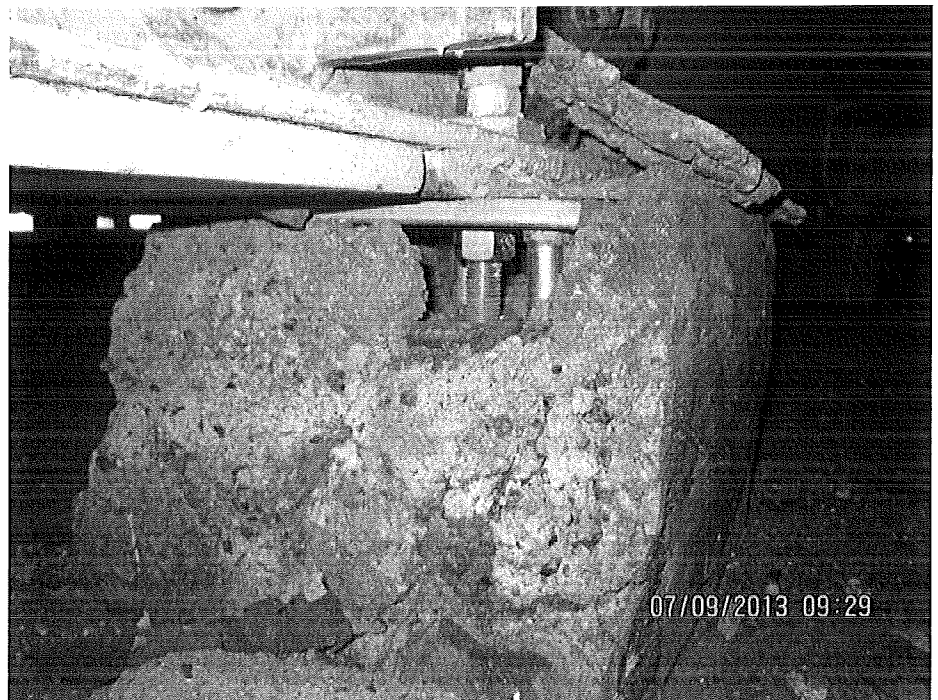
(Priority Repair 12)

Description: The pedestal exhibits spalled concrete with voids, causing minor undermining of the bearing plate under the stringer.

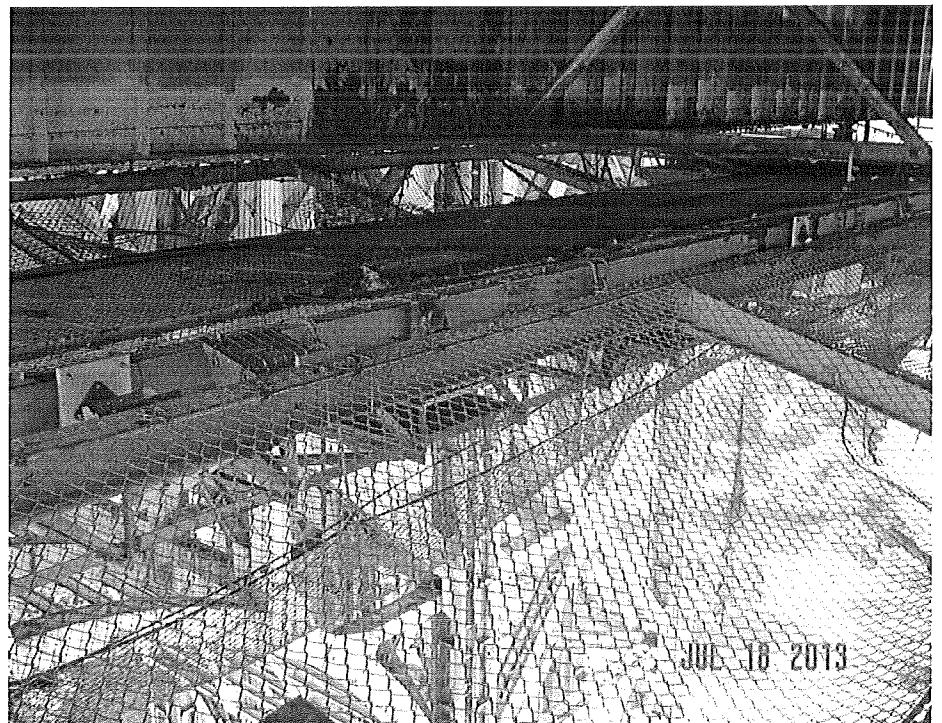
(Priority Repair 20)

Description: General View. The traveler is not operational and is enclosed by netting to prevent falling debris. The traveler exhibits moderate to severe corrosion and section loss to main support truss members.

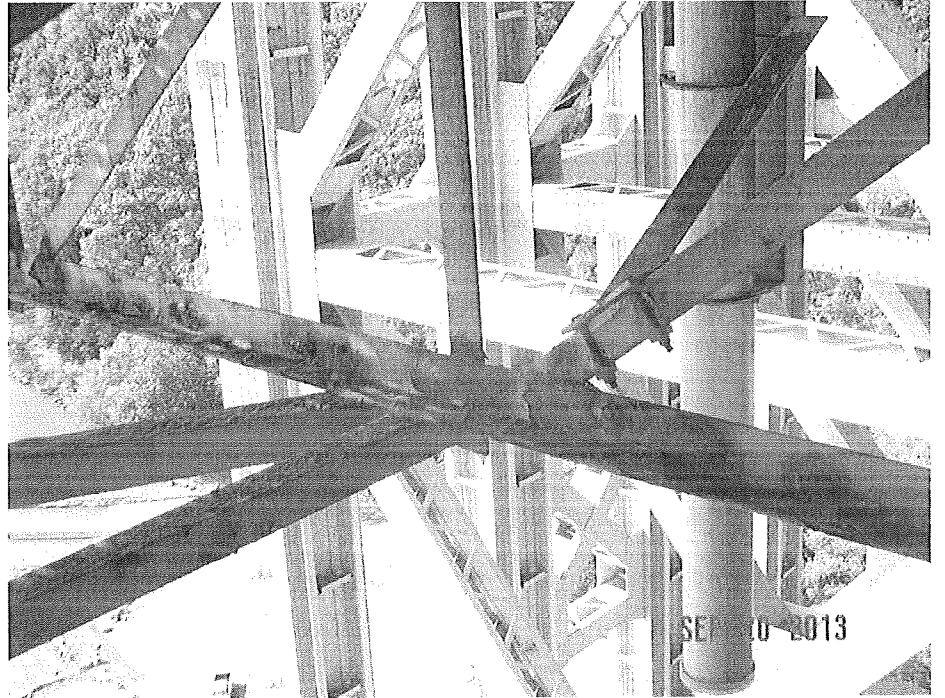
(Priority Repair 21)

Description: Moderate to severe section loss and corrosion at west bottom main support truss members.

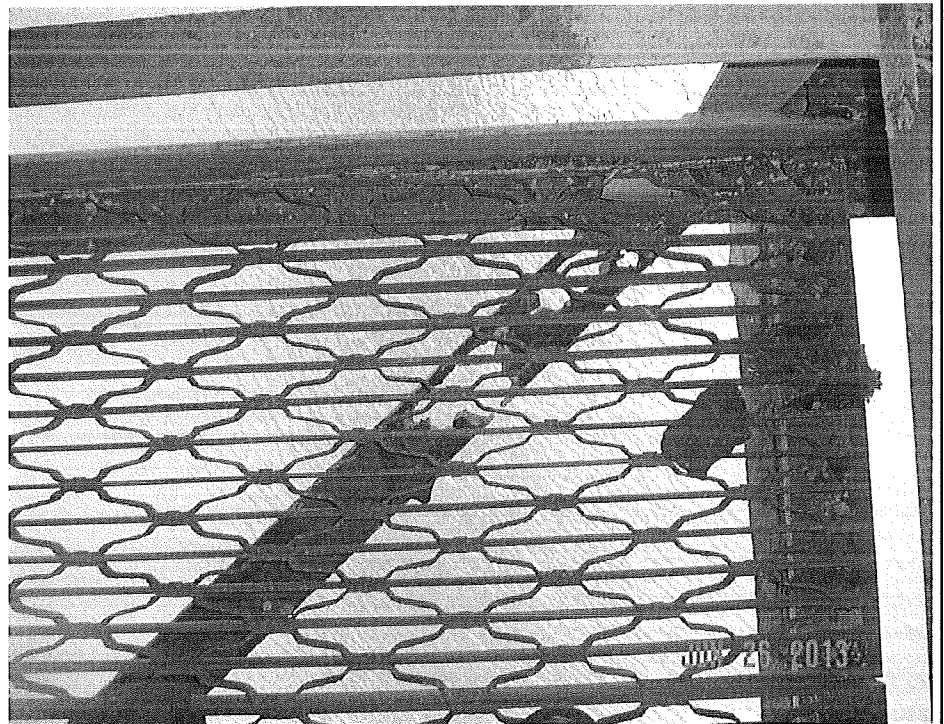
(Priority Repair 22)

Description: The bracing angle for the top chord of the traveler truss is severely corroded with large holes.

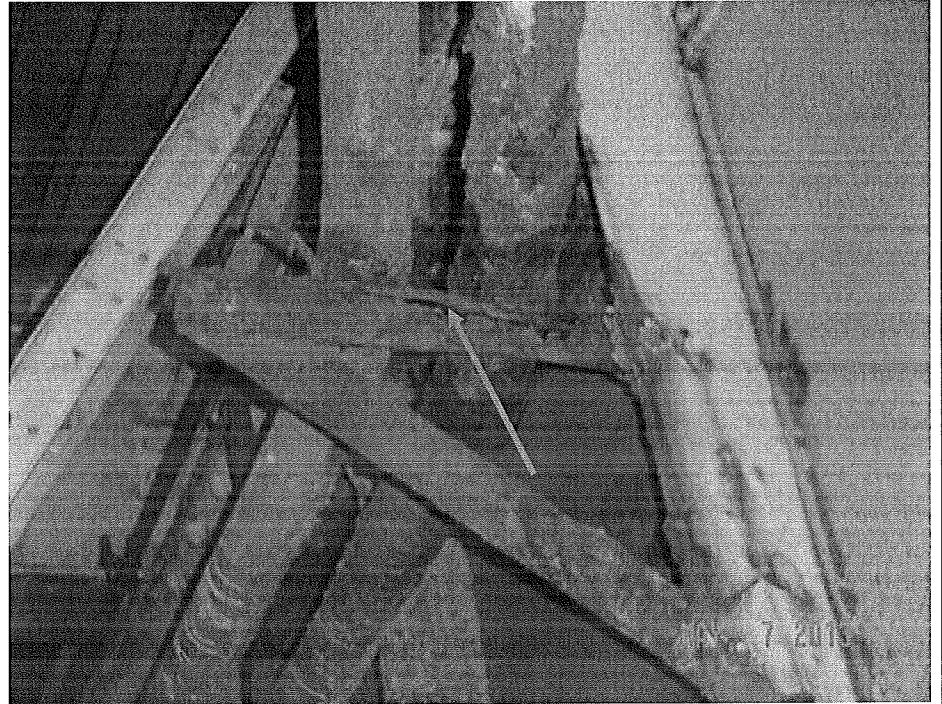
(Safety Repair 1)

Description: The conduit knee brace support exhibits severe corrosion with up to 90% section loss to the horizontal support member. One of the conduits is severely corroded.

Repair Recommendation - 2013 Inspection	Dwg. No. (Photo No.)
1. Replace severely deteriorated steel knee brace support bracket for two 3-inch diameter electrical conduits at stringer S2, west of Floorbeam 3W at span 1 (1 location).	SDU-1 (Photo 31)

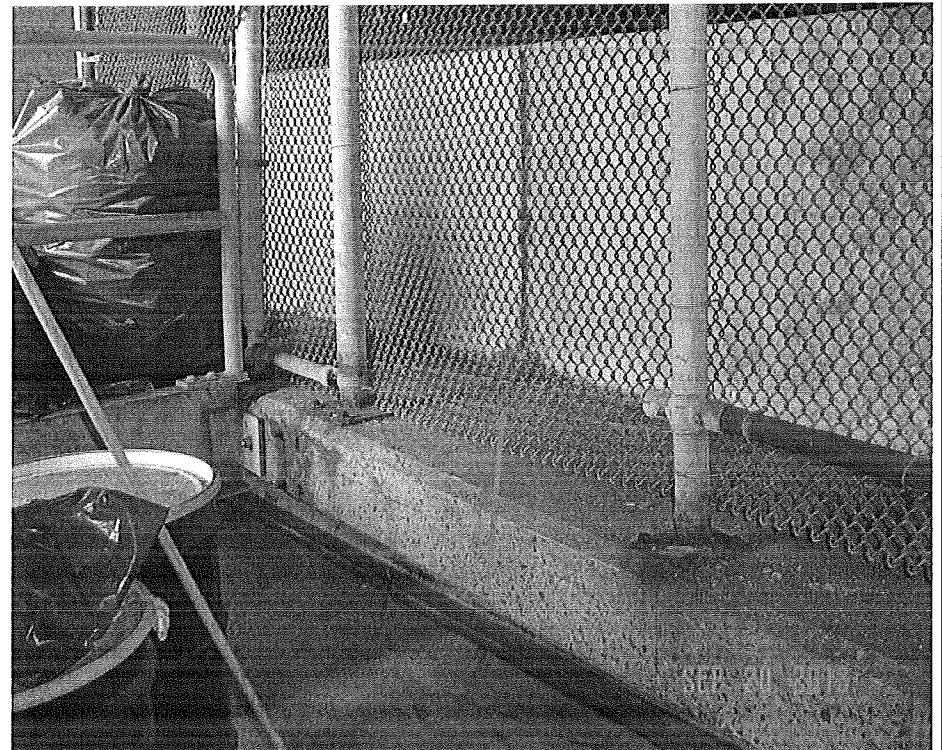
(Safety Repair 2)

Description: Bottom rail of the chain link fence panel is missing.

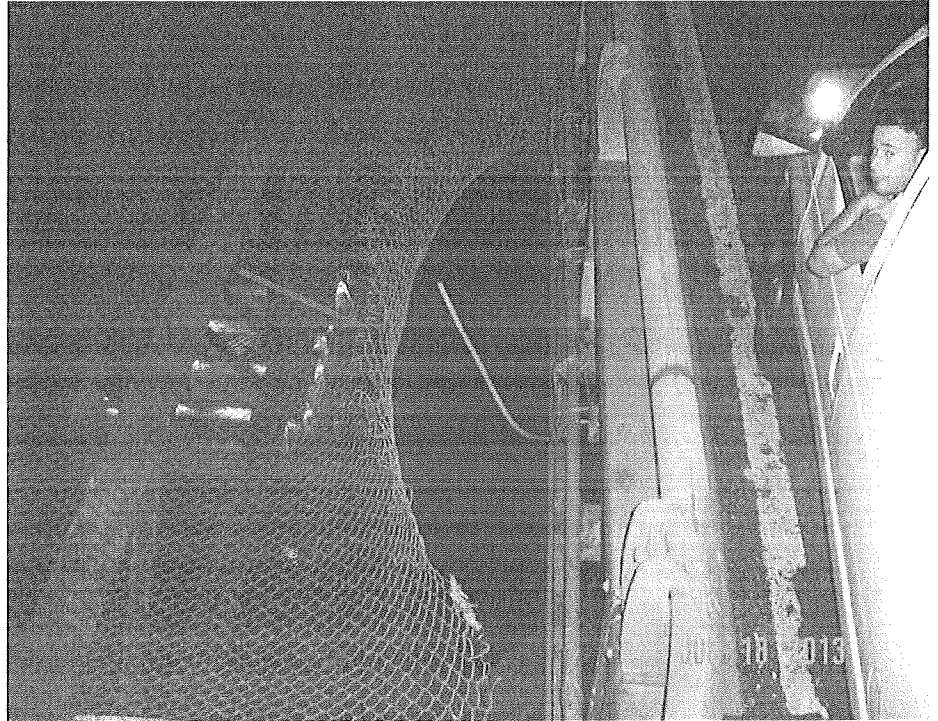
(Safety Repair 3)

Description: The netting exhibits a 10' long x 4' wide hole.

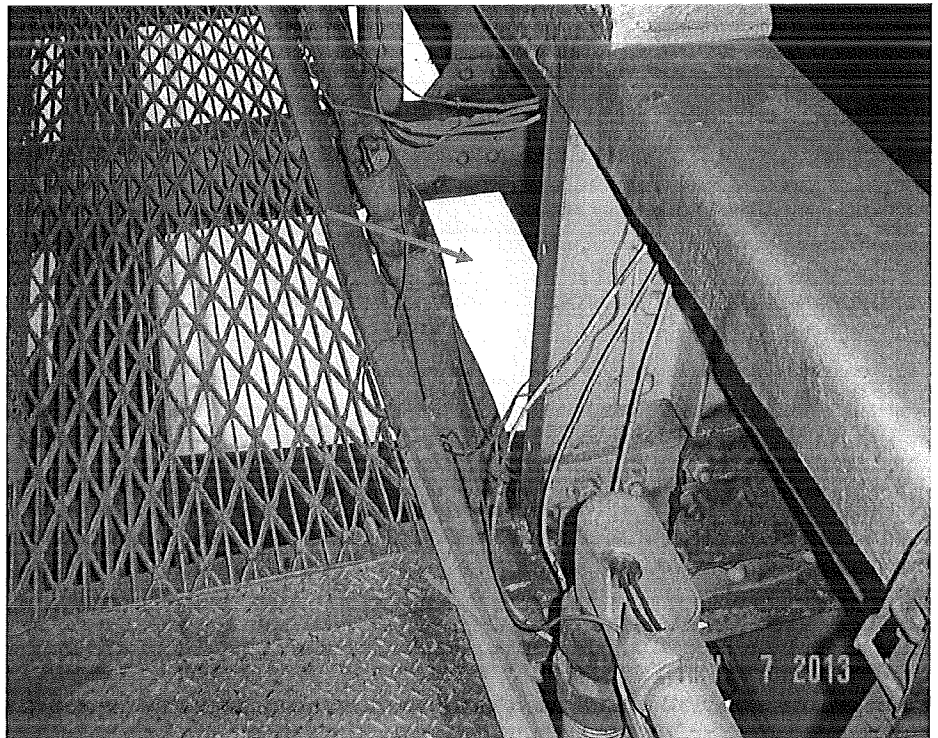
(Safety Repair 4)

Description: 2' x 1' opening in the safety walk, and 2' long x 4" wide cut out area of safety walk grating for conduits.

4. Repair or replace the 2' x 1' opening in the north safety walk due to removed conduits and 2' long x 4" wide section of removed safety walk grating at the New Jersey Tower (1 location).	TD-2 (Photo 34)

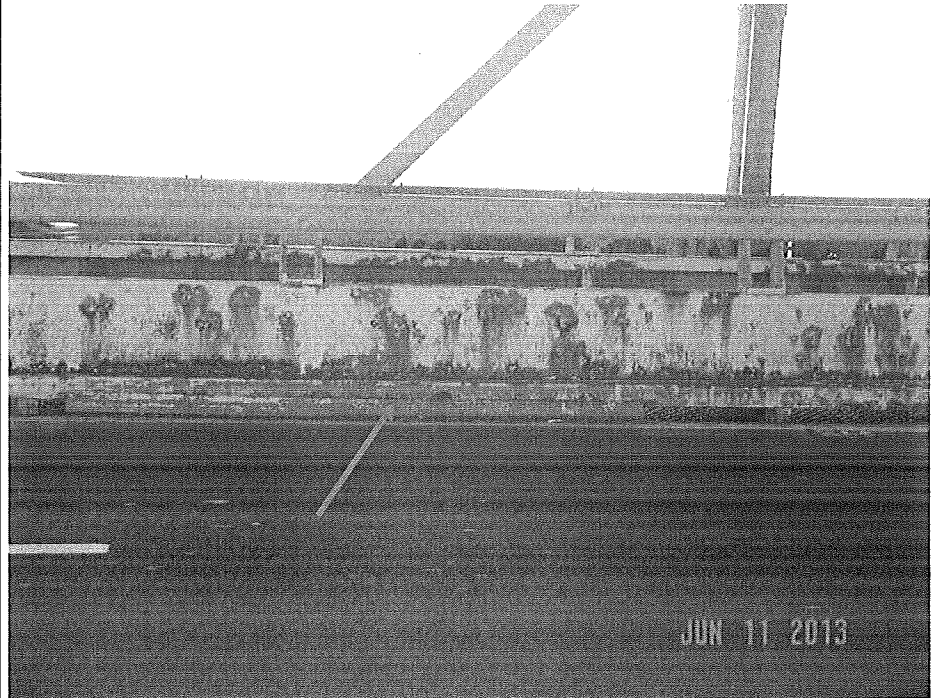
(Safety Repair 5)

Description: Section of steel curb plate has been partially detached along the median barrier.

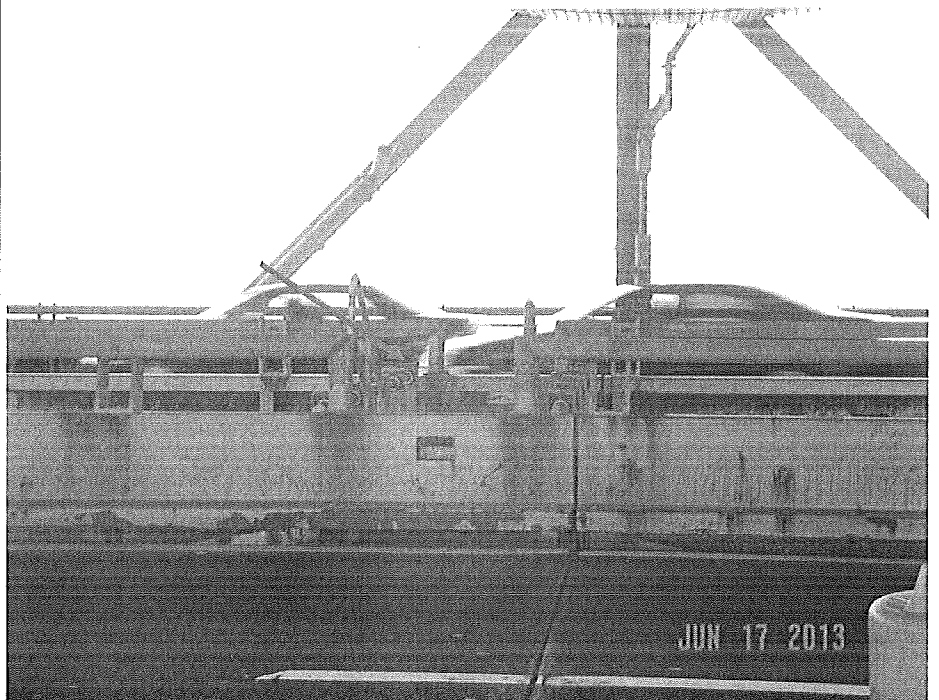
(Safety Repair 6)

Description: The southeast handrail (one of four) is missing at the stairs from the median barrier to the access catwalk.

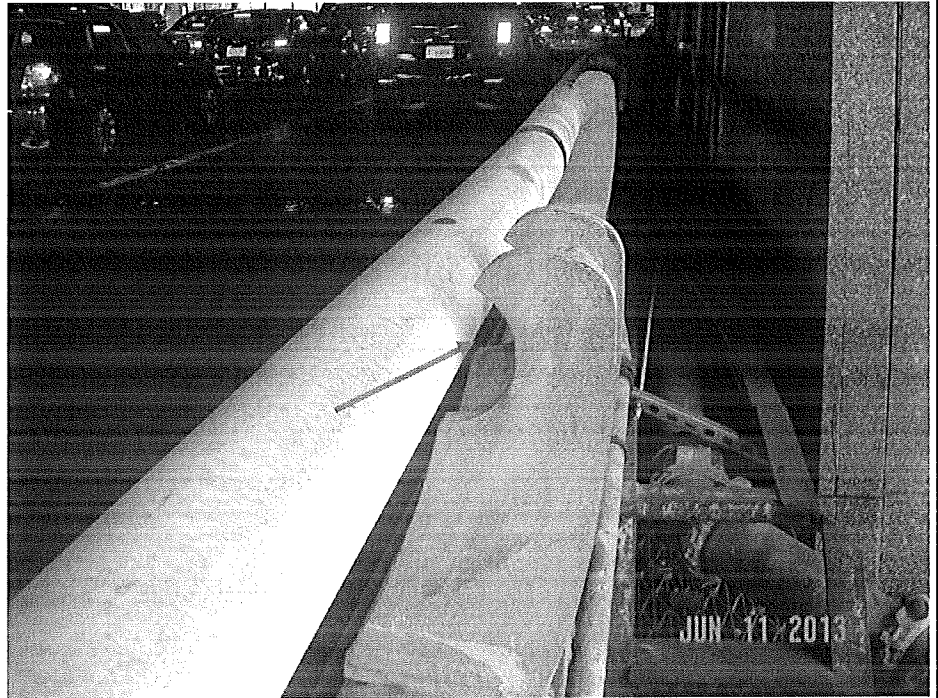
(Safety Repair 7)

Description: Railing is detached from the post connection along the top of the roadway barrier.

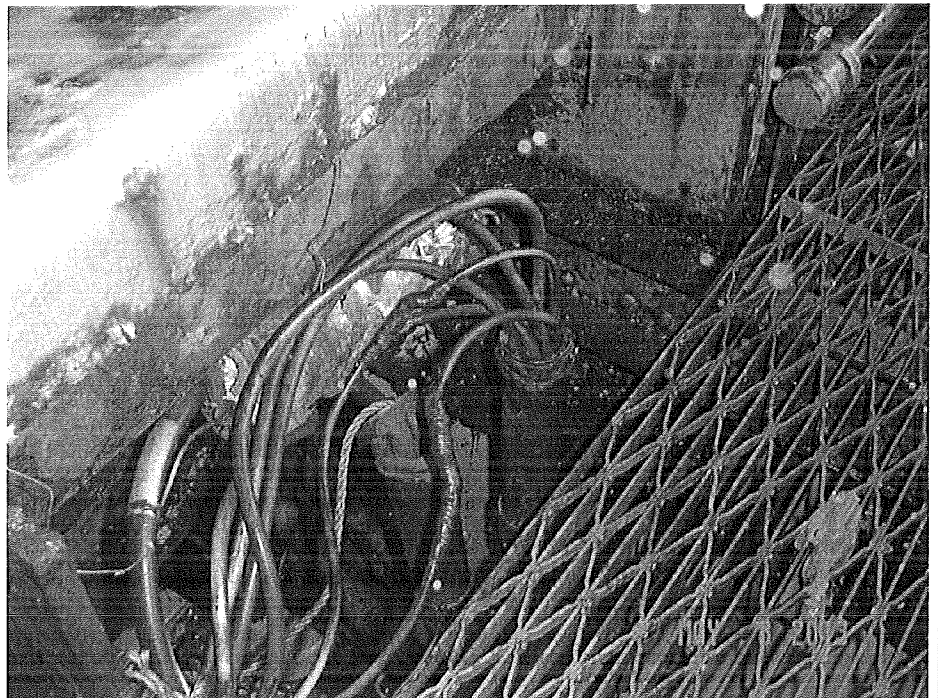
(Safety Repair 8)

Description: Missing electrical box cover with exposed wires attached to the back of roadway barrier (Accessible to public/stranded motorists).

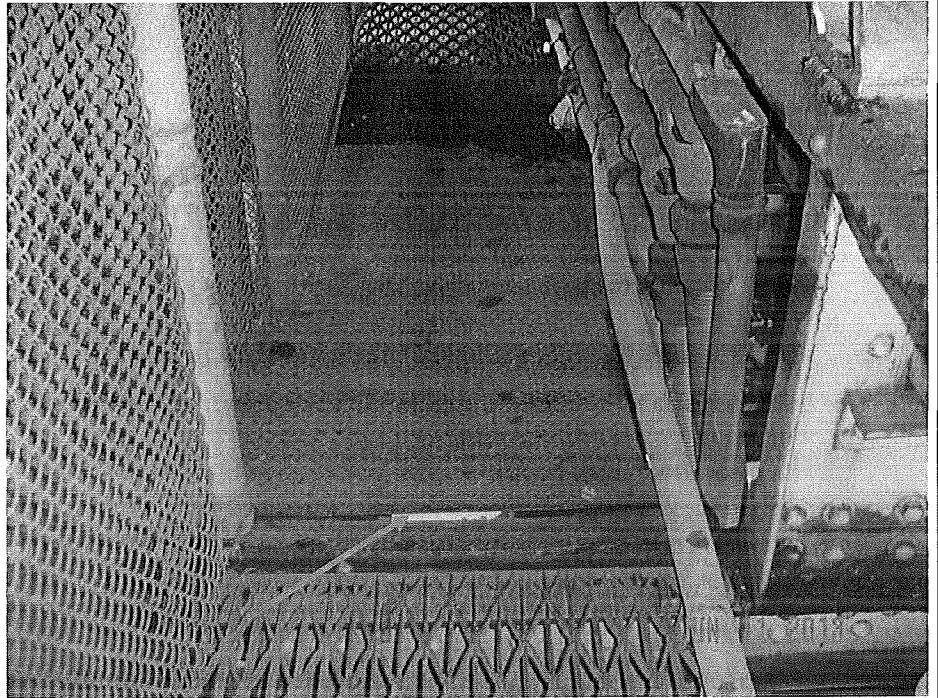
(Safety Repair 9)

Description: The west edge of the safety walk diamond plate is uplifted 1.5" causing a tripping hazard.

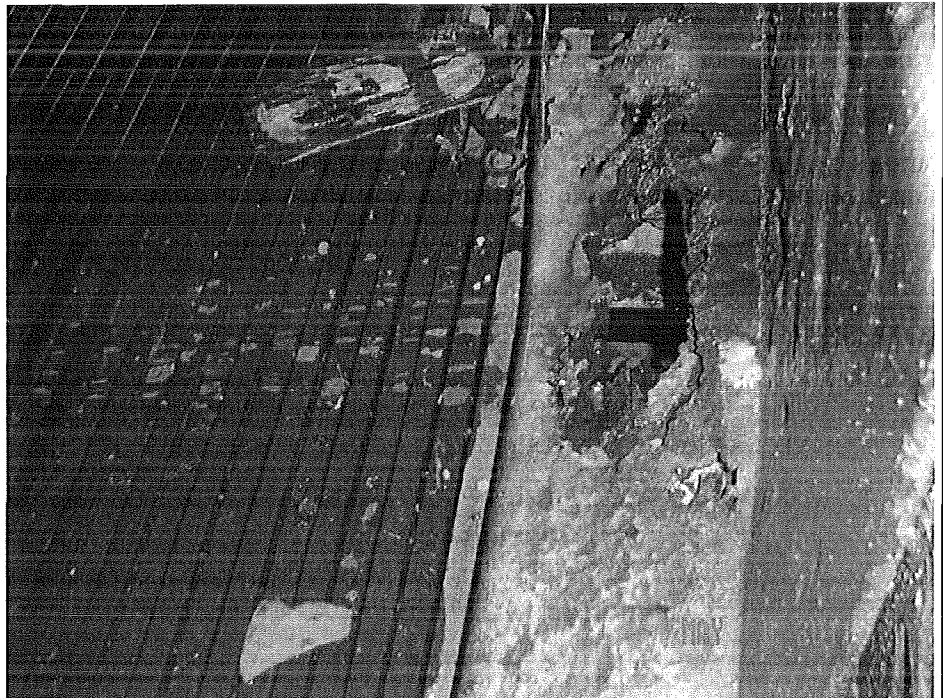
(Safety Repair 10)

Description: A four feet long section of steel curb is severely corroded with numerous holes.

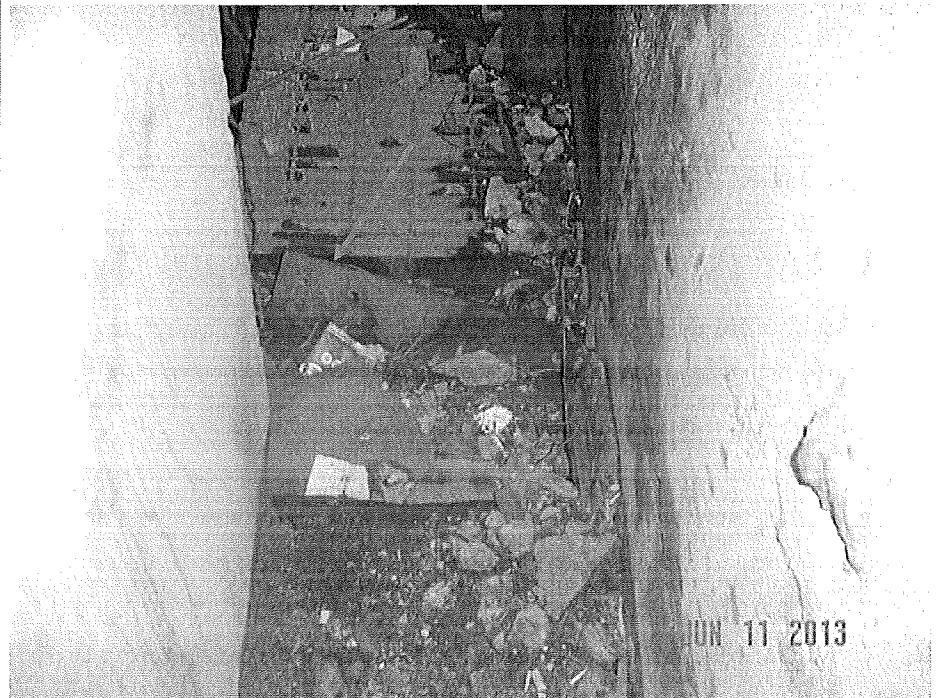
(Safety Repair 11)

Description: There is a bent and broken end plate at the end of the safety walk (creating a tripping hazard).

Repair Recommendation - 2013 Inspection	Dwg. No. (Photo No.)
11. Replace bent and broken diamond end plate at the end of the north safety walk at 1E (creating a tripping hazard) (1 location).	TD-9 (Photo 41)

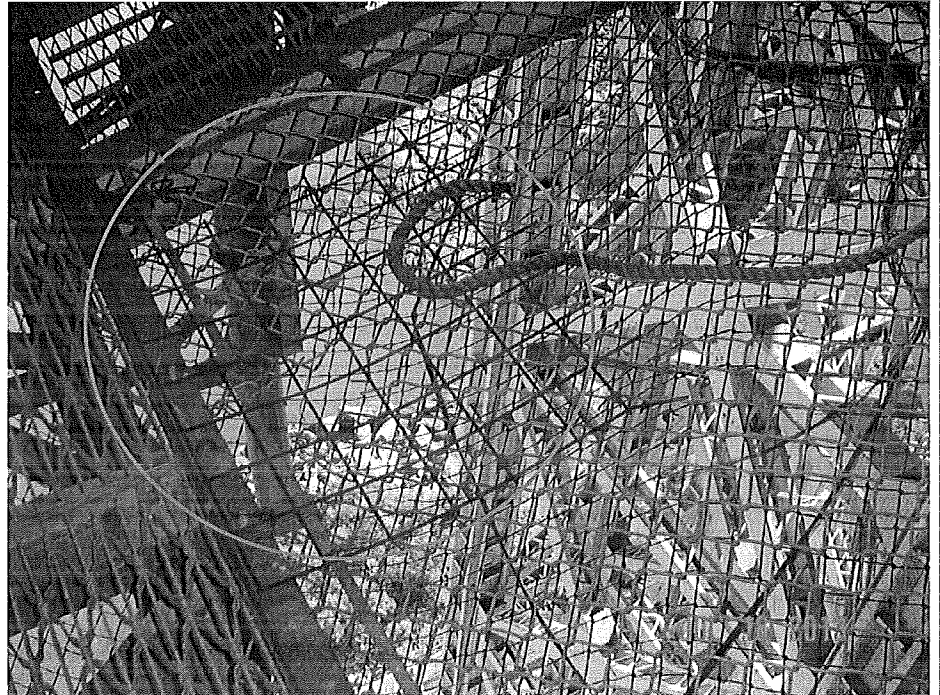
(Safety Repair 13)

Description: Large hole in the safety netting with inadequate wire mesh.
