Port Authority Facility Condition Survey Program

George Washington Bridge
2015 Inspection Report of
Main Span Upper Level

Volume 1 of 2

January 2016

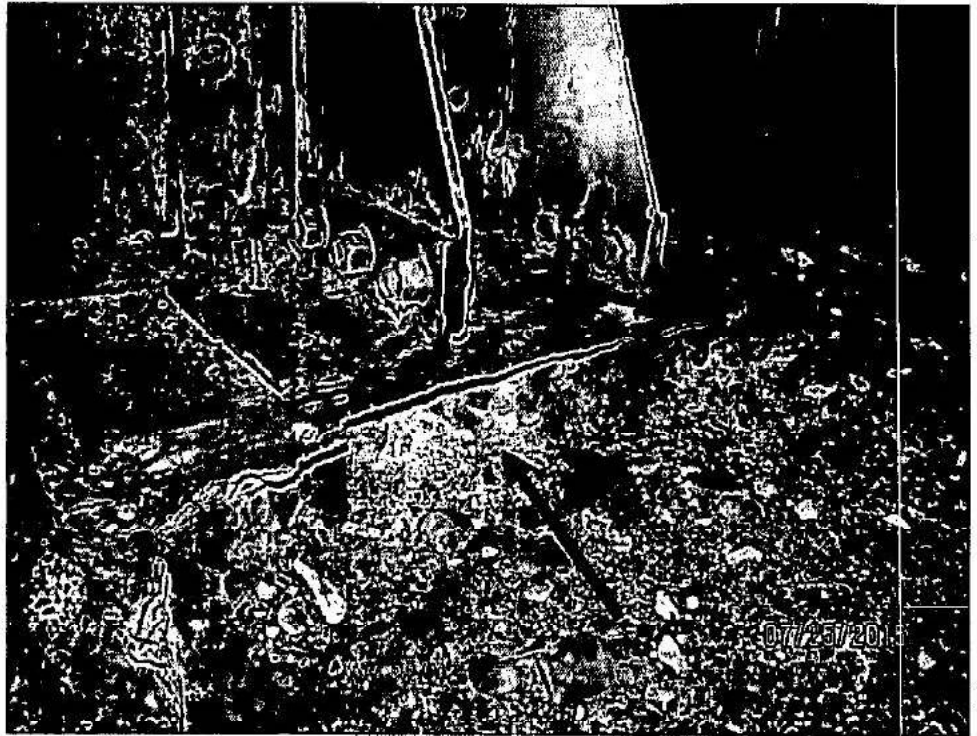
Photo No.: A4

(Priority Repair No. 3)

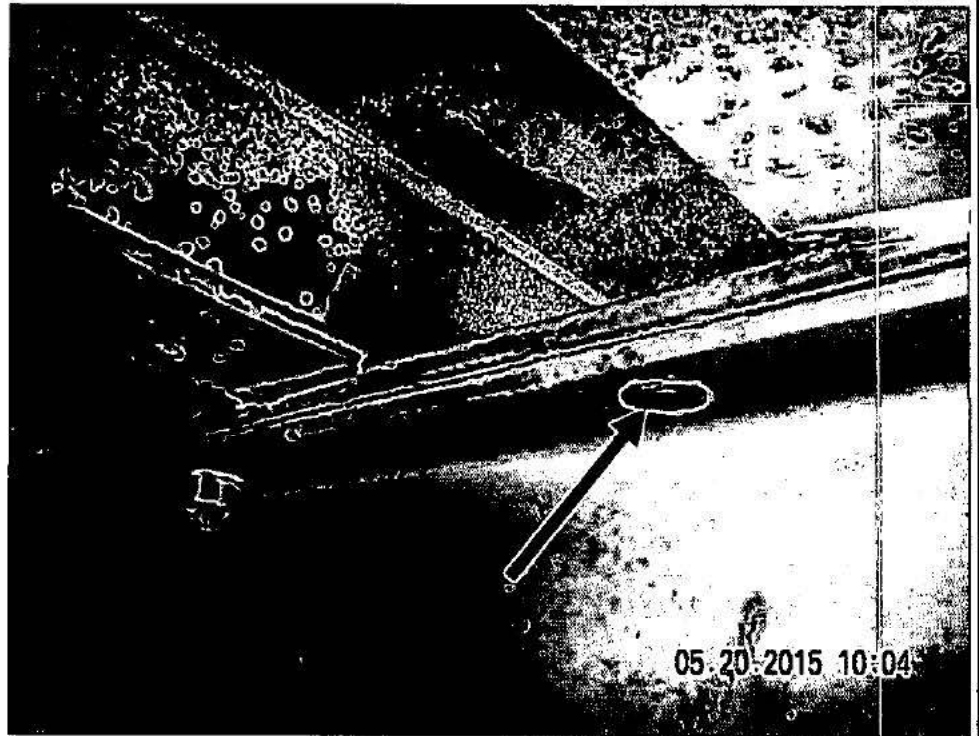
Photo No.: A6

(Priority Repair No. 5)

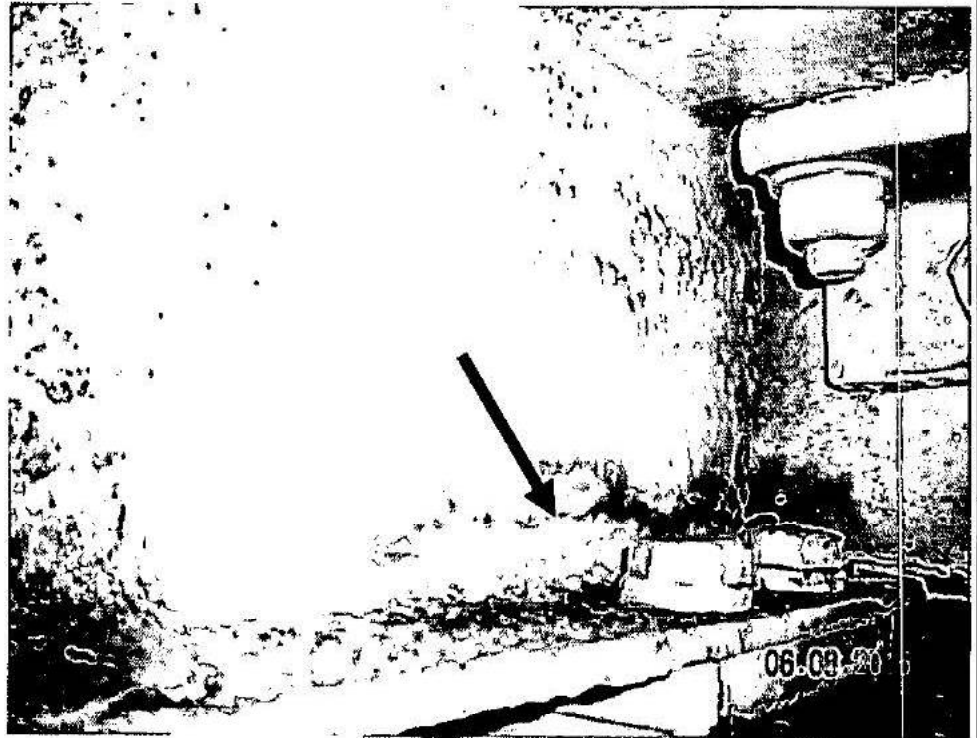
Photo No.: A12

(Priority Repair No. 11)

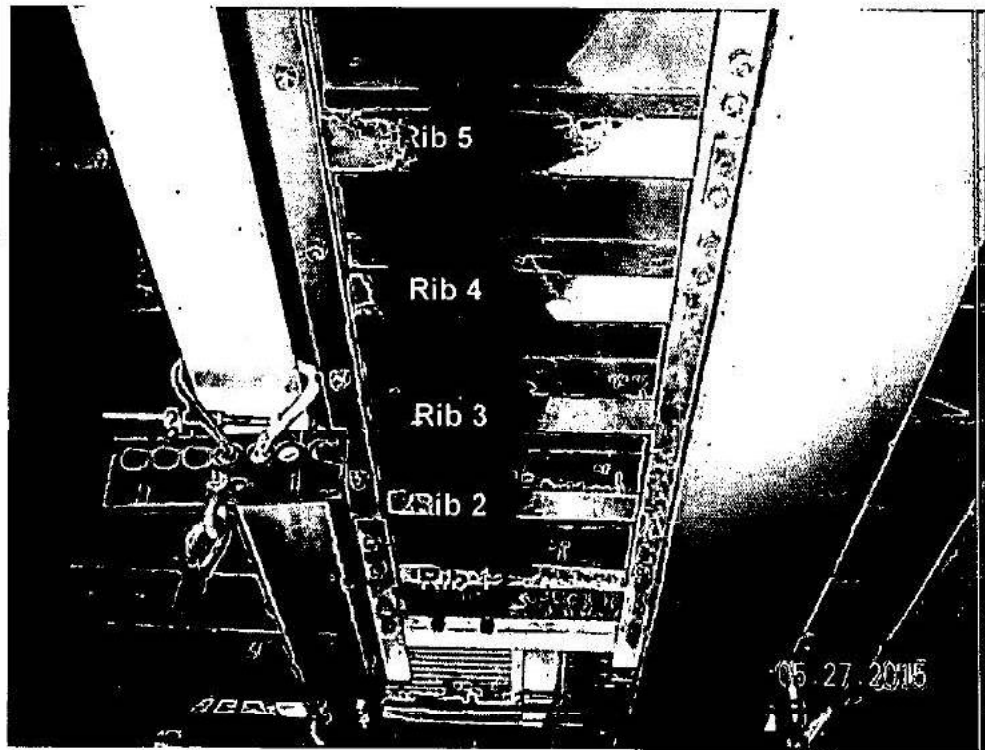
Severely deteriorated deck ribs 1 thru 5 with cracks and/or corrosion holes in the web.

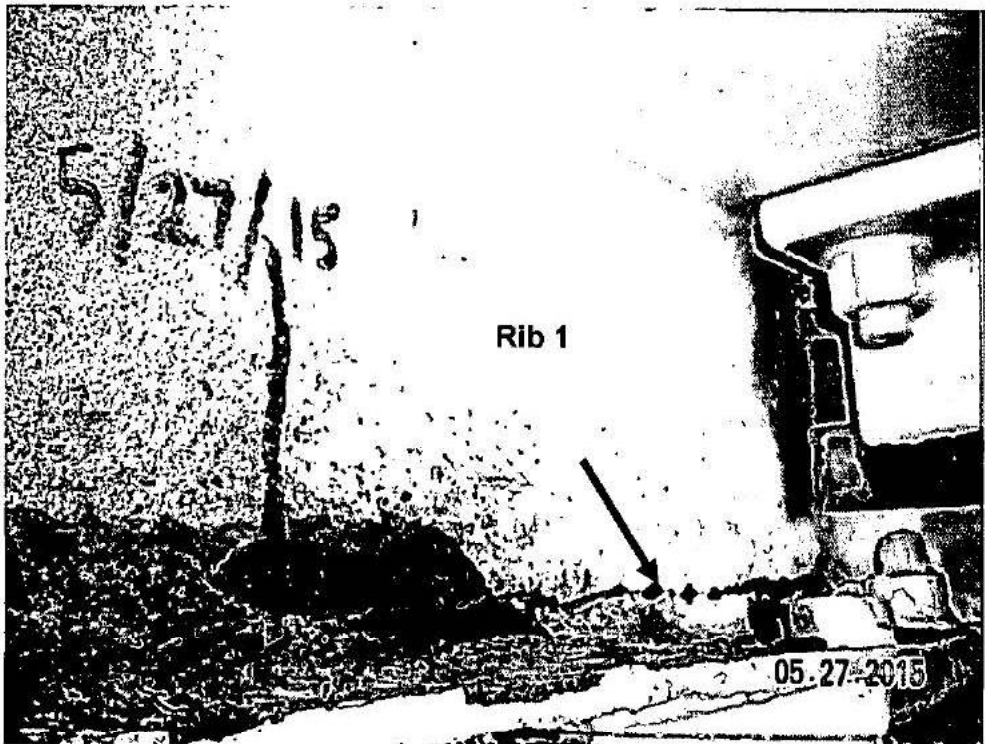
Photo No.: 2

Severely deteriorated deck rib with 12" long crack at the bottom of the web.

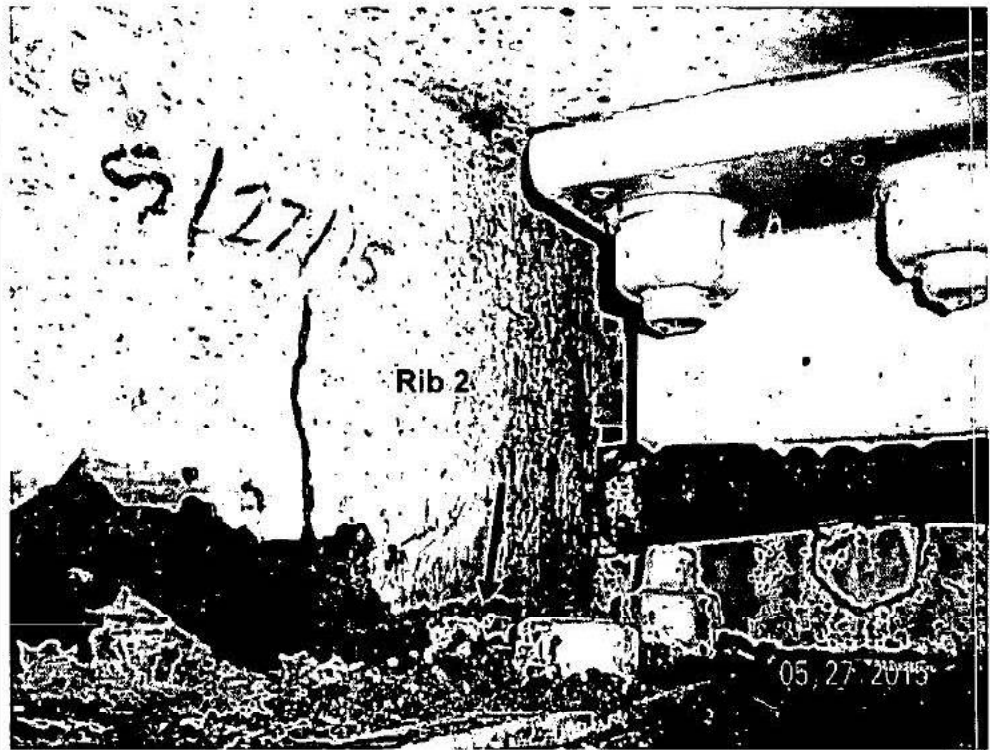
Photo No.: 3

Severely deteriorated deck rib with 7 1/2" long crack at the bottom of the web.

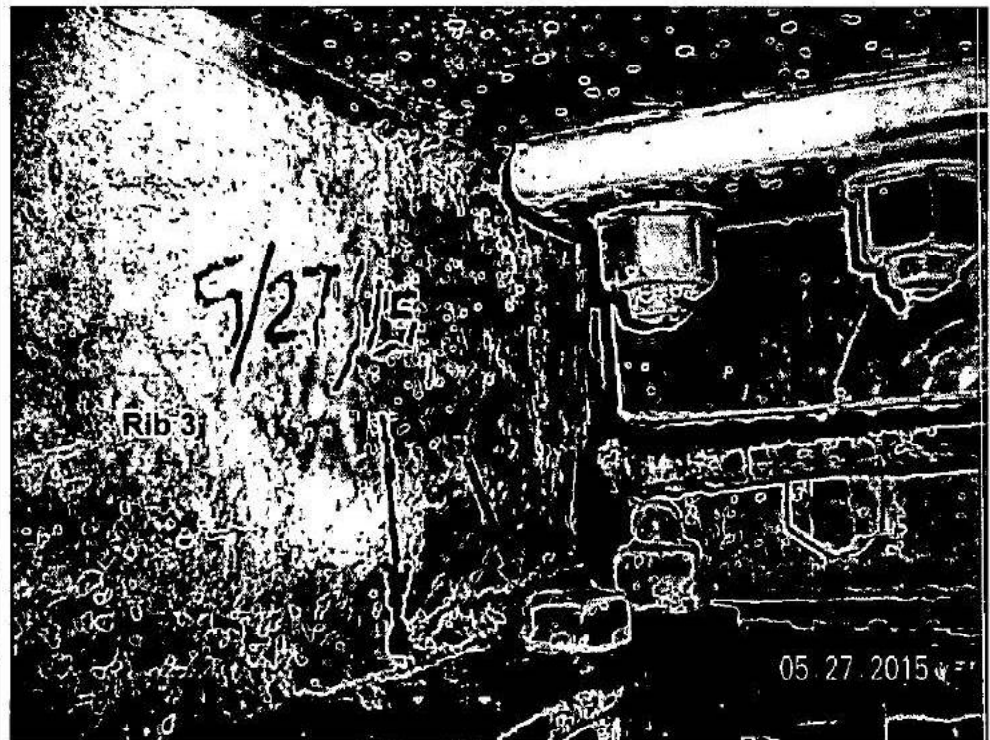
Photo No.: 4

Severely deteriorated deck rib with 6" long crack at the bottom of the web.

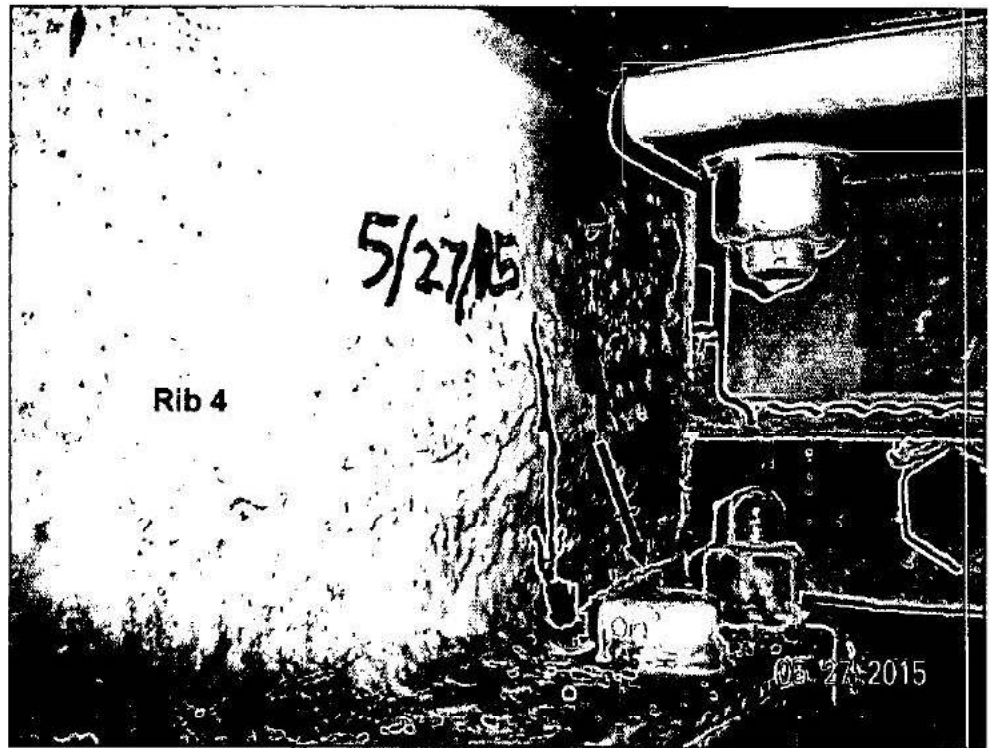
Photo No.: 5

Severely deteriorated deck rib with 4" long crack at the bottom of the web.

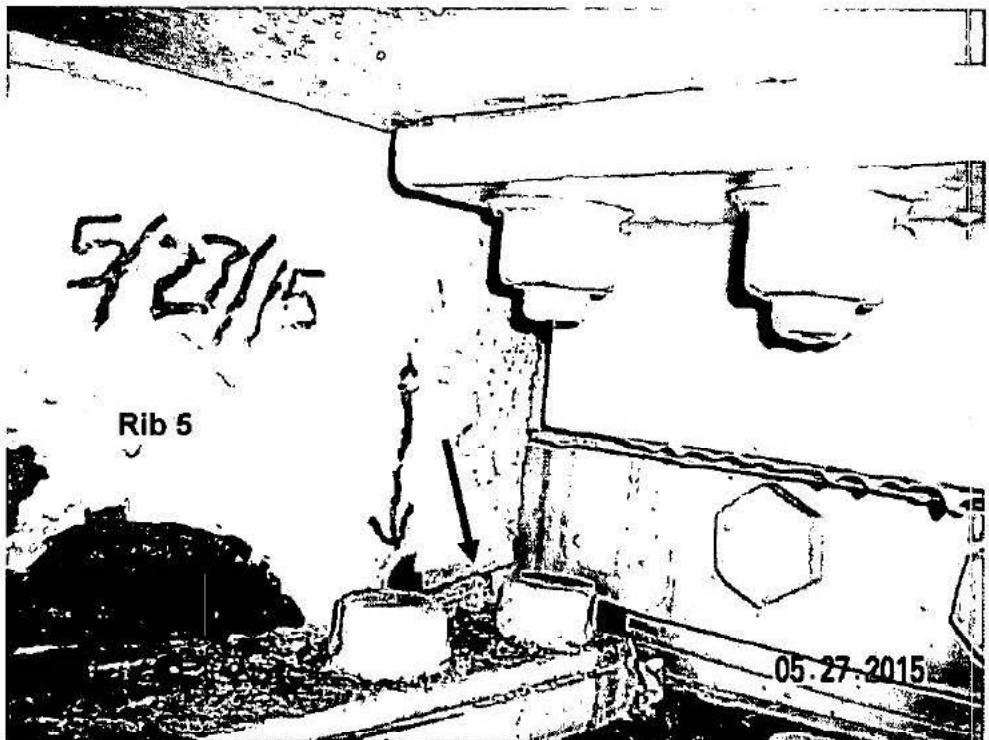
Photo No.: 6

Severely deteriorated deck rib with 2" long crack at the bottom of the web.

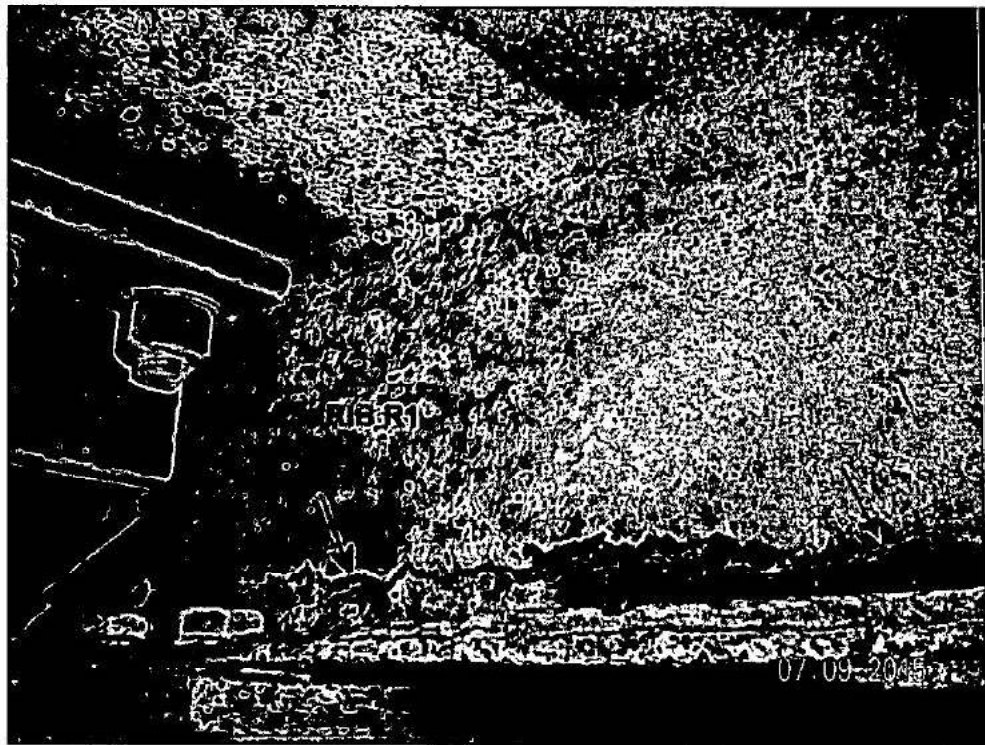
Photo No.: 2

Severely deteriorated deck rib with 30" long crack at the bottom of the web.

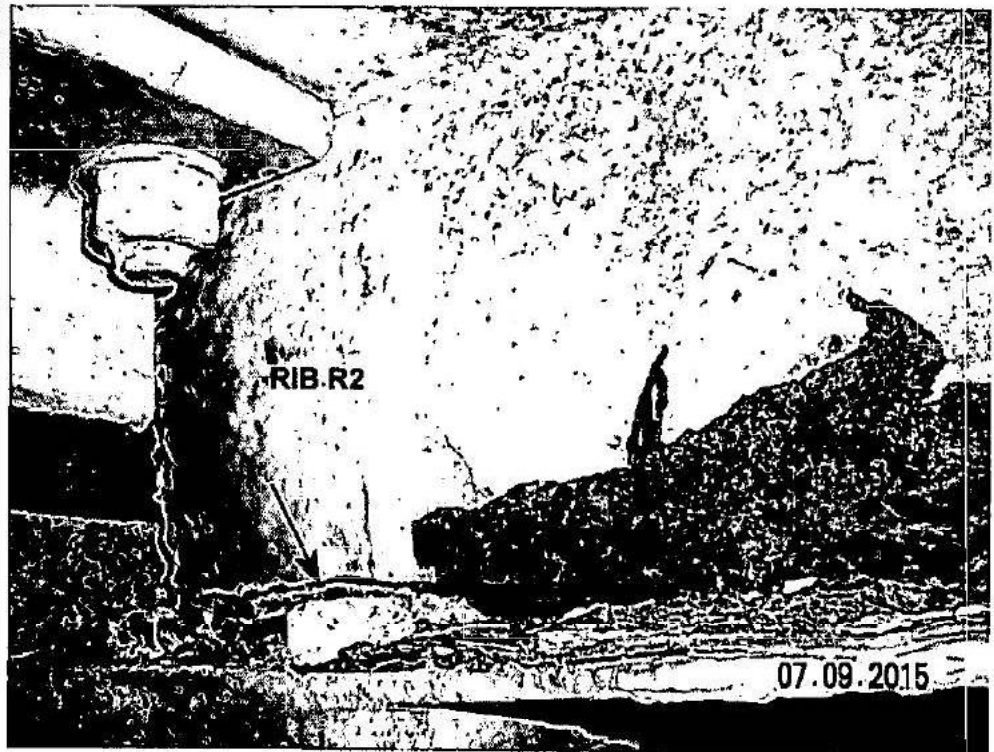
Photo No.: 3

Severely deteriorated deck rib with 9" long crack at the bottom of the web.

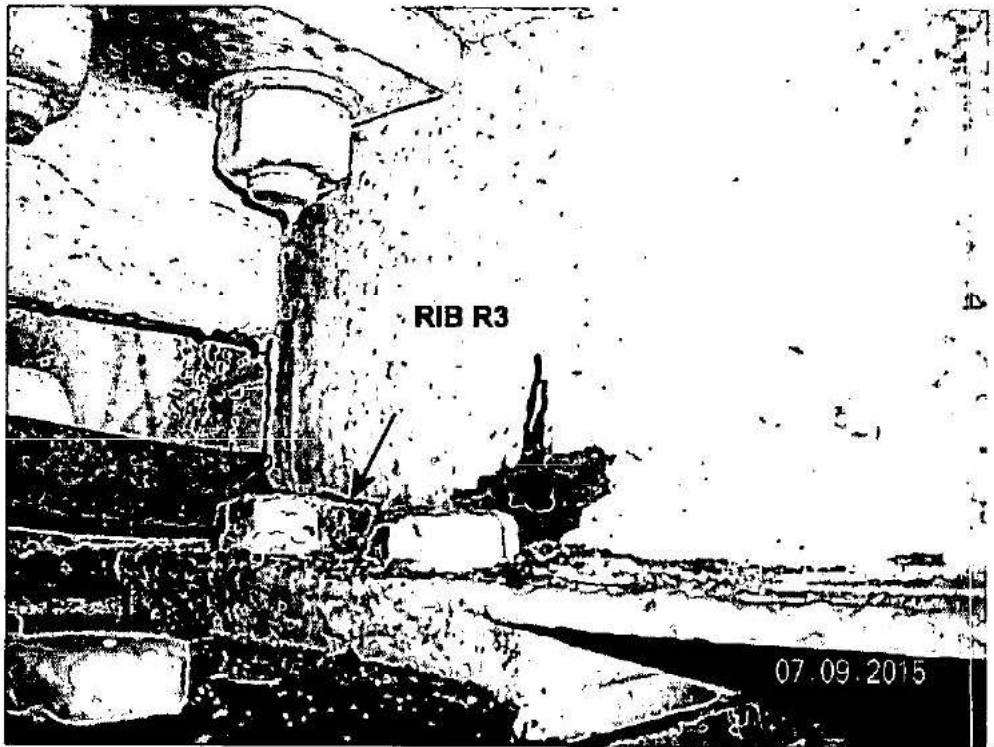
Photo No.: 4

Severely deteriorated deck rib with 5" long crack at the bottom of the web.

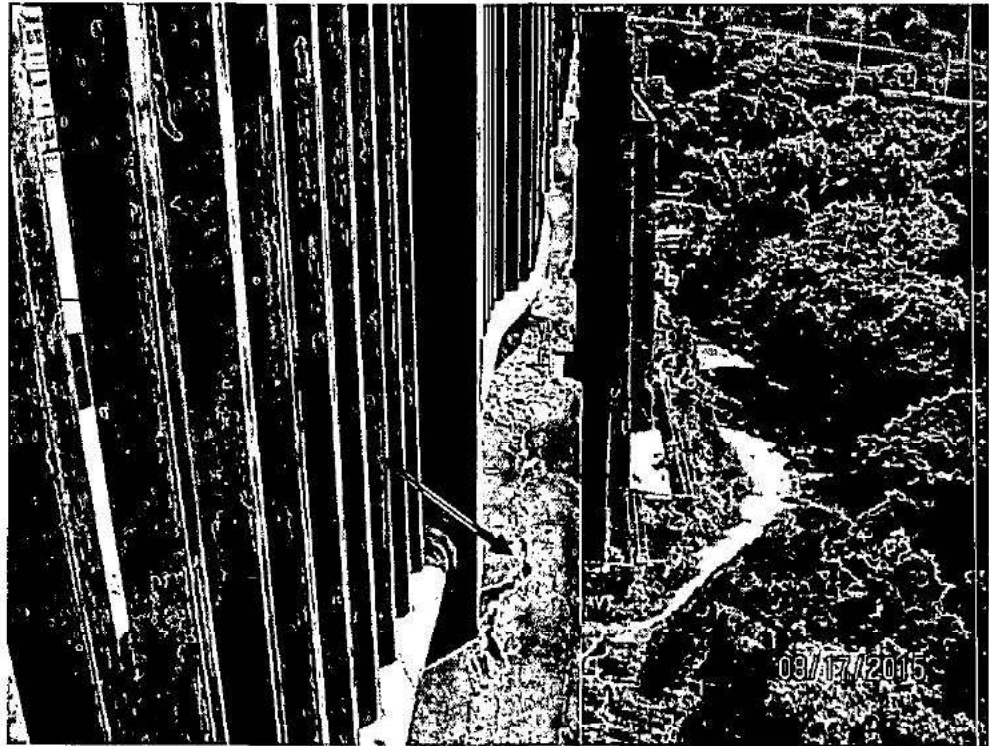
Photo No.: 1

Cracked, delaminated,
and spalled concrete.
