# **Port Authority Facility Condition Survey Program**

**George Washington Bridge  
Main Span Lower Level  
2011 Biennial Inspection**

**December 2011**

**2011 FINAL Condition Survey Report / GWB Lower Level**

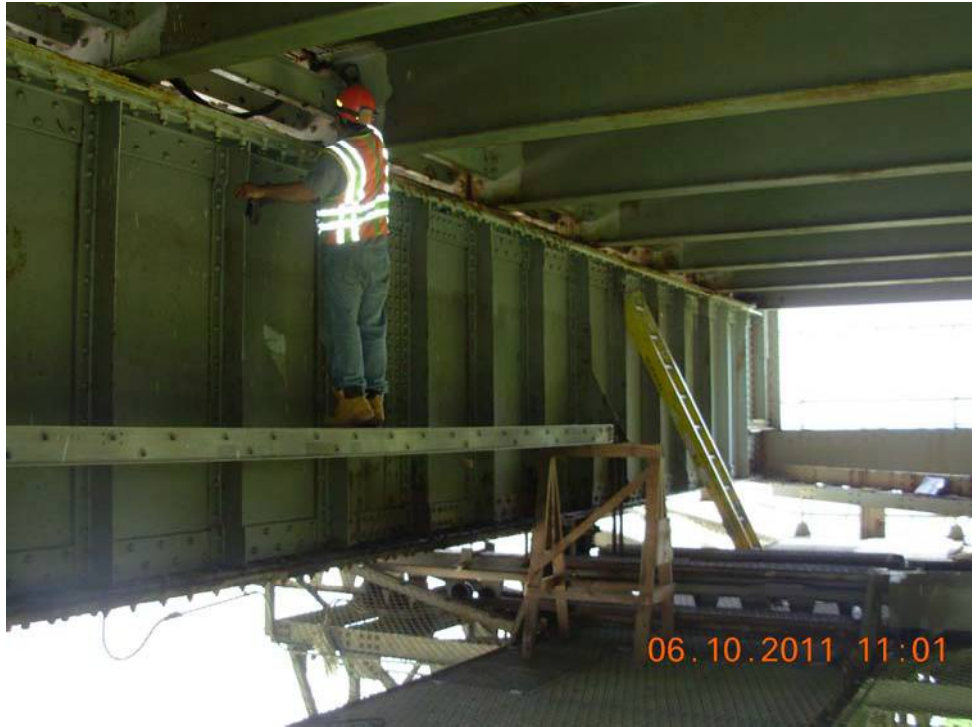
**Location:** Span 1, main floorbeam at Panel Point 7W.

**Description:** Hands-on inspection of main floorbeam and stringers utilizing scaffolding access from traveler platform between support beams.

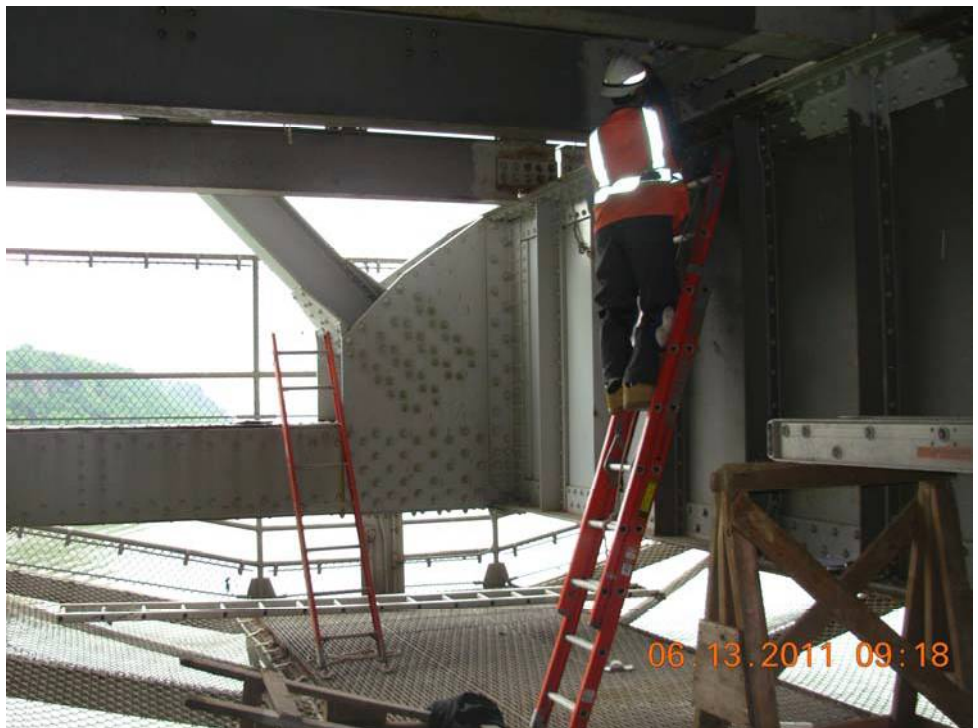
### PHOTO B

**Location:** Span 1, main floorbeam, stiffening truss lower chord and gusset plate at Panel Point 9W\*.

**Description:** Hands-on inspection of stiffening truss lower chord, floorbeams and stringer with ladders set on traveler.

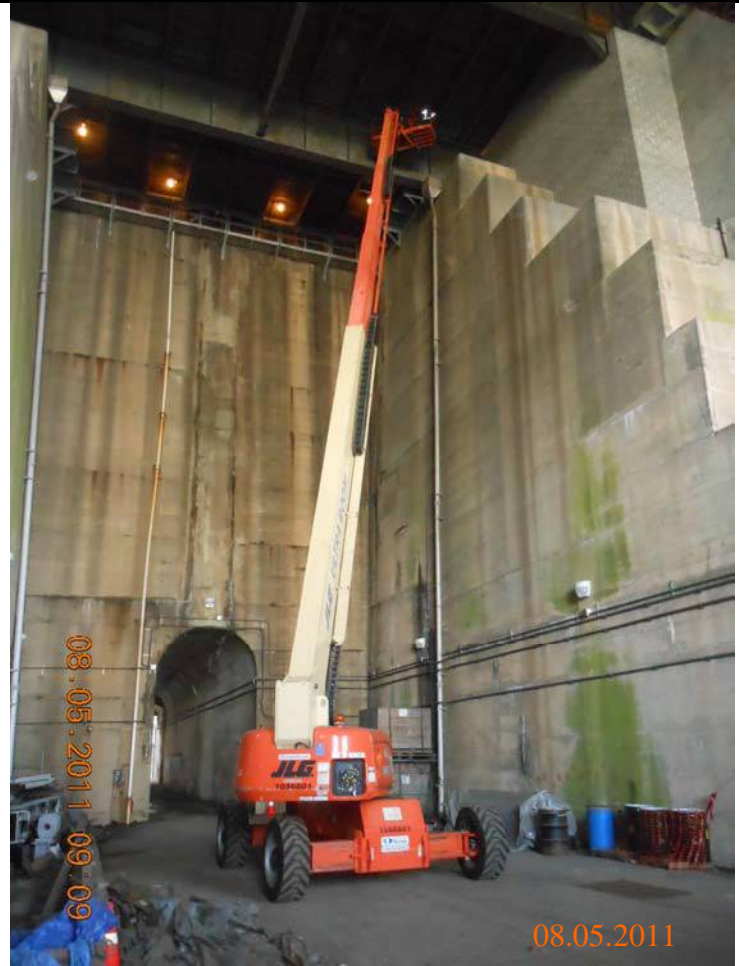
### PHOTO C

**Location:** New York Anchorage Courtyard.

**Description:** 120' man lift was utilized within the NY anchorage courtyard to access the superstructure and deck underside in Spans 4 through 9.

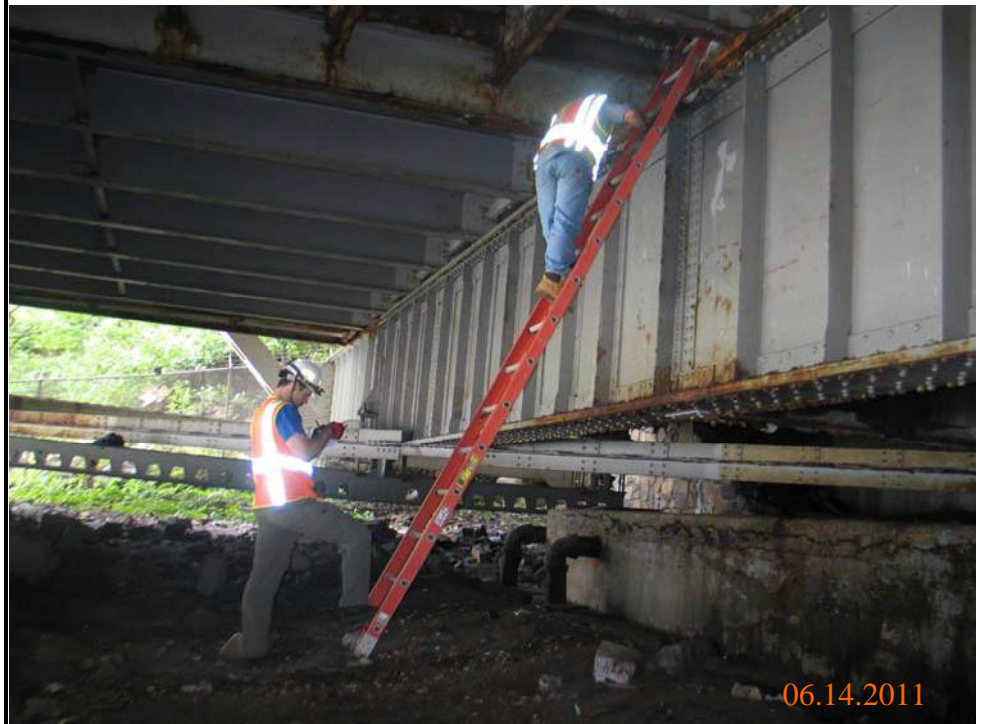
### PHOTO D

**Location:** Span 1, main floorbeam and stringers at Panel Point 2W\* - 3W.

**Description:** Hands-on inspection of floorbeams and stringers with ladders near the New Jersey Anchorage.

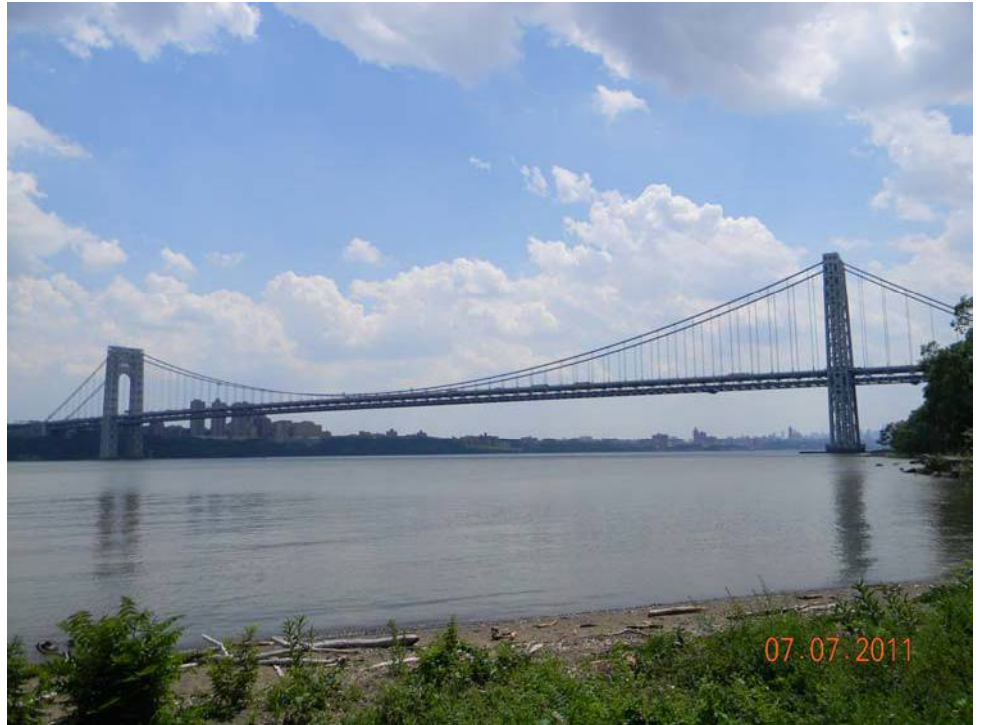
**Location:** North elevation.

**Description:** General view.

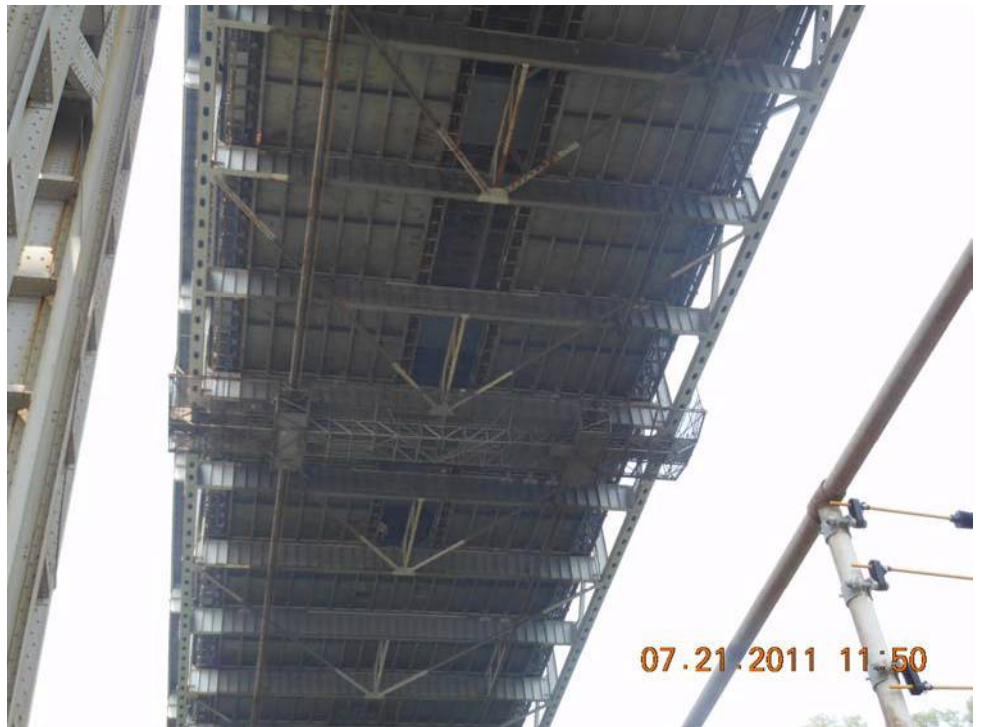
**Photo No.:** 2.

**Location:** Span 1, underside of deck, superstructure and New Jersey Back Span Traveler.

**Description:** General view.

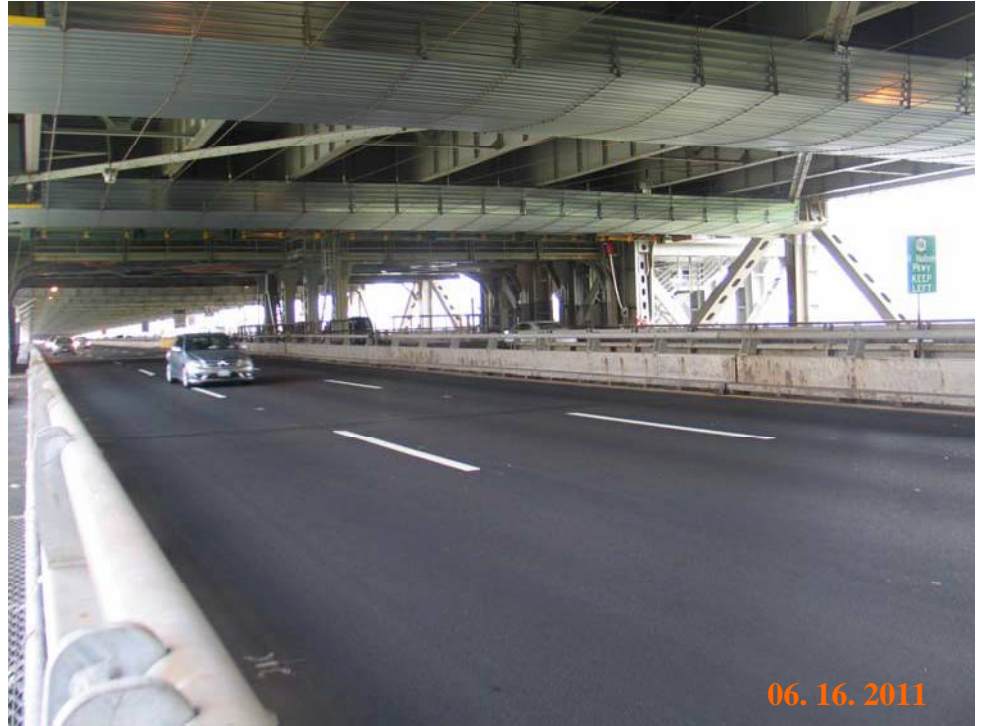
**Photo No.:** 3.

**Location:** Top of deck in Spans 1 and 2, westbound roadway.

**Description:** General view from Panel Point 9W.

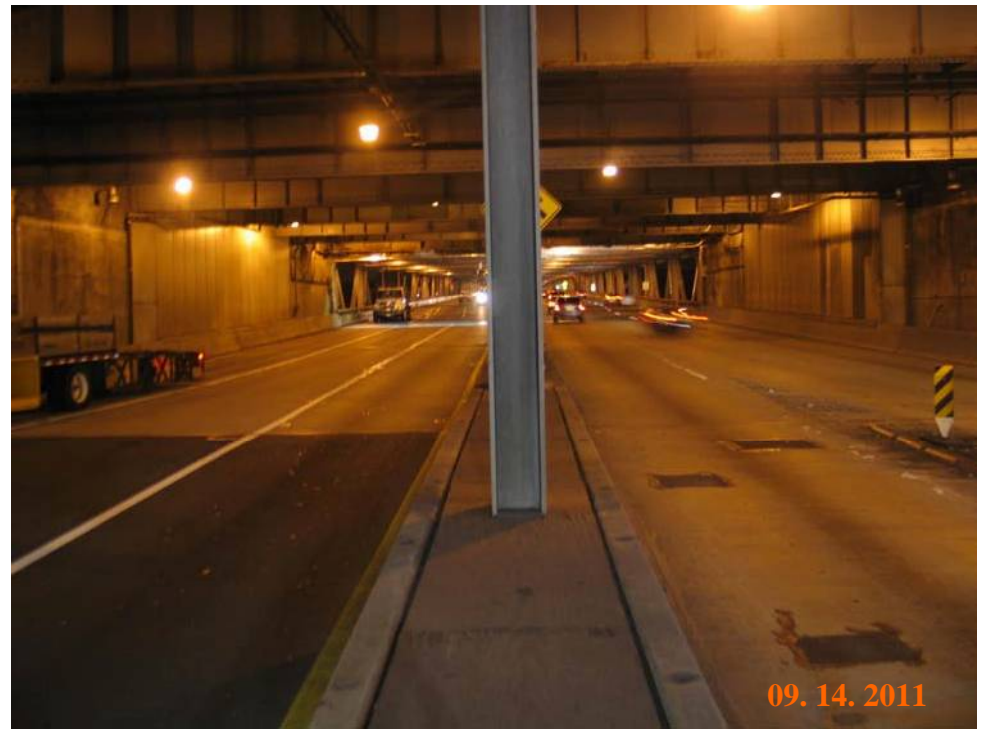
**Photo No.:** 4.

**Location:** Top of deck in Spans 9, 10 and 11.

**Description:** General view from Span 11.

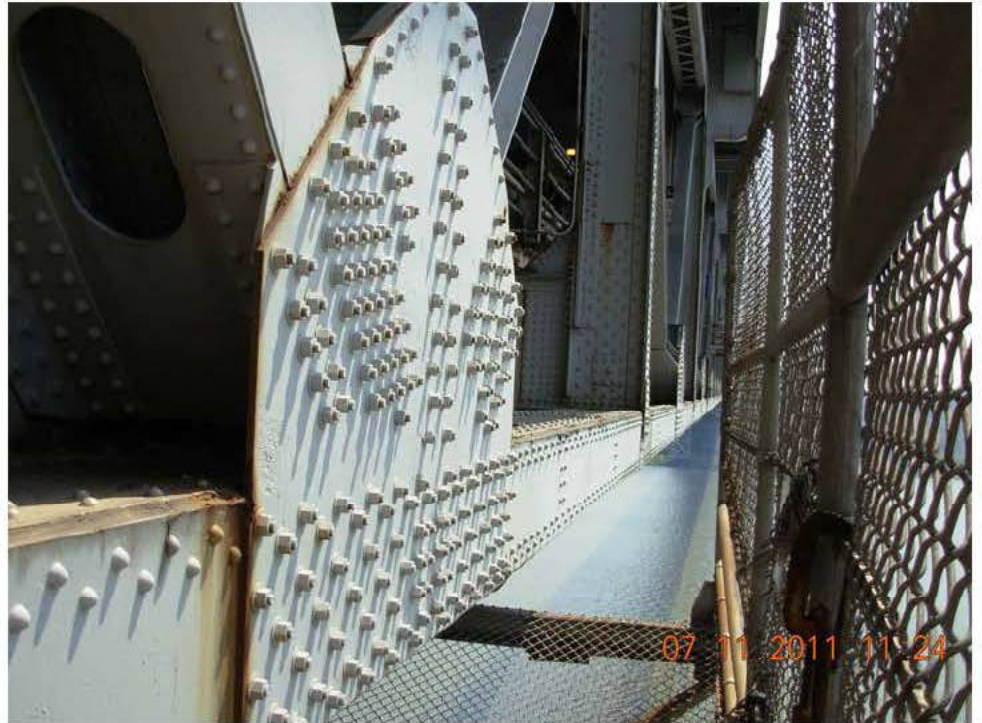
**Photo No.:** 5.

**Location:** Span 2, south stiffening truss at Floorbeam 15W\*.

**Description:** General view of bolted gusset plate along the bottom chord of the stiffening truss.

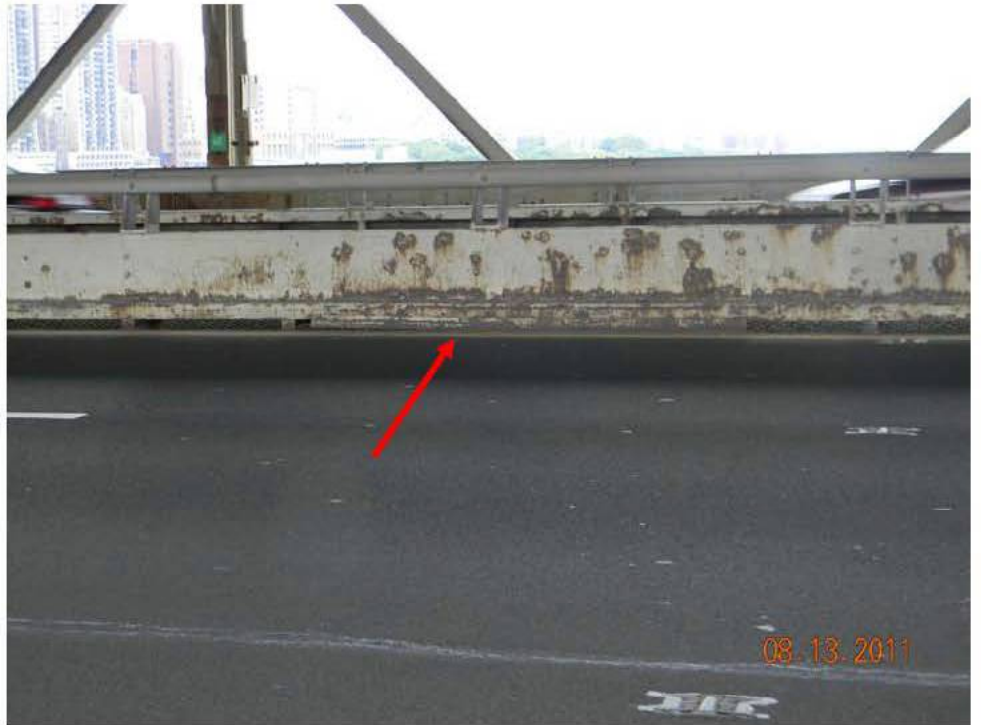
**Description:** Section of steel curb plate has detached from the steel curb along the median barrier.

(Safety Repair 5)

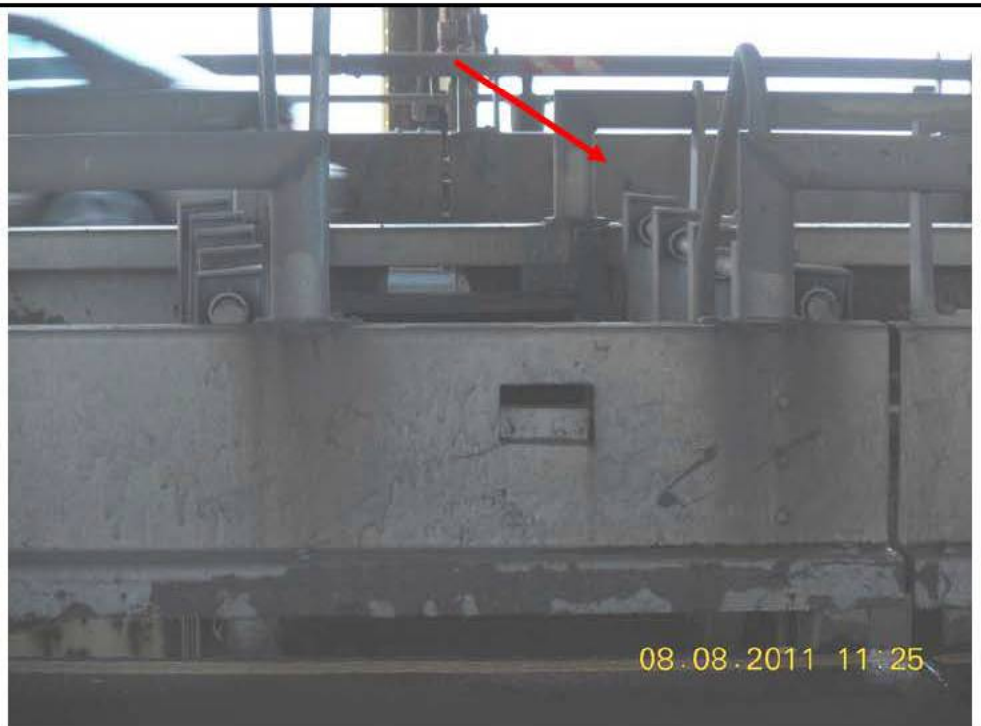
**Photo No.:** 38.

**Location:** Span 2, crossover walkway at Panel Point 27W.

**Description:** The southwest handrail (one of four) is missing at the stairs from the median barrier to the access catwalk.

(Safety Repair 6)

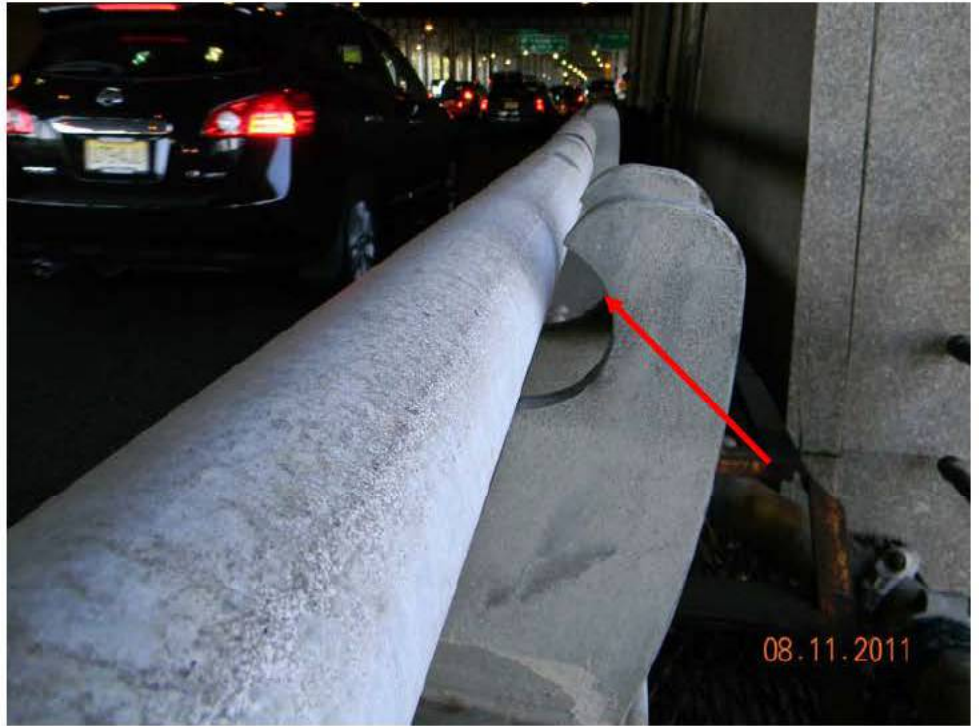
**Photo No.:** 39.

**Description:** The rail is detached from the post connection along the top of the roadway barrier.

(Safety Repair 7)

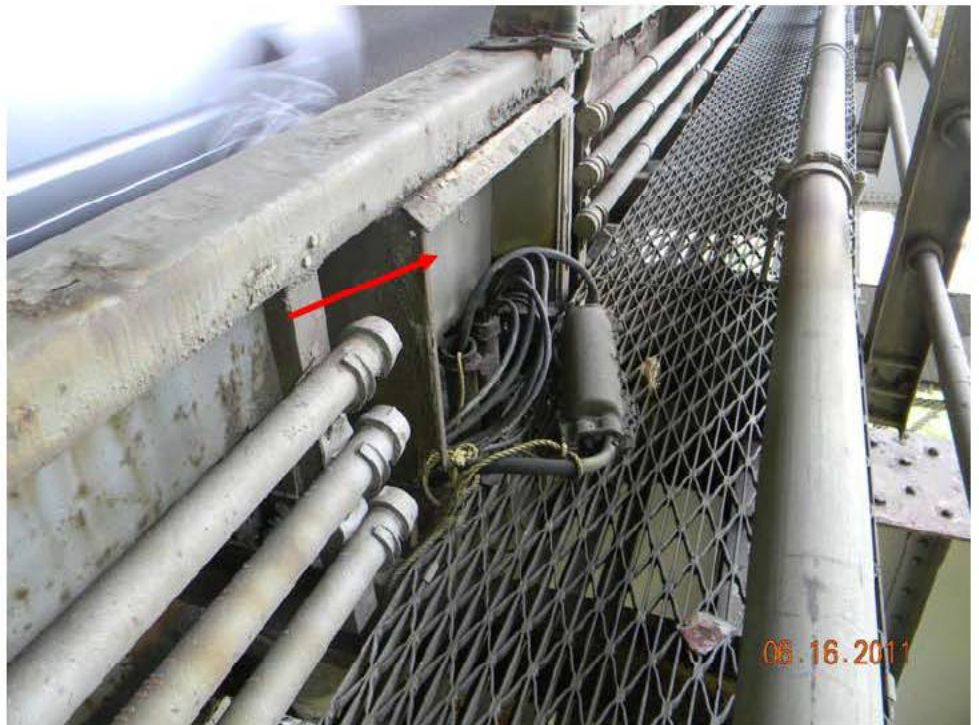
**Photo No.:** 40.

**Location:** Span 1, south safety walk at Panel Point 3W.

**Description:** Missing electrical box cover with exposed wires attached to the back of roadway barrier along safety walk (Accessible to public/stranded motorists).

(Safety Repair 8)

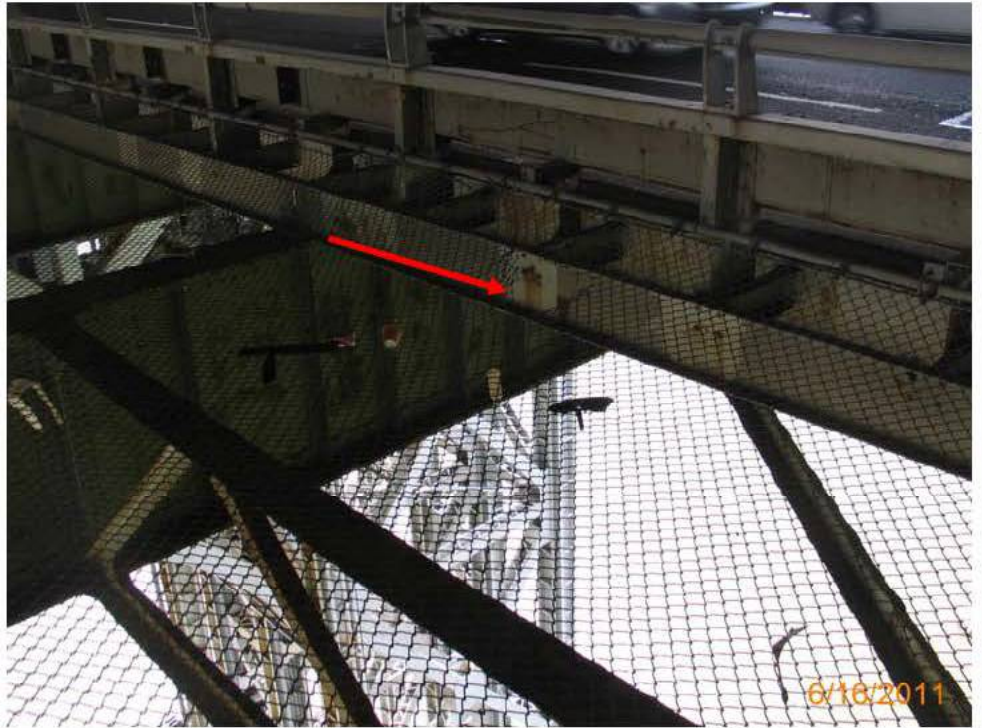
**Description:** The netting exhibits a 18" long x 12" wide hole and a 6" diameter hole.

(Safety Repair 15)

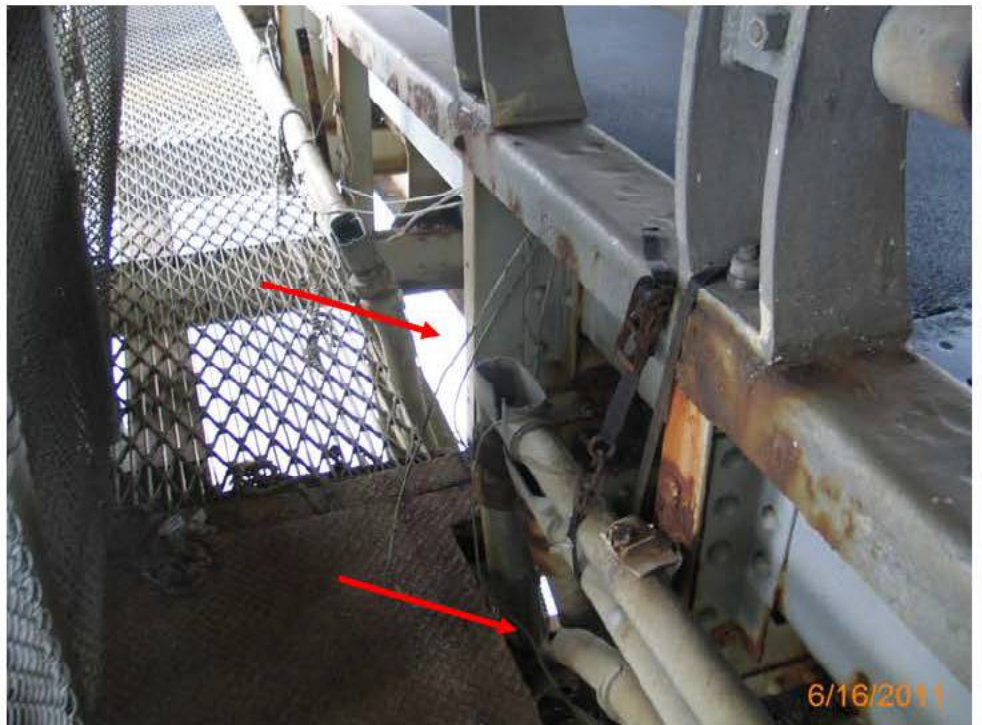
**Photo No.:** 48.

**Location:** New Jersey Tower north safety walk.

**Description:** 2' x 2' opening in the safety walk, and 2' long x 4" wide cut out area of safety walk grating for conduits.

(Safety Repair 16)

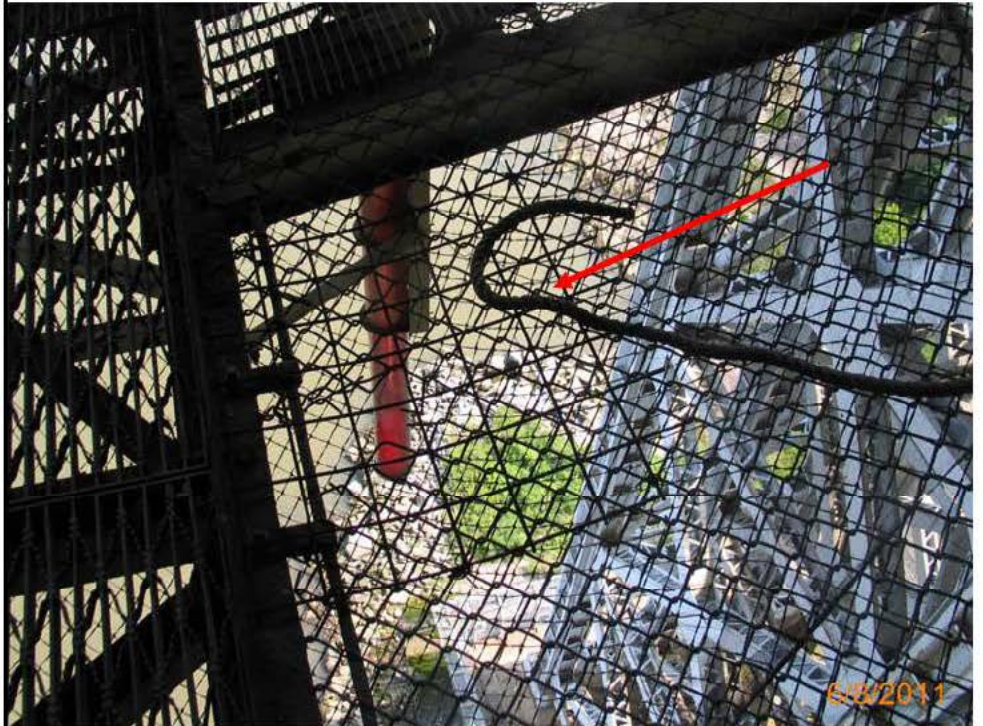
**Description:** Large hole in the safety netting with inadequate wire mesh (arrow) provided as temporary repair.

(Safety Repair 19)

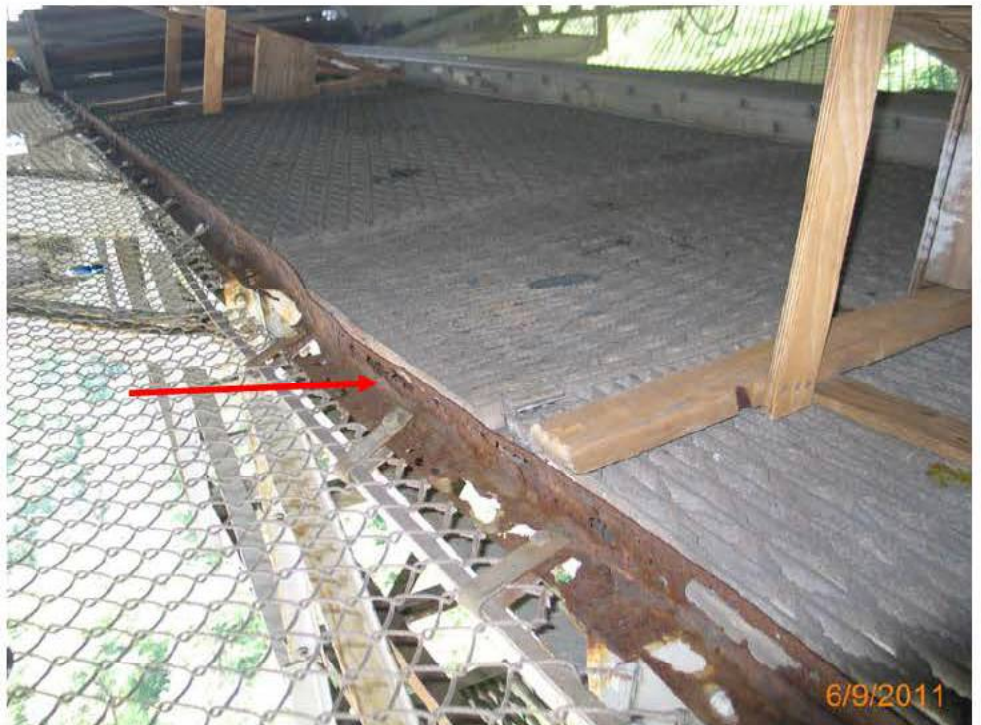
**Photo No.:** 52.

**Location:** New Jersey Back Span Traveler.

**Description:** The 3" x 3" angle supporting the safety netting is severely corroded with holes in horizontal and vertical legs (arrow).

(Safety Repair 20)
