Port Authority Facility Condition Survey Program

**George Washington Bridge
Main Span Lower Level
2013 Biennial Inspection**

December 2013

**Re: Expert Professional Services for the Performance
of Biennial Inspection of the George Washington
Bridge Upper & Lower Levels
PA Agreement No. 405-13-005; P.O. 4900009127**

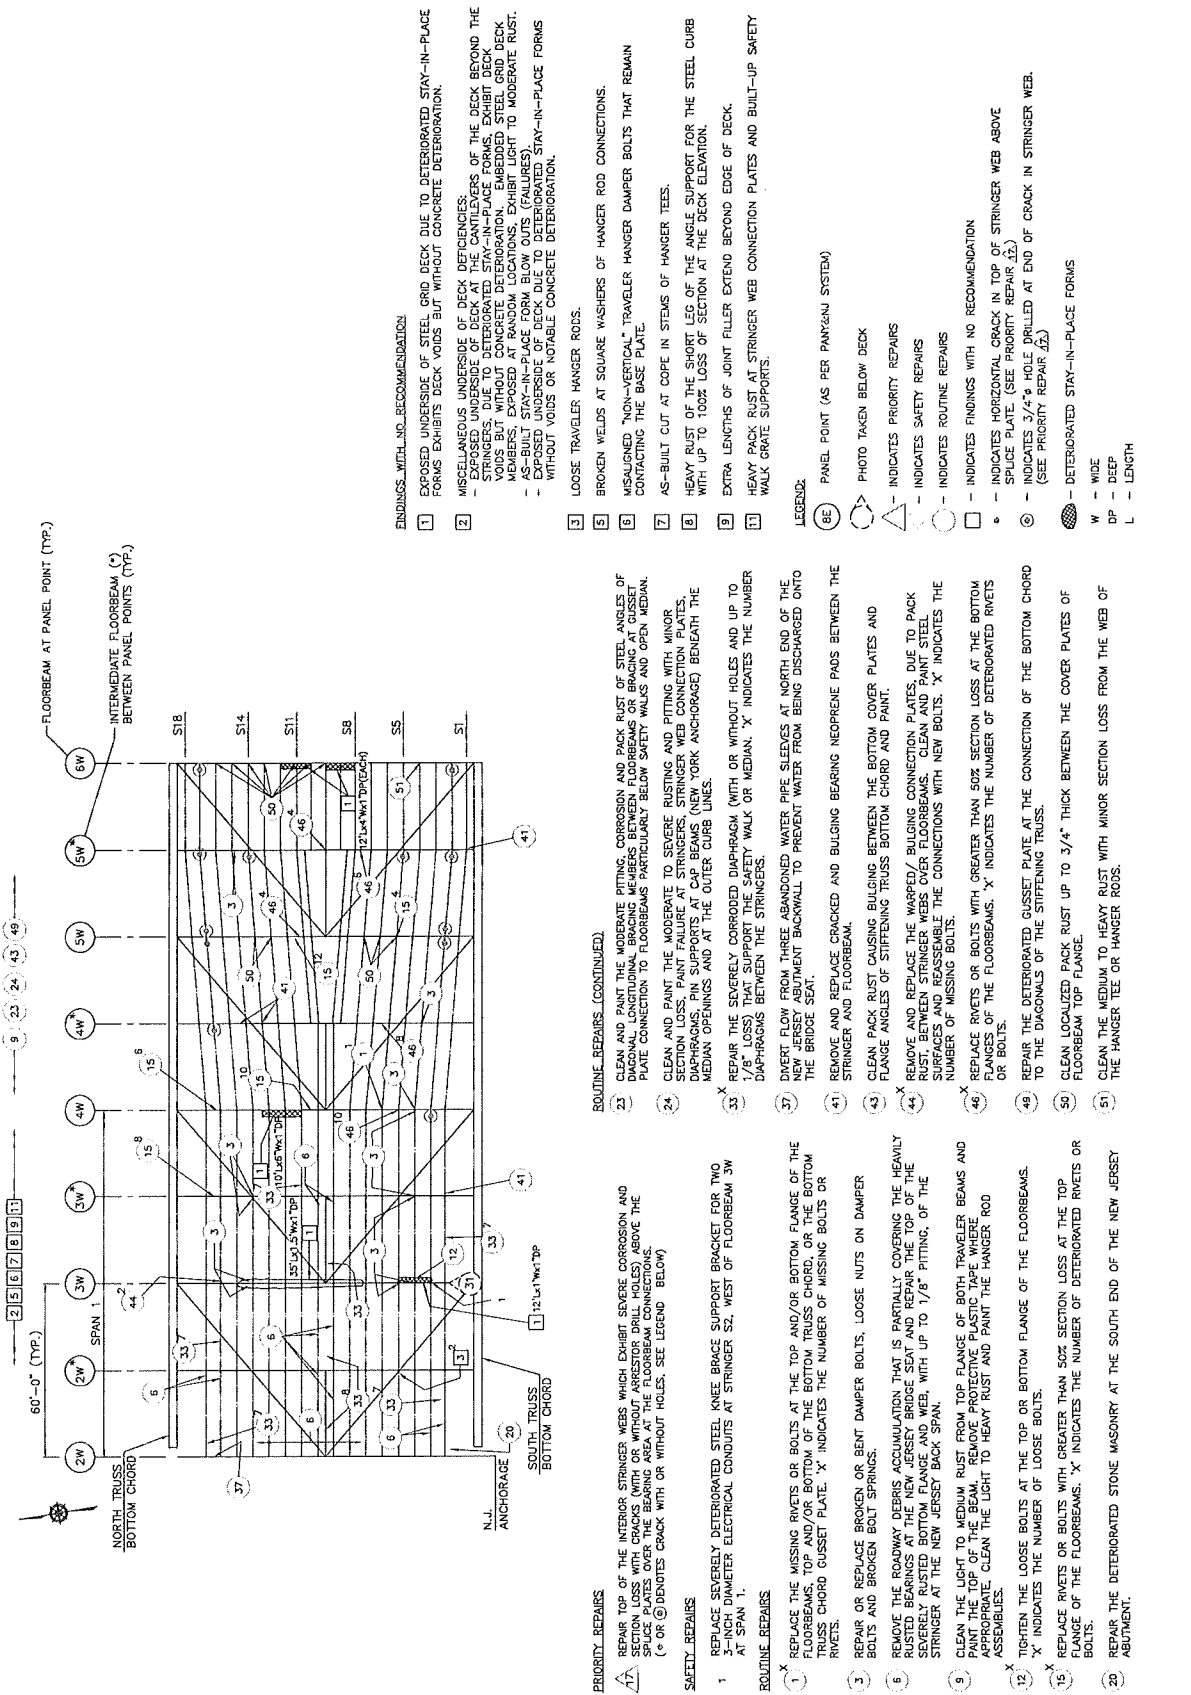
- 1 EXPOSED UNDERSIDE OF STEEL GRID DECK DUE TO DETERIORATED STAY-IN-PLACE FORMS EXHIBITS DECK VOIDS BUT WITHOUT CONCRETE DETERIORATION.
- 2 MISCELLANEOUS UNDERSIDE OF DECK DEFICIENCIES:
 - EXPOSED UNDERSIDE OF DECK AT THE CANTILEVERS OF THE DECK BEYOND THE STRINGERS. DUE TO DETERIORATED STAY-IN-PLACE FORMS, EXHIBIT DECK VOIDS AND REINFORCING BARS EXPOSED AT RANDOM LOCATIONS. EXHIBIT TO AGGRAVATE RUST.
 - AS-BUILT STAY-IN-PLACE FORM BLOW OUTS (FAILURES).
 - EXPOSED UNDERSIDE OF DECK DUE TO DETERIORATED STAY-IN-PLACE FORMS WITHOUT VOIDS OR NOTABLE CONCRETE DETERIORATION.

- 5 REMOVE THE ROADWAY DEBRIS ACCUMULATION THAT IS PARTIALLY COVERING THE HEAVILY RUSTED BEARINGS AT THE NEW JERSEY BRIDGE SEAT AND REPAIR THE TOP OF THE SEVERELY RUSTED BOTTOM FLANGE AND WEB WITH UP TO 1/8" PITTING, OF THE STRINGER AT THE NEW JERSEY BACK SPAN.
- 9 CLEAN THE LIGHT TO MEDIUM RUST FROM TOP FLANGE OF BOTH TRAVELER BEAMS AND PAINT THE TOP OF THE BEAM. REMOVE PROTECTIVE PLASTIC TAPE WHERE APPROPRIATE. CLEAN THE LIGHT TO HEAVY RUST AND PAINT THE HANGER ROD ASSEMBLIES.
- 12 TIGHTEN THE LOOSE BOLTS AT THE TOP OR BOTTOM FLANGE OF THE FLOORBEAMS. 'X' INDICATES THE NUMBER OF LOOSE BOLTS.
- 19 REPLACE RIVETS OR BOLTS WITH GREATER THAN 50% SECTION LOSS AT THE TOP FLANGE OF THE FLOORBEAMS. 'X' INDICATES THE NUMBER OF DETERIORATED RIVETS OR BOLTS.
- 20 REPAIR THE DETERIORATED STONE MASONRY AT THE SOUTH END OF THE NEW JERSEY ABUTMENT.

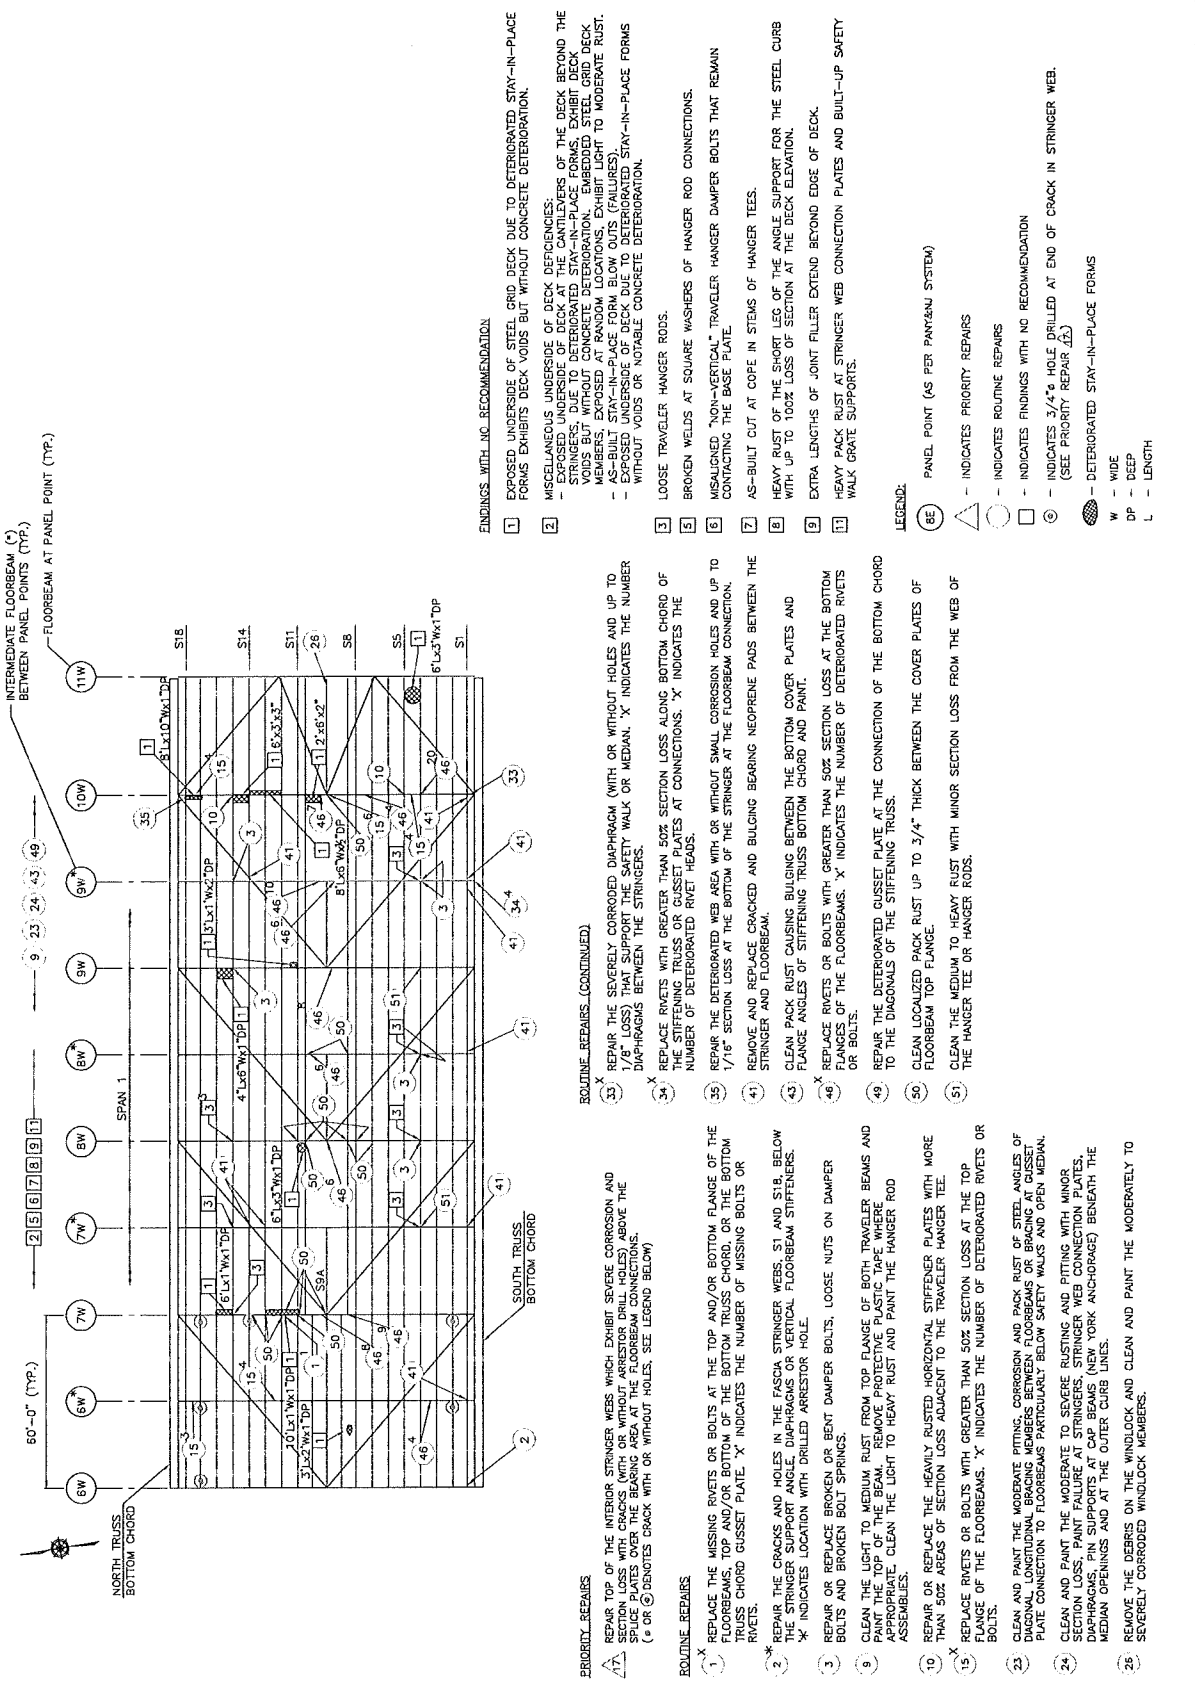
- 1 EXPOSED UNDERSIDE OF STEEL GRID DECK DUE TO DETERIORATED STAY-IN-PLACE FORMS EXHIBITS DECK VOIDS BUT WITHOUT CONCRETE DETERIORATION.
- 2 MISCELLANEOUS UNDERSIDE OF DECK REFERENCES TO EXISTING TRAVELER HANGER RODS. DUE TO DETERIORATED STAY-IN-PLACE FORMS, EXHIBIT DECK VOIDS BUT WITHOUT CONCRETE DETERIORATION. EMBEDDED STEEL GRID DECK MEMBERS, EXPOSED AT RANDOM LOCATIONS, EXHIBIT LIGHT TO MODERATE RUST. - BUILT STAY-IN-PLACE FORM BELOW OUTS (PAIRED). - SPREADERS OF CONCRETE FORMS EXHIBIT LIGHT TO MODERATE RUST. - WITHOUT VOIDS OR NOTABLE CONCRETE DETERIORATION.

- 25 REMOVE THE DEBRIS ON THE WINDLOCK AND CLEAN AND PAINT THE MODERATELY TO SEVERELY CORRODED WINDLOCK MEMBERS.

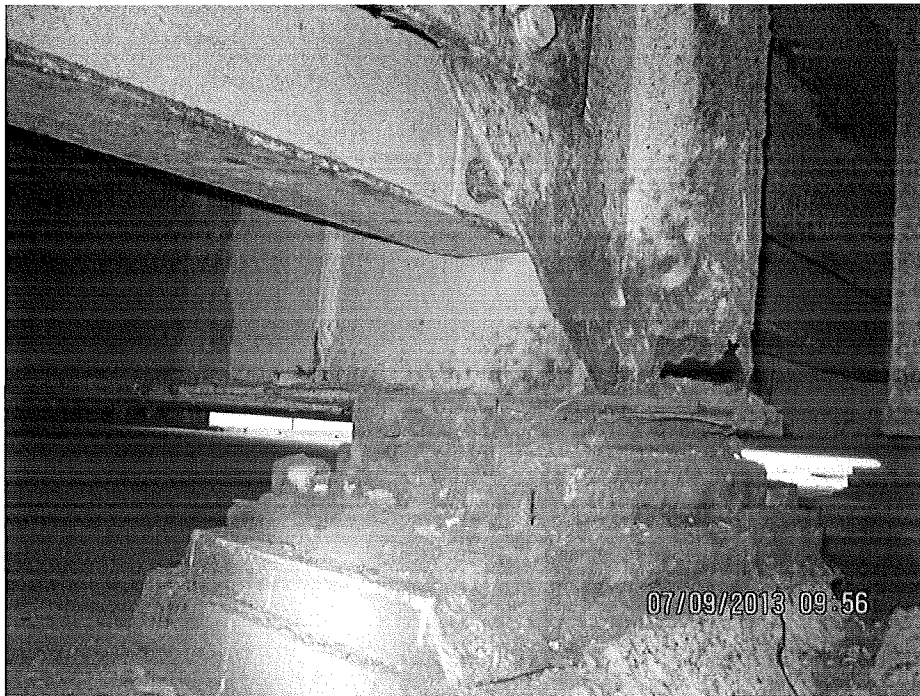
Location: Span 9, at east end of Stringer S14, looking northwest.

Description: The end of stringer exhibits severe corrosion with a 6" x 3" hole in the web above the bearing.

(Priority Repair 2)

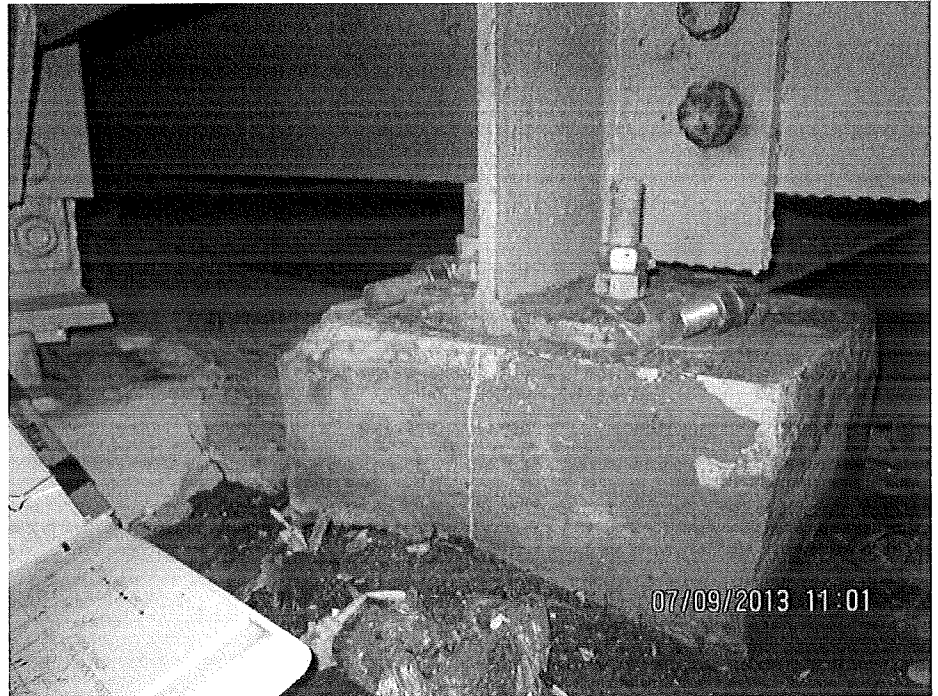
Description: One out of two anchor bolts is sheared off on the south side of stringer. Also, one out of two anchor bolts is sheared off on the north side.

(Priority Repair 13)

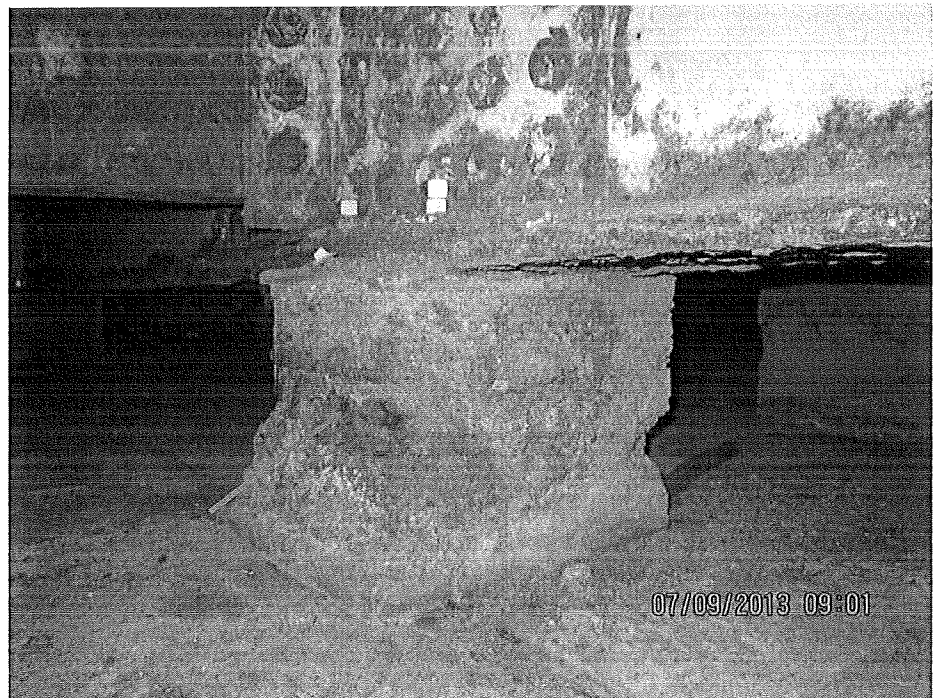
Photo No.: 20.

Location: Span 10, concrete pedestal for Stringer S9 bearing at Pedestal 3 from west, looking northwest.

Description: Spalled concrete pedestal below stringer bearing with exposed rusted rebar.

(Priority Repair 14)

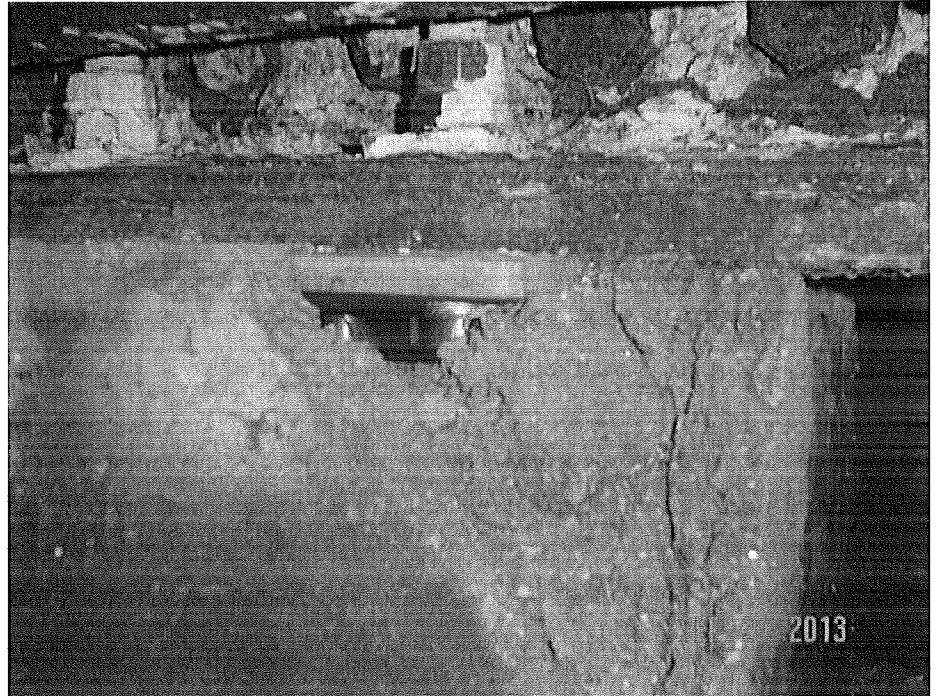
Photo No.: 21.

Description: The pedestal exhibits spalled concrete with voids, causing minor undermining of the bearing plate under the stringer.

(Priority Repair 15)

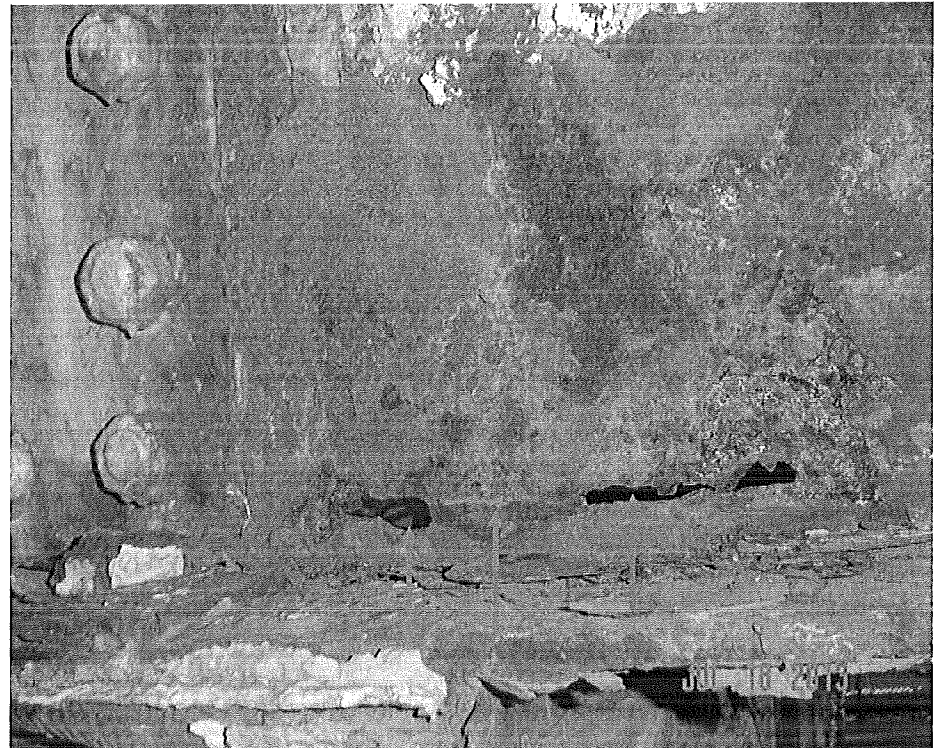
Photo No.: 22.

Location: Span 2, Stringer S10 at the west side of Floorbeam 15E, looking south.

Description: The bottom of the stringer web exhibits severe corrosion and section loss with 4"x1" and 2"x1" holes and a 3" crack in between over the bearing area at the floorbeam connection.

(Priority Repair 16)

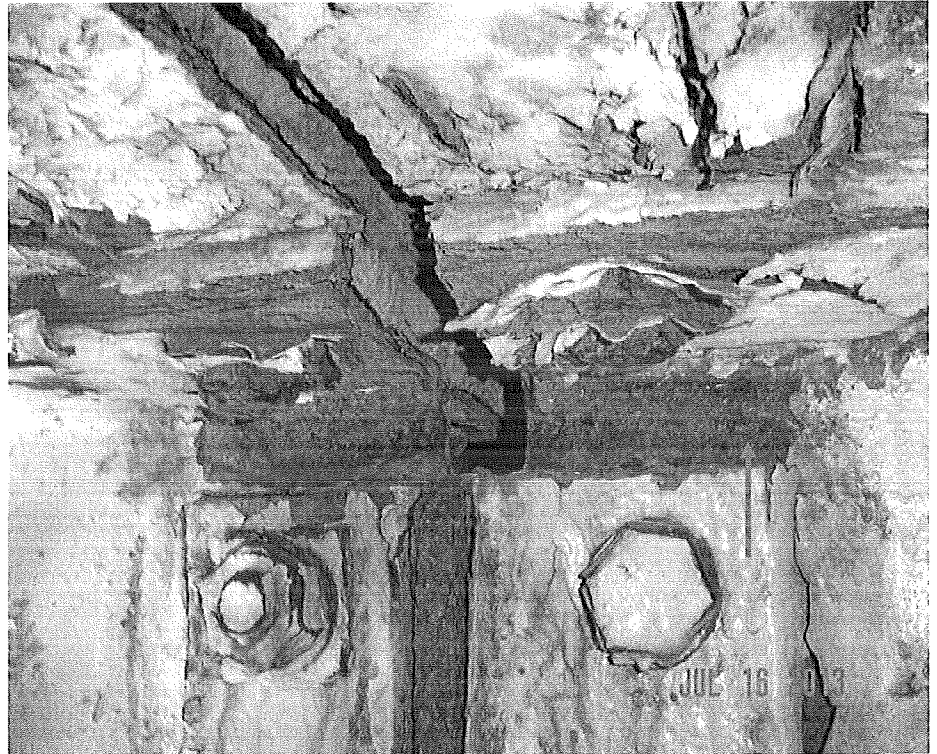
Photo No.: 23.

Description: The top of the stringer web exhibits severe corrosion and section loss with a 1-1/2" crack above the splice plate over the bearing area at the floorbeam connection.

(Priority Repair 17)

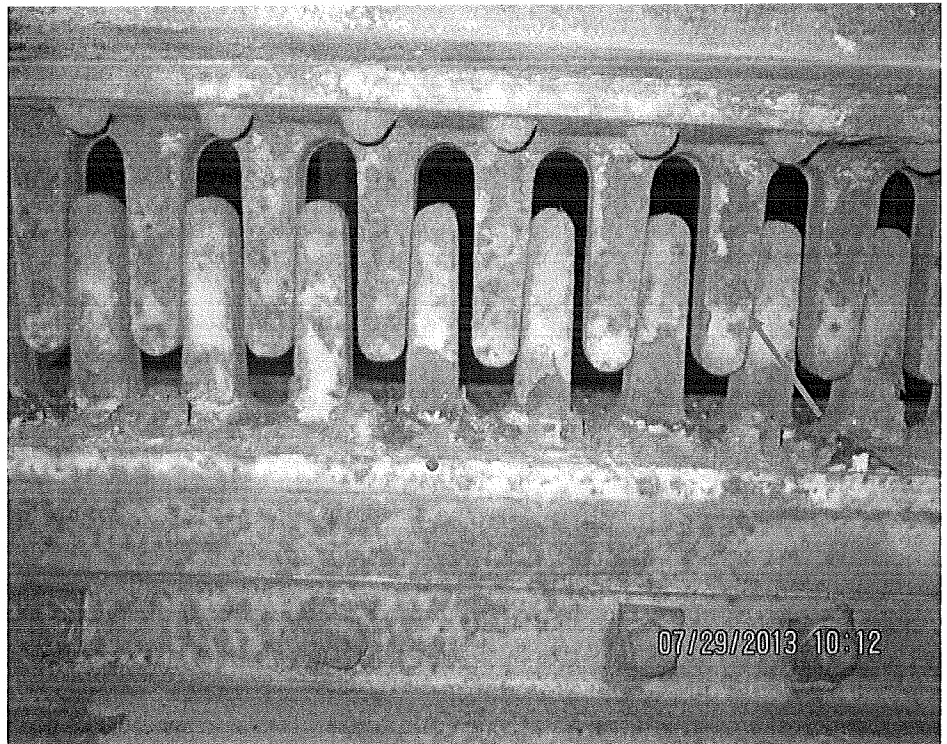
Photo No.: 24.

Location: Span 3, underside of steel finger joint below the eastbound roadway at Panel Point 1E, looking west and up.

Description: The finger joint plates are shifted and jammed against each other, restricting movement.

(Priority Repair 18)

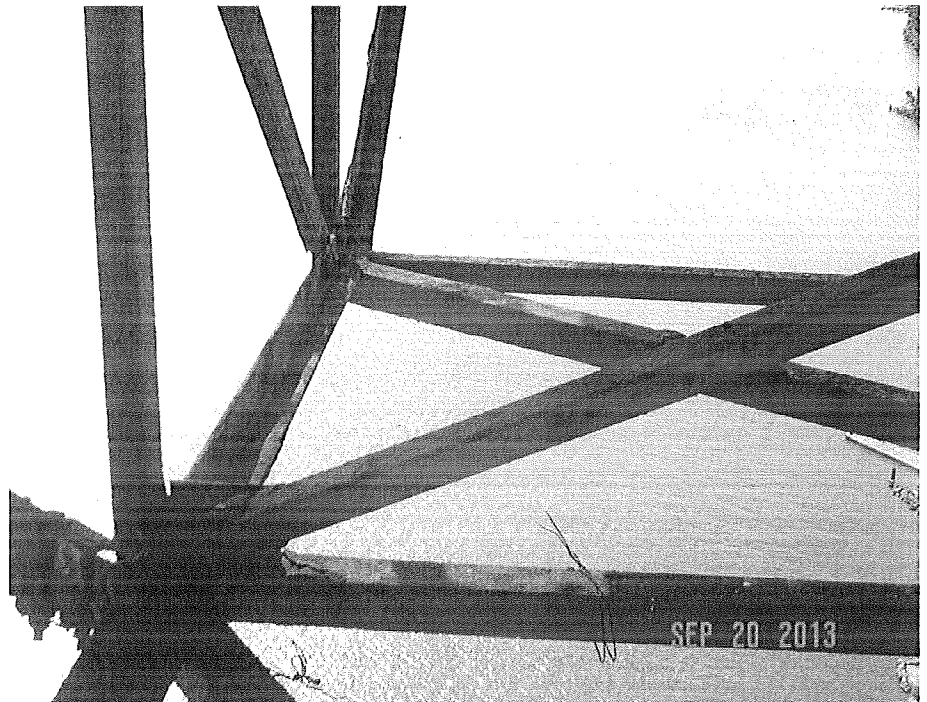
Location: New Jersey Main Span Traveler, looking south.

Description: Moderate to severe section loss and corrosion at east bottom main support truss members.

(Priority Repair 19)

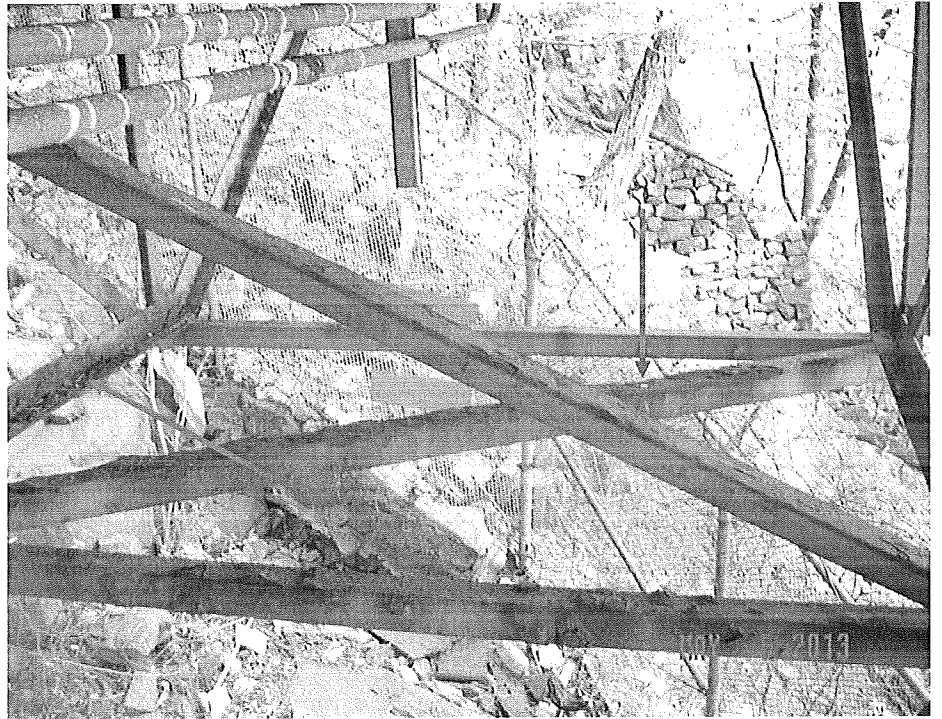
Description: Moderate to severe section loss at main support truss members.

(Priority Repair 23)

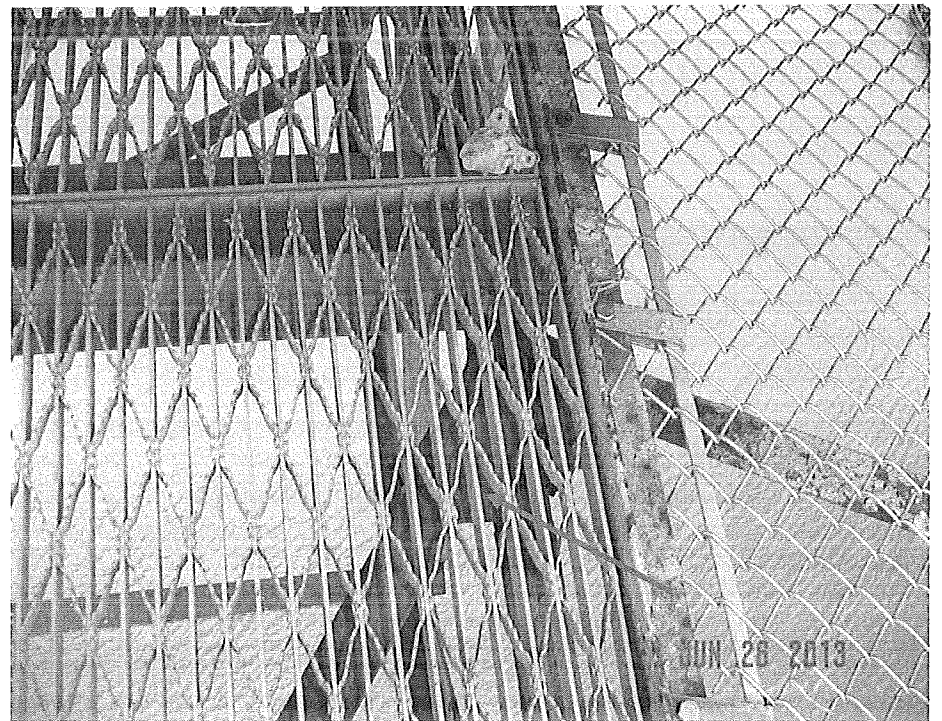
Photo No.: 30.

Location: New Jersey Main Span Traveler, looking south and down.

Description: Missing 3 of 3 connection bolts at the frame bracing gusset plate.

(Priority Repair 24)

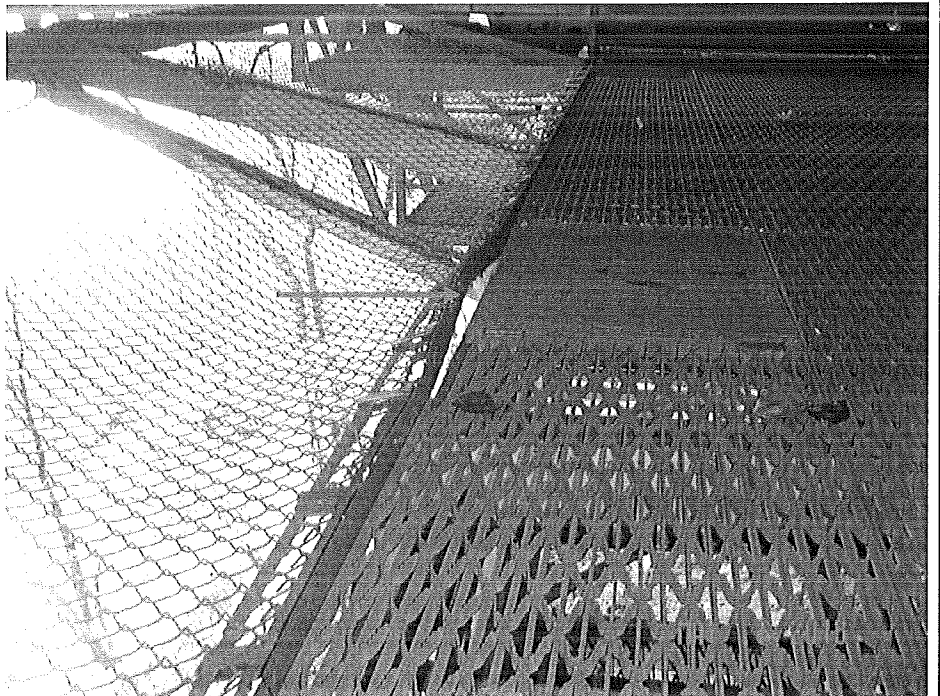
Location: New Jersey Back Span Traveler, looking south.

Description: The 3" x 3" angle supporting the safety netting is severely corroded with holes in horizontal and vertical legs.

(Safety Repair 14)

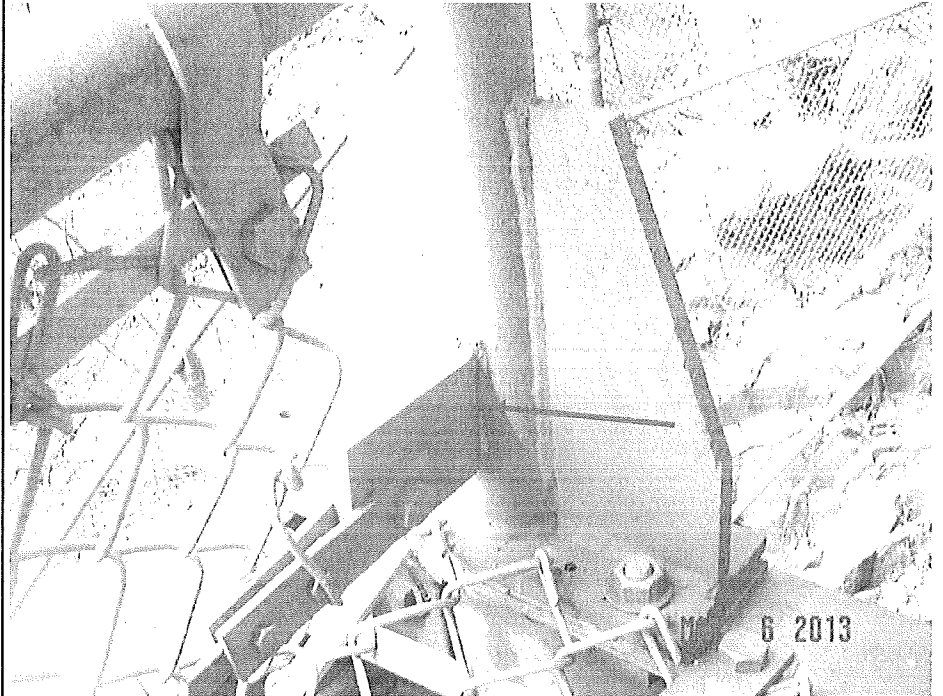
Location: Southwest corner of New Jersey Back Span Traveler, looking southwest.

Description: The weld between the fence fabric connection plate and the aluminum post is broken.

(Safety Repair 17)

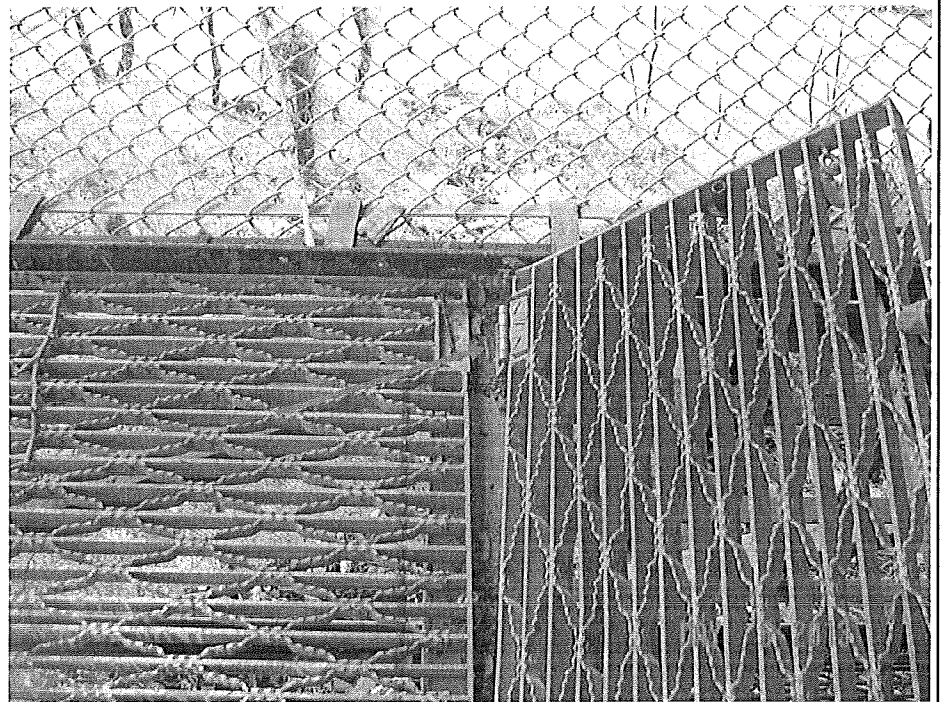
Photo No.: 48.

Location: East side of New Jersey Back Span Traveler, looking east.

Description: The connection screws for the access hatch hinge are missing at the north side of the floor grating.

(Safety Repair 18)

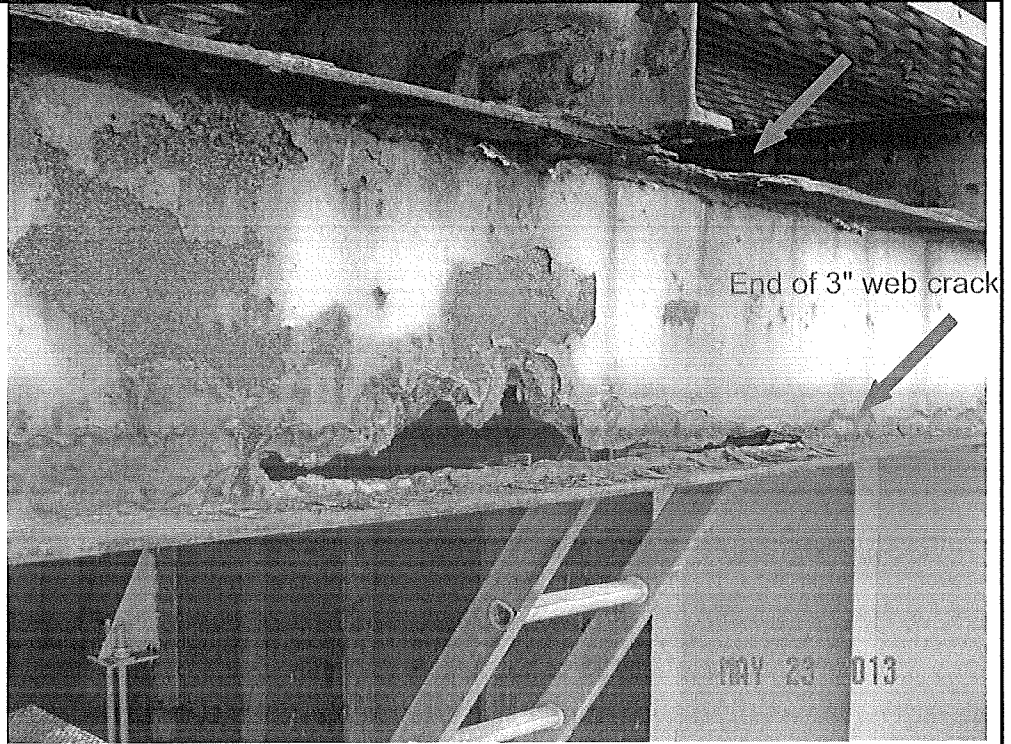
Photo No.: 1

Approximately 3'-6" long by up to 4" high section of the web exhibits severe corrosion with a 3" long crack and hole thru near the bottom flange starting approximately 5' west of PP7E* floorbeam. At the same location, the bottom flange exhibits up to 70% section loss with several rusted thru holes in the north leg. In addition, a 10" (L) x 2" (W) portion of the top flange south leg above the deteriorated web area exhibits severe corrosion with hole thru and up to 50% section loss. See attached location plan and photos.

Severely deteriorated
web bottom with holes up
to 4" high. Also, 10" (L)
x 2" (W) hole thru in the
top flange.

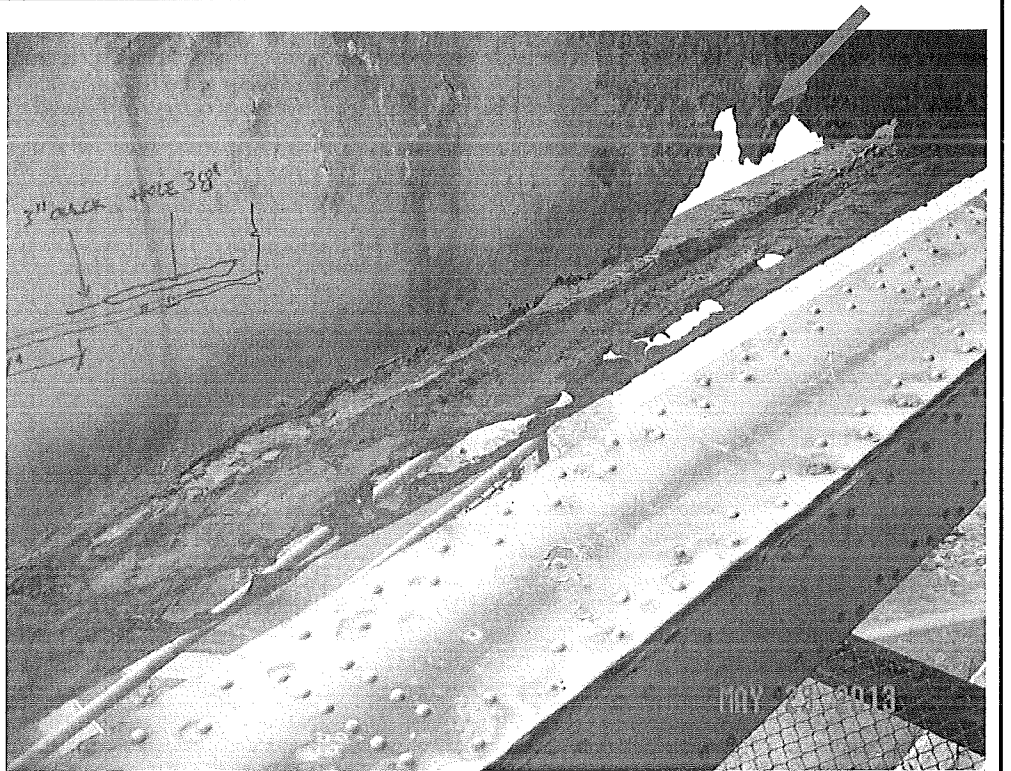
Photo No.: 2

Severely deteriorated
web bottom with holes up
to 4" high. Also, rusted
thru holes in the bottom
flange.

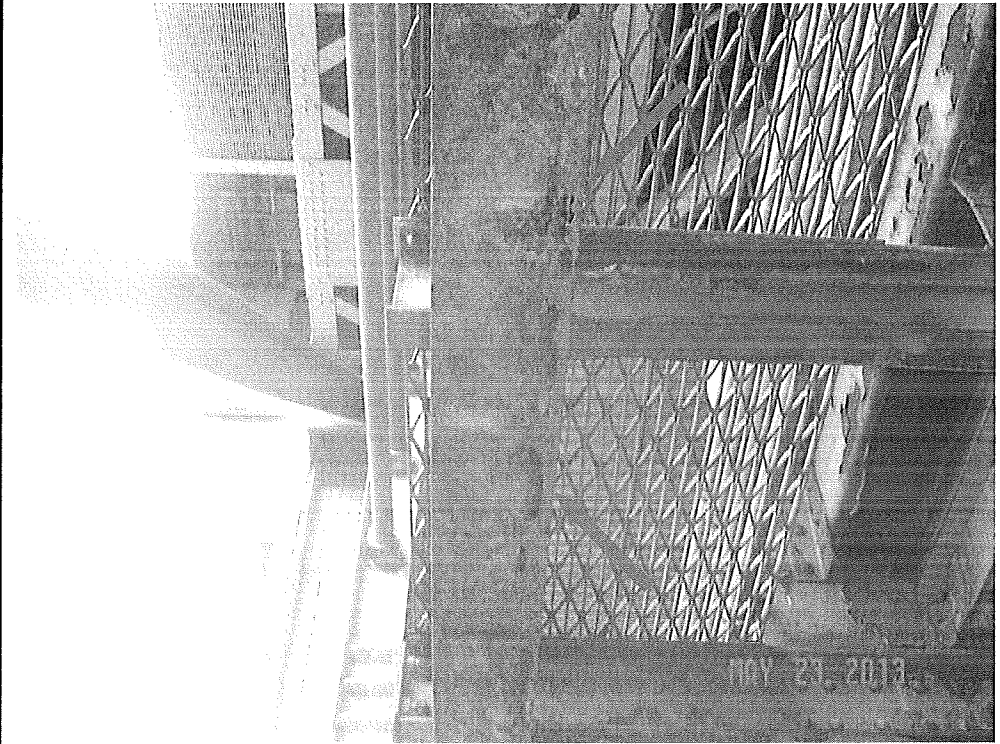
Photo No.: 3

Severely deteriorated
bottom flange North side
with rusted thru holes.
