Port Authority Facility Condition Survey Program

George Washington Bridge
2015 Inspection Report of
Main Span Upper Level

Volume 1 of 2

January 2016

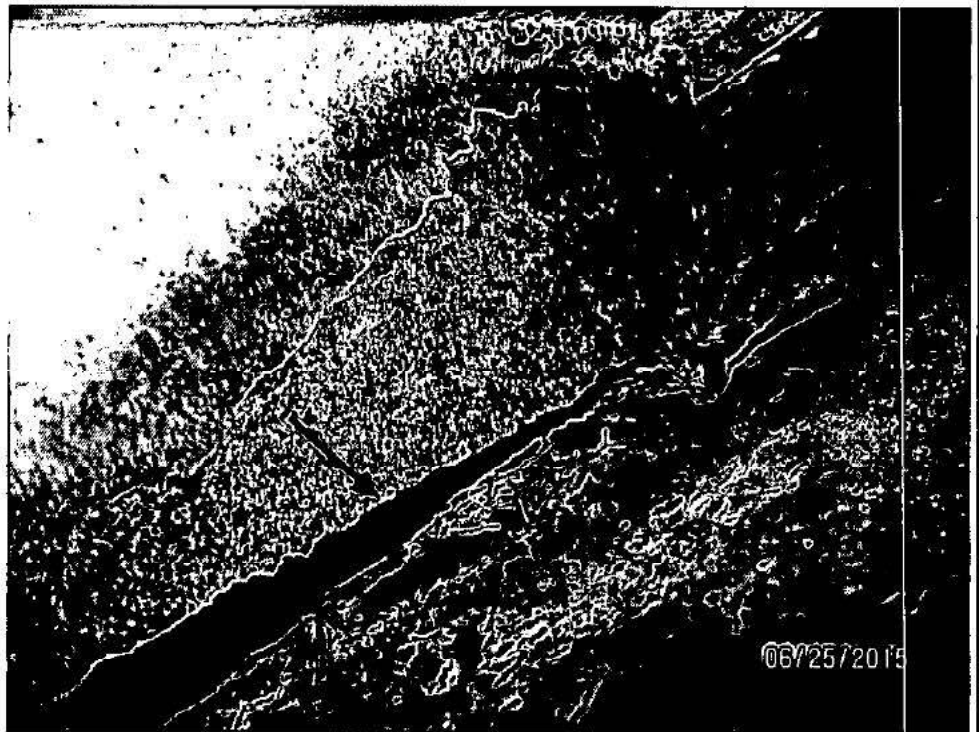
Corrosion holes in the
web of orthotropic deck
rib (tee).

(Priority Repair No. 8)

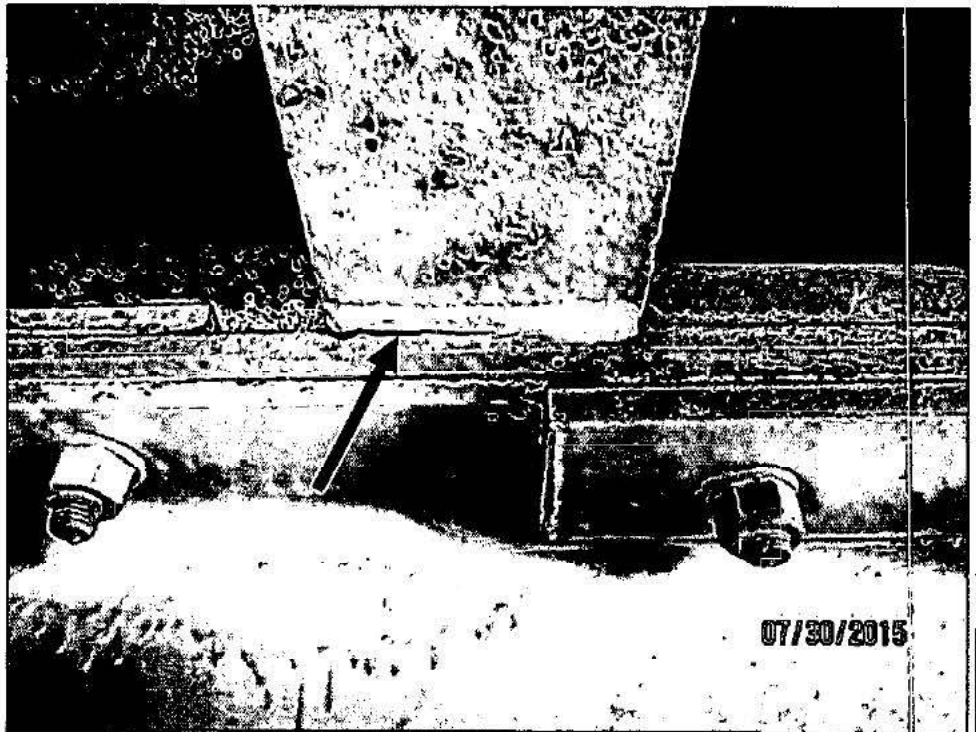
Typical cracked weld
between the deck rib
(tee) and the deck strap
plate.

(Priority Repair No. 10)

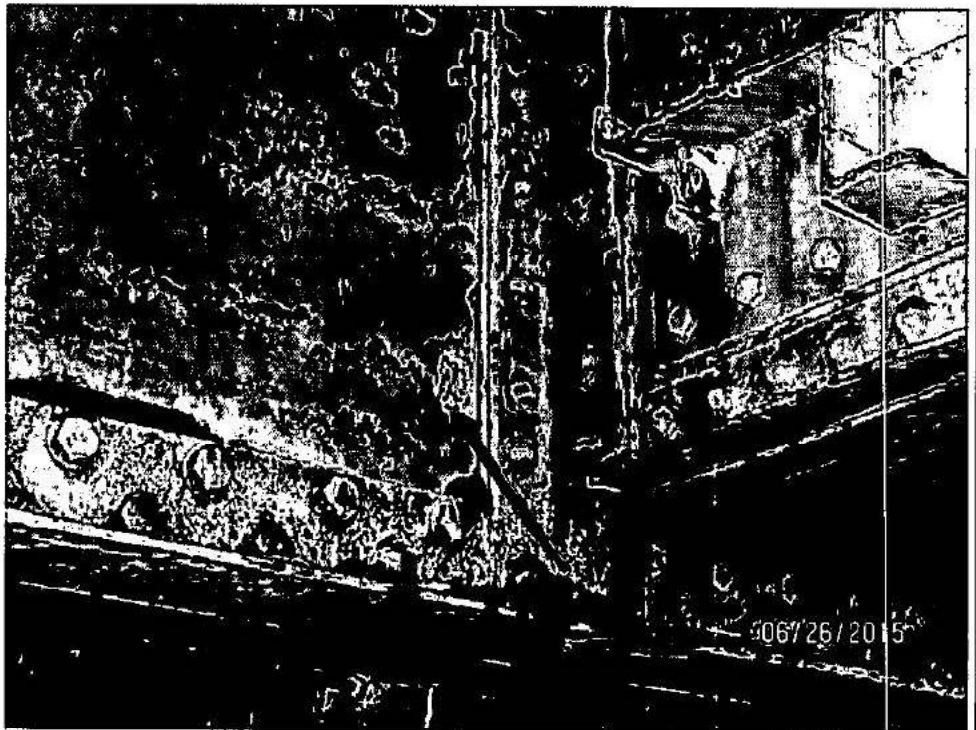
Web of stringer exhibits
a 3" diameter corrosion
hole with moderate
section loss near the
bearing area.

(Priority Repair No. 14)

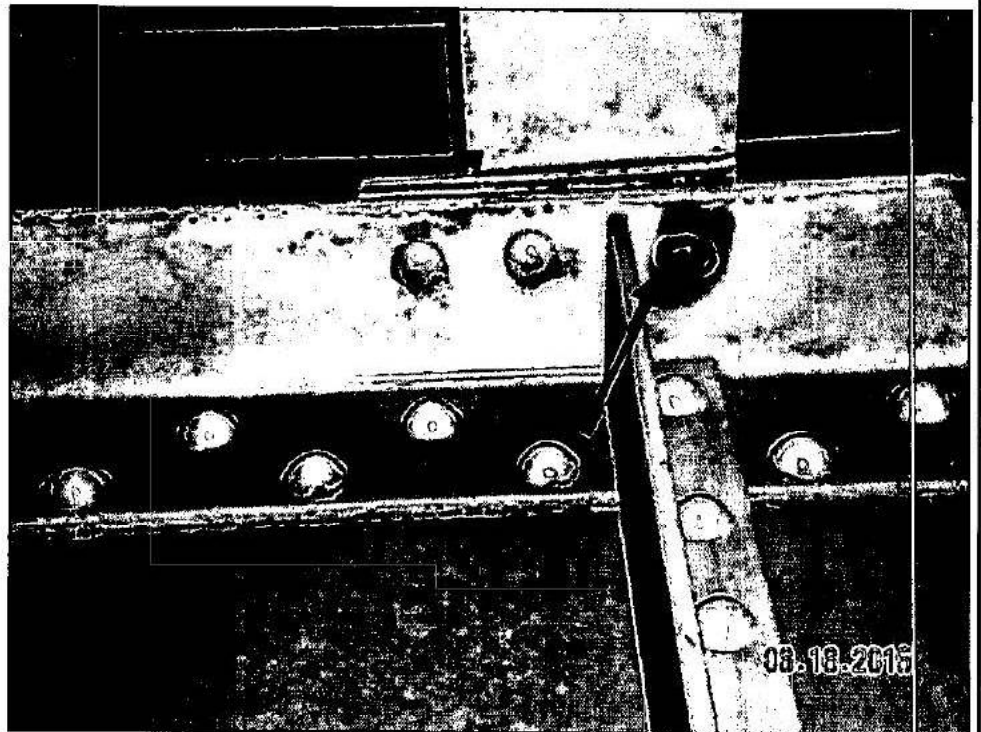
Photo No.: A21

Frozen sliding plate bearing due to pack rust.

(Priority Repair No. 21)

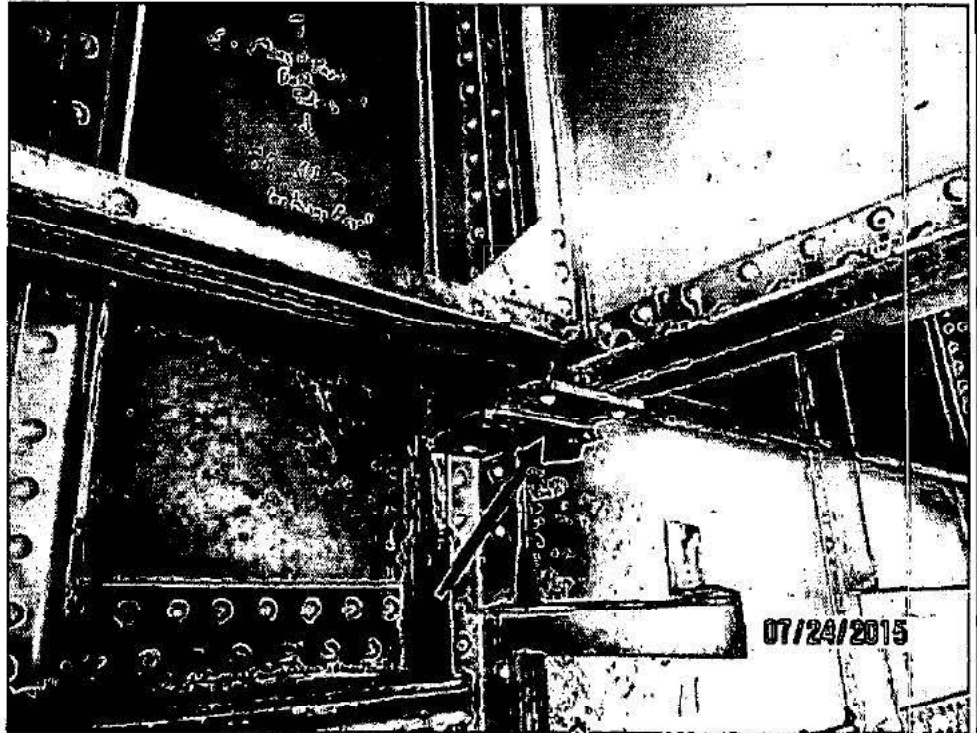
Photo No.: A22

Web of stringer exhibits 3" and 1/4" diameter corrosion holes with moderate section loss above the bearing area.

(Priority Repair No. 22)

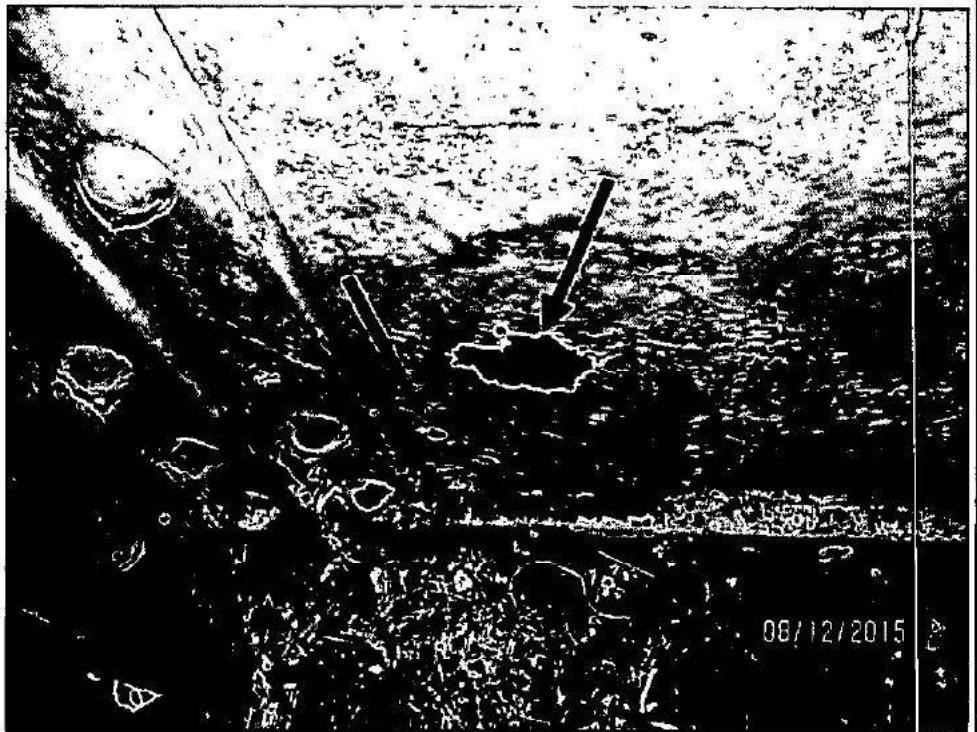
Photo No.: A23

Bent angle at stringer
bearing connection due
to pack rust.

(Priority Repair No. 23)

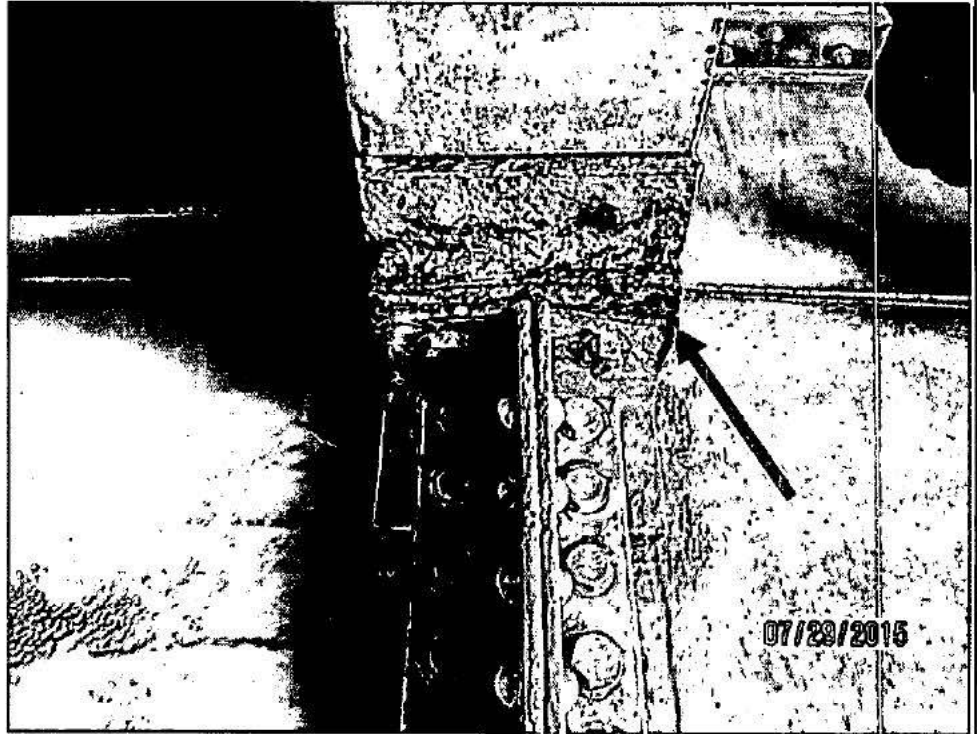
Photo No.: A24

Corrosion holes and
section loss to bearing
stiffener.

(Priority Repair No. 24)

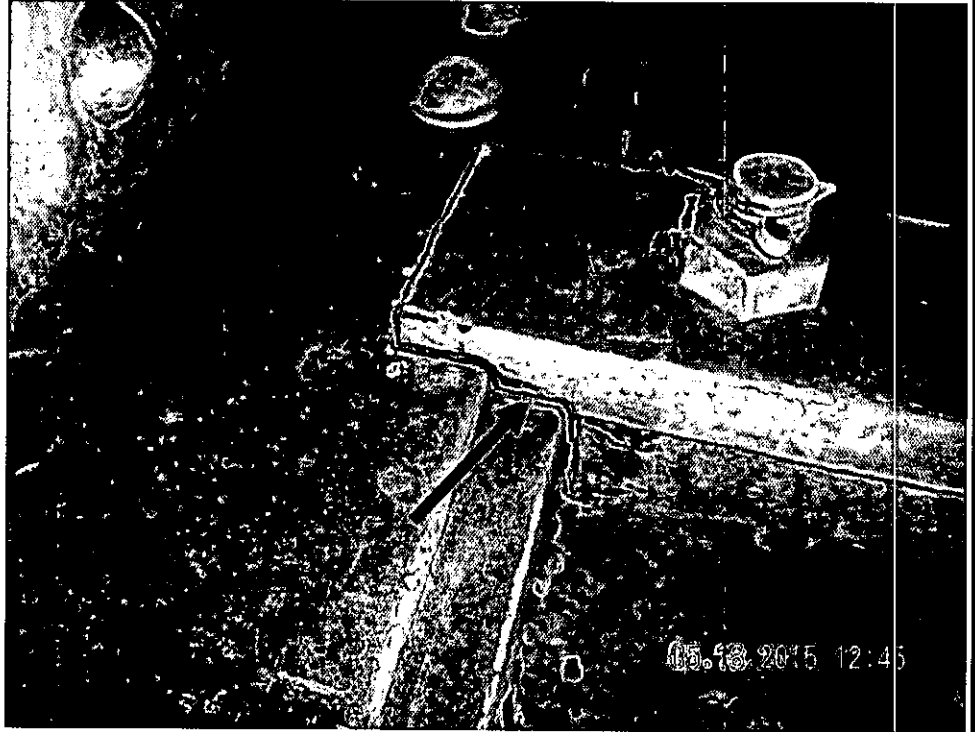
Photo No.: A28

Frozen sliding plate
bearing due to pack
rust.

(Priority Repair No. 28)

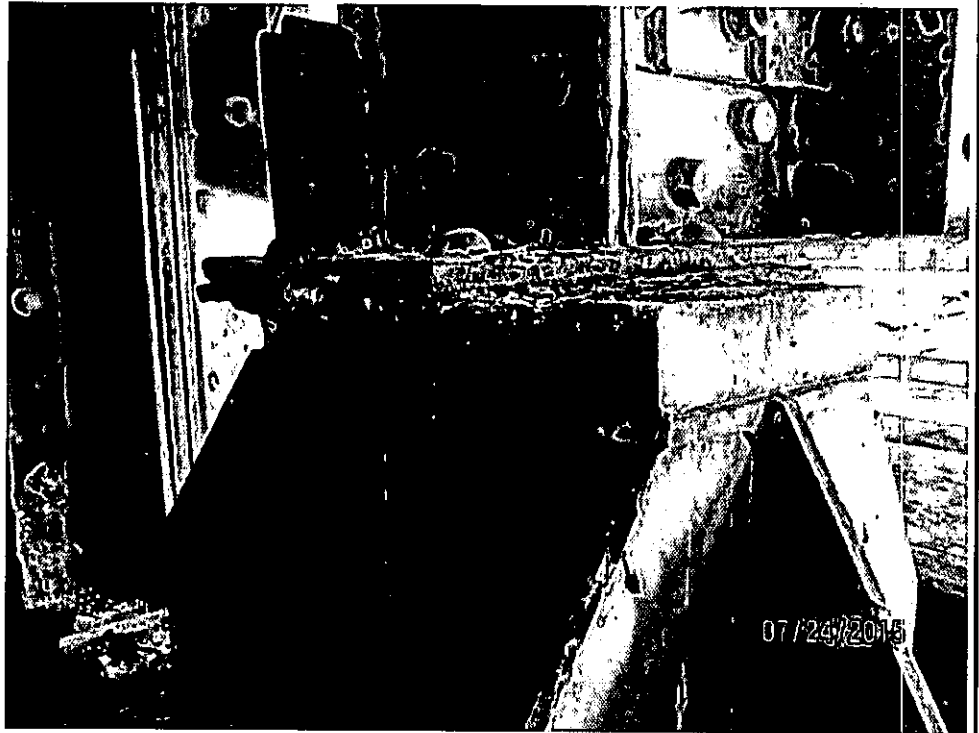
Photo No.: A29

Cracked shim plate and
loose tie down bolts
connecting stringer
bottom flange to the
seated angle.

(Priority Repair No. 29)

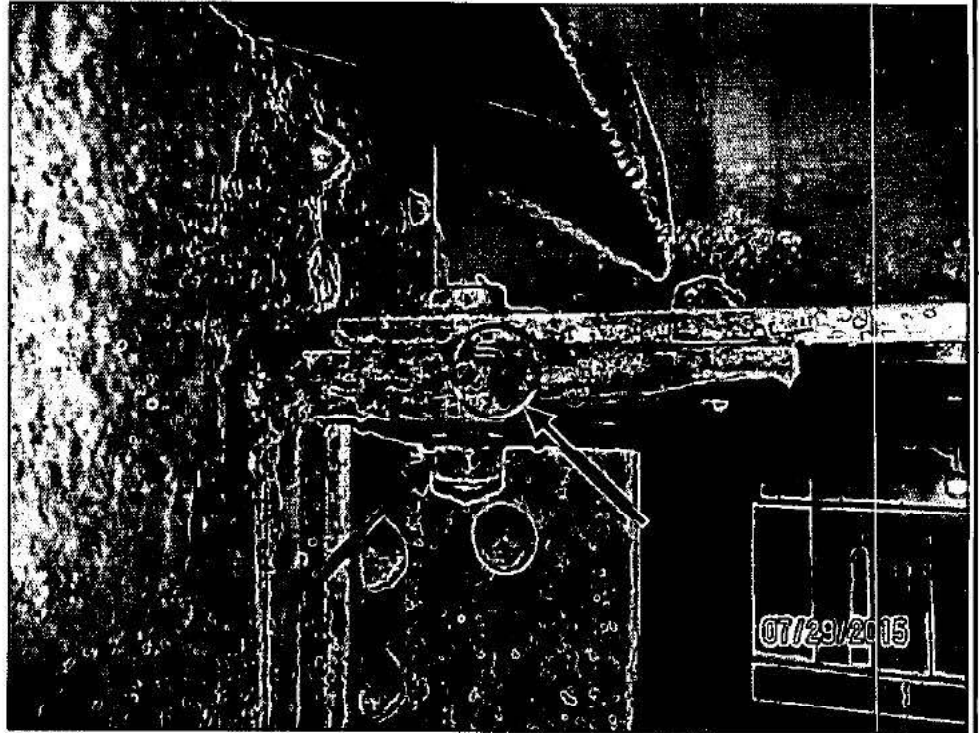
Photo No.: A30

2 of 2 sheared
rivets/bolts at the south
side of deck to stringer
top flange connection.
North side similar.

(Priority Repair No. 30)

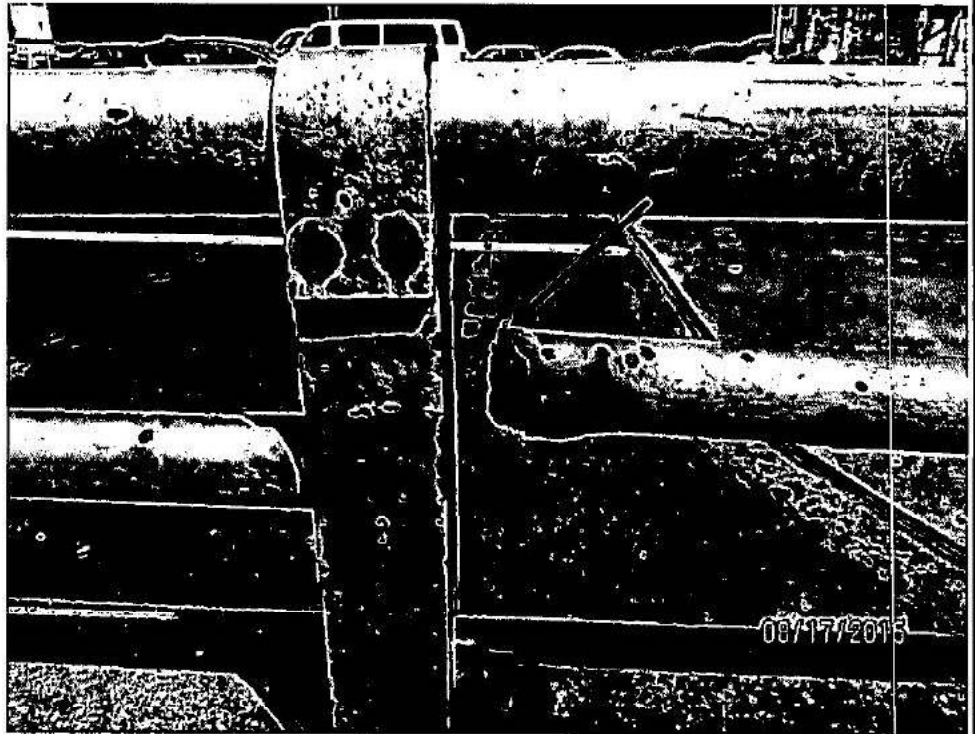
Photo No.: A34

Railing post is
disconnected at the
base due to (2 of 2)
sheared anchor bolts.

(Safety Repair No. 3)

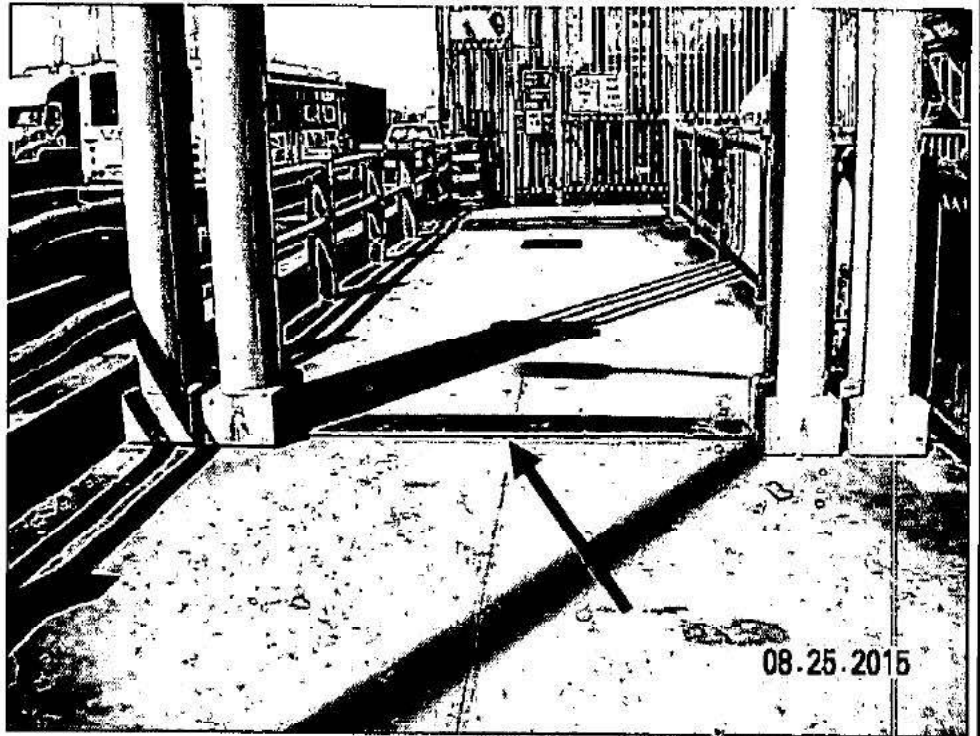
Photo No.: A36

1 of 2 missing bolts at the bottom of the vertical railing post of the catwalk.

(Safety Repair No. 5)

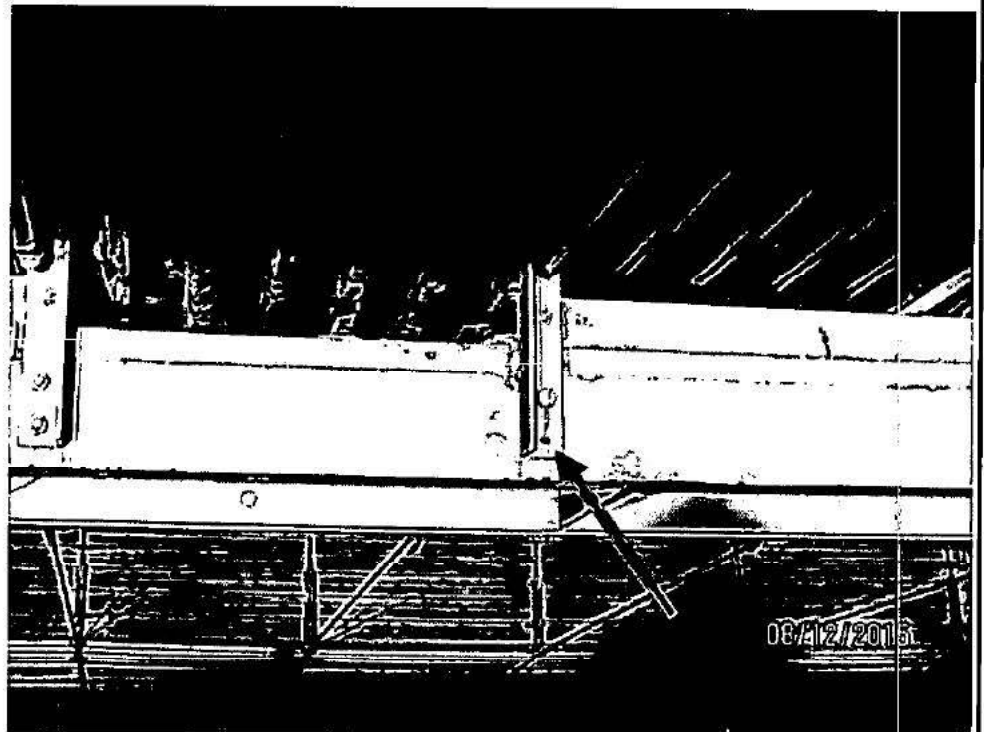
Photo No.: A37

Heavy overflowing debris accumulation on horizontal connection plate and tower strut.

(Safety Repair No. 6)

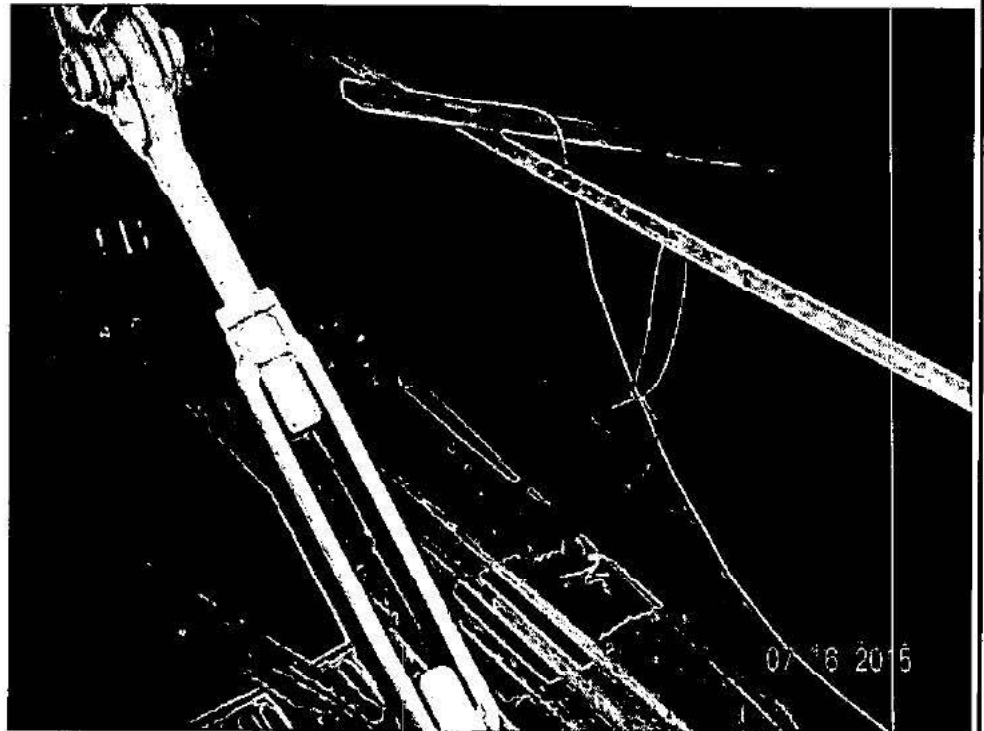
Photo No.: A39

Deteriorated
maintenance platform
grating.

(Safety Repair No. 8)

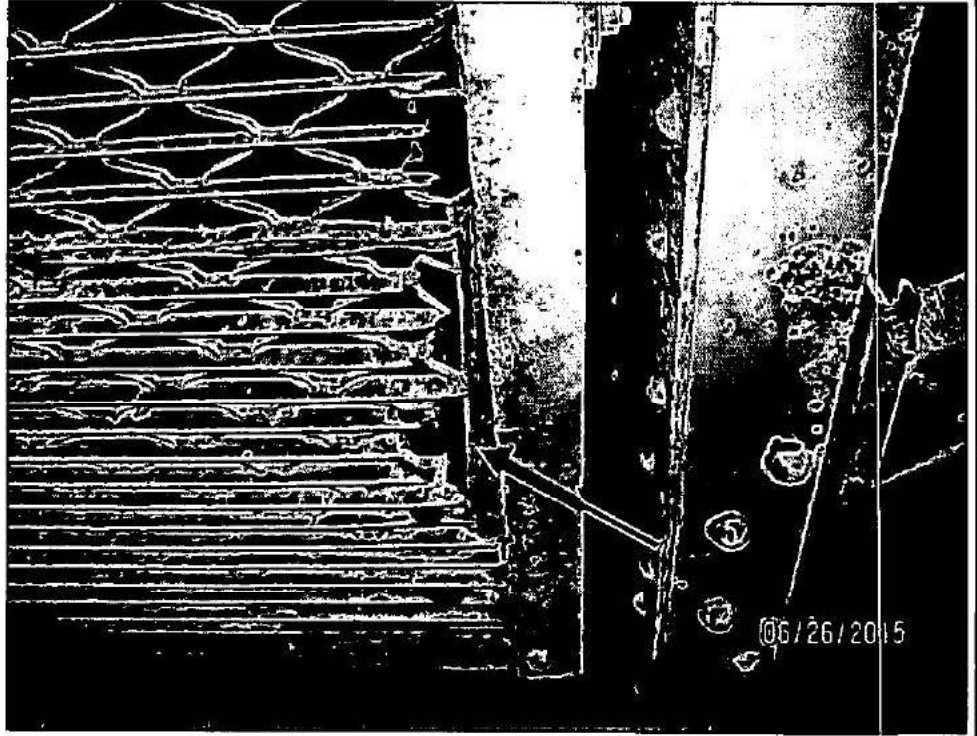
Photo No.: A40

Partially detached utility
support angle.

(Safety Repair No. 9)

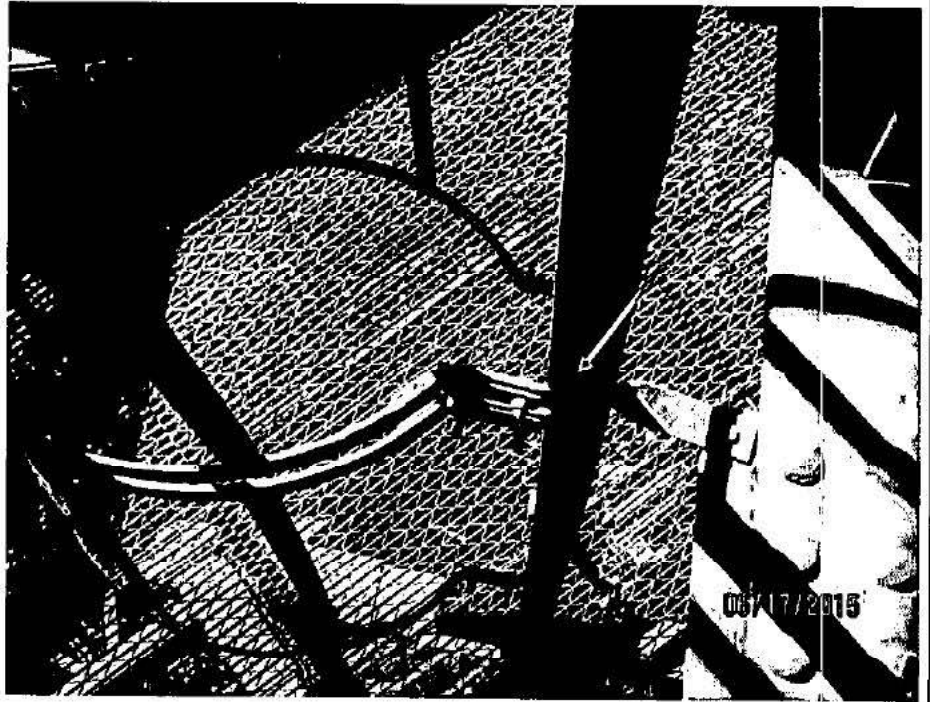
Photo No.: B4

The railing of the catwalk at Level 3M at the south leg exhibits corrosion and holes (see Photo B4). There is also a crack in the stair, 11th from the bottom, between Levels 3M and 4 at the south leg (see Photo B5).

Location: New Jersey Tower, Level 3M, catwalk railing at the south leg of the tower, looking northeast.

Description: Corrosion and holes in the railing of the catwalk.

(Safety Repair 2)

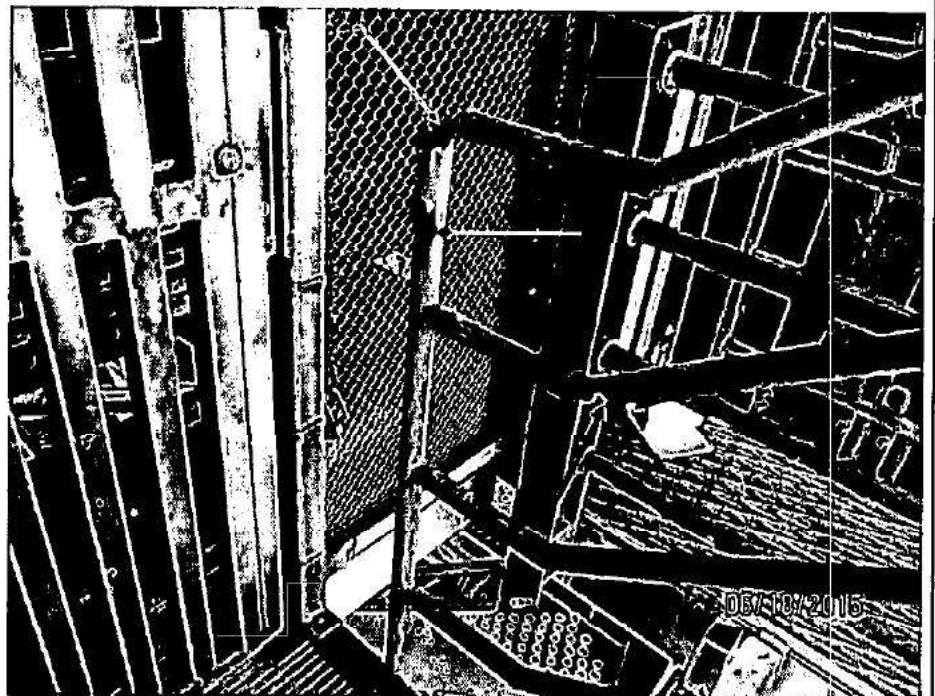
Photo No.: B5

Location: New Jersey Tower, between Levels 3M and 4, catwalk stairs at the south leg of the tower, looking south.

Description: Crack in the stair.

(Safety Repair 3)

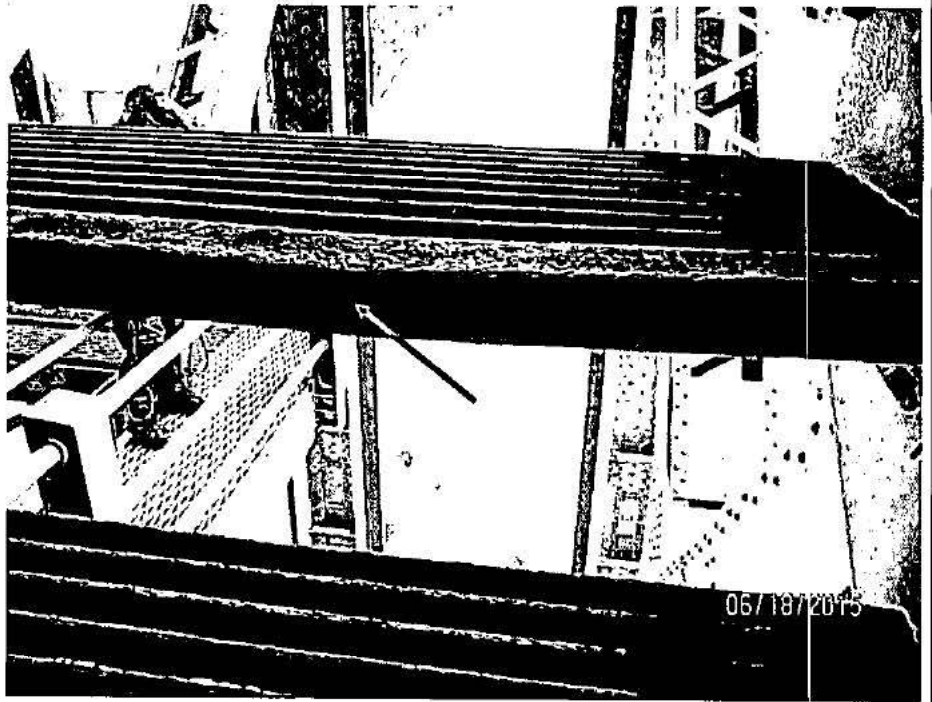
Photo No.: B6

Since the last inspection, the support beam for the maintenance catwalks at Level 3M of the south tower leg which exhibited severe corrosion and holes near the connections has been repaired. The support beams of the north tower leg exhibit severely deteriorated or missing bolts at the connections (see Photo B6).

Location: New Jersey Tower, Level 3M, catwalk support near the south leg of the tower, looking up and northwest.

Description: Severely deteriorated bolts in the catwalk support member at the connection.

(Safety Repair 4)

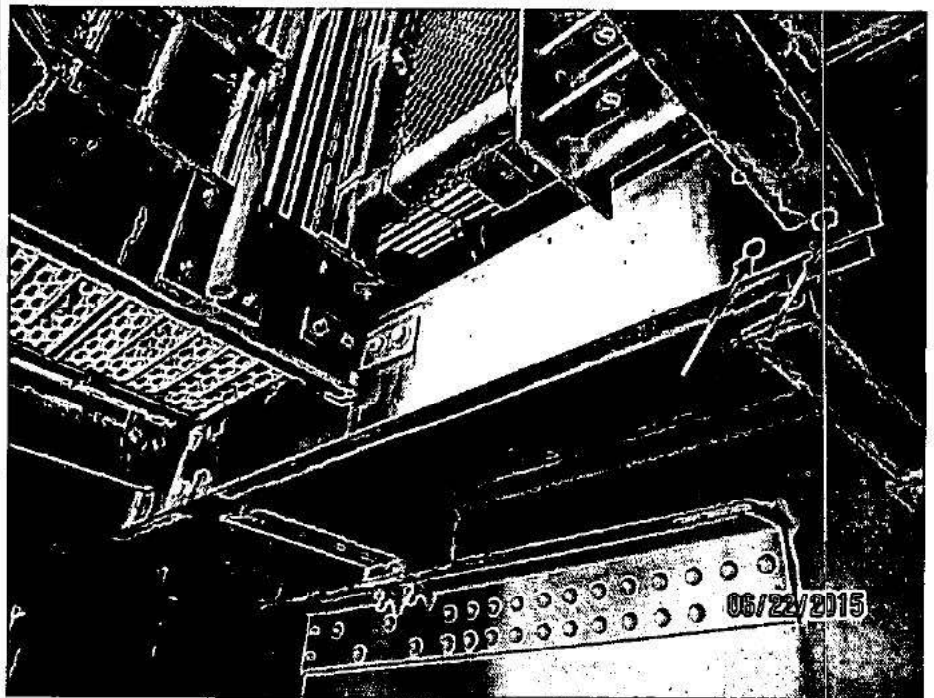
Photo No.: B7

Location: New York Tower, south leg, northeast corner of the northwest exterior column base, looking southwest.

Description: Moderate corrosion of exposed steel surfaces.

<u>No.</u>	<u>Description</u>	<u>Dwg. No.</u>
1	Clean and spot paint the New York and New Jersey Tower column bases. <i>(Photo B7)</i> (32 Locations).	---
2	Repair, clean and paint the deteriorated horizontal bracing members at Levels 3 and 3M of the New York and New Jersey Towers. <i>(Photo B8)</i> (29 Locations)	TW-3 and TW-4
3	Repair the cracked and holed thru outstanding angle leg at the east upper flange of the horizontal strut between west interior columns of the south leg at Level 0 of the New York Tower. <i>(Photo B9)</i> (1 Location)	---

(Routine Repair 1)

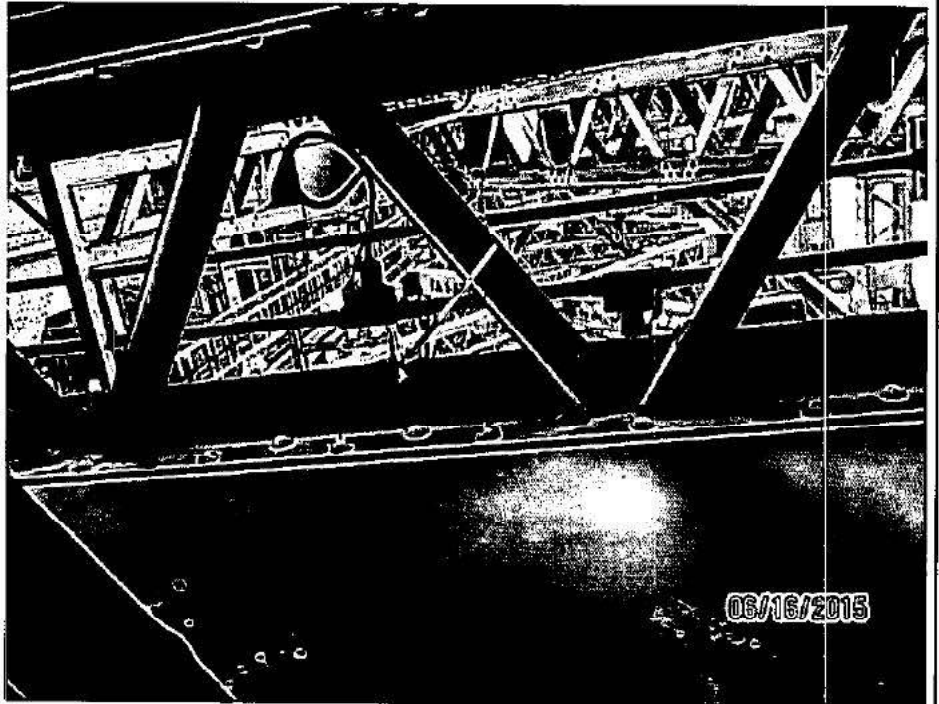
Photo No.: B10

The concrete encasement protecting steel pedestals at the base of the towers exhibits few medium to wide cracks. The encasement also exhibits spalls allowing water penetration onto the encased steel (see Photo B10).

Location: New York Tower, north leg, northwest corner of northeast interior column base and northeast corner of northwest interior column base, looking southwest.

Description: Localized spall in the concrete encasement at steel bearing pedestal.

(Routine Repair 4)

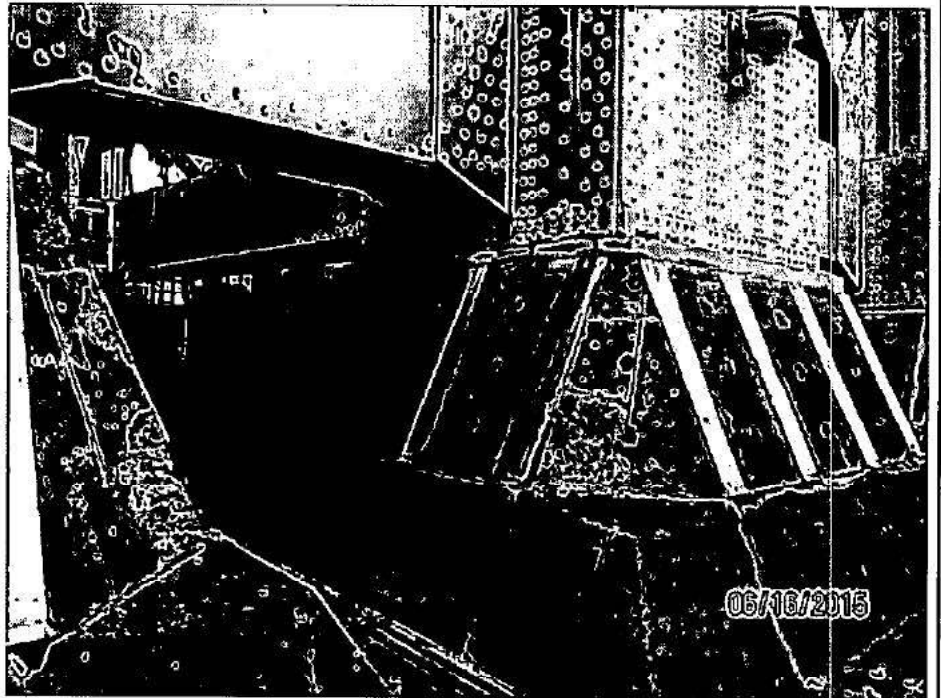
Photo No.: B11

The drainage downspout at the base of northwest exterior column at the south leg is deteriorated and is missing a section of the pipe (see Photo B11).

Location: New Jersey Tower, south leg, northwest exterior column, looking north.

Description: Deteriorated drainage pipe with missing section near base of tower.

6	Remove the deteriorated and missing section of drainage downspout at the base of the northwest exterior column at the south leg of the New Jersey Tower. <i>(Photo B11)</i> (1 Location)	---
7	Remove the debris causing partially or fully clogged weep holes at the base of the box columns at the New Jersey and New York Towers. <i>(Photo B12)</i> (5 Locations)	---
8	Replace the missing or sheared off bolts on the box column access hatch covers located on the interior faces of the columns at the New Jersey and New York Towers. <i>(Photo B13)</i> (24 Locations)	---
9	Clean and paint the areas of pack rust between the vertical connection plate and tower members at Levels 0 to 3 at the New Jersey and New York Towers. <i>(Photo B14)</i> (13 Locations)	---
10	Replace the missing mortar at the base pedestals of the New Jersey and New York Towers. <i>(Photo B15)</i> (4 Locations)	---
11	Replace the missing handhole cover for the electrical conduit at the New York Tower, north leg, southwest interior column at Level 0. <i>(Photo B16)</i> (1 Location)	---

(Routine Repair 6)

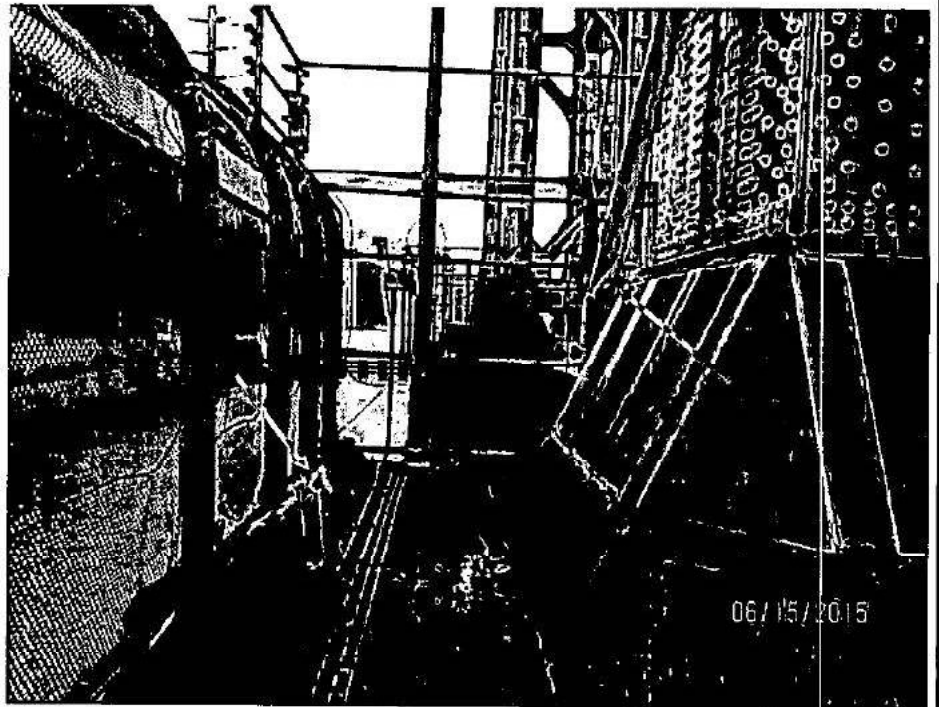
Photo No.: B12

Location: New Jersey Tower, south leg, northeast exterior column, looking down.

Description: Debris within base of column causing clogging of drainage weephole.

(Routine Repair 7)

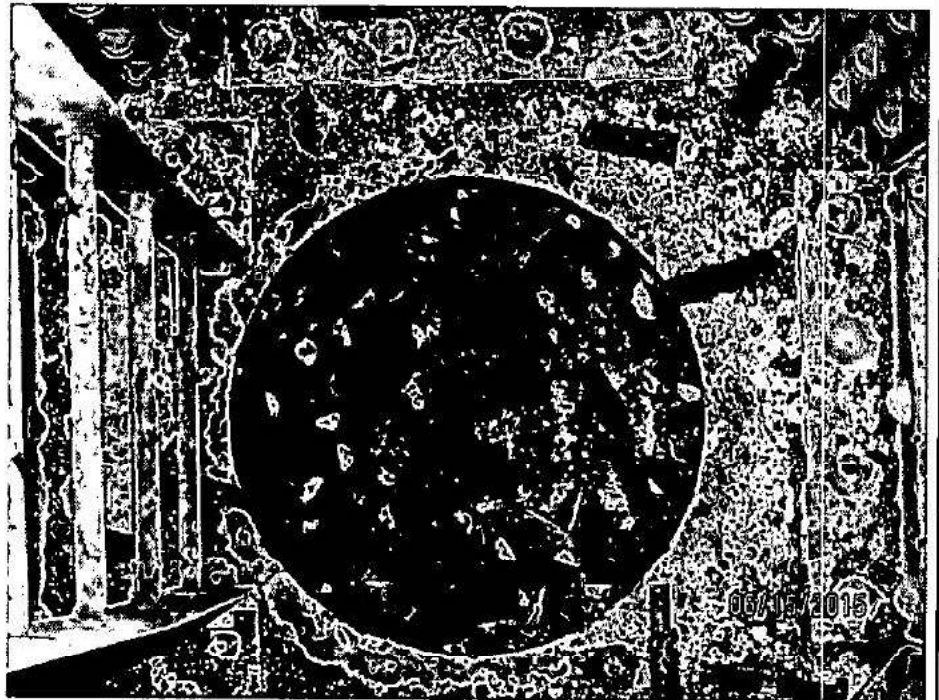
Photo No.: B13

Several access hatch covers for the box columns at the south and north tower legs exhibit missing or sheared off bolts (see Photo B13). An interior inspection was performed within the base of the northeast and southeast exterior columns at the north tower leg and within the southeast interior and northeast exterior column legs at the south tower leg. The weep holes at the base of several box columns of the tower leg are partially or fully clogged due to debris accumulation within the base of the box columns (see Photo B12). No water was found inside the columns and few areas of light to moderate corrosion were noted near the base of the columns.

Location: New Jersey Tower, north leg between Levels 0-1, southwest interior column, looking southeast.

Description: Missing (2 of 4) bolts for the box column access hatch cover located on the interior face of the column.

(Routine Repair 8)

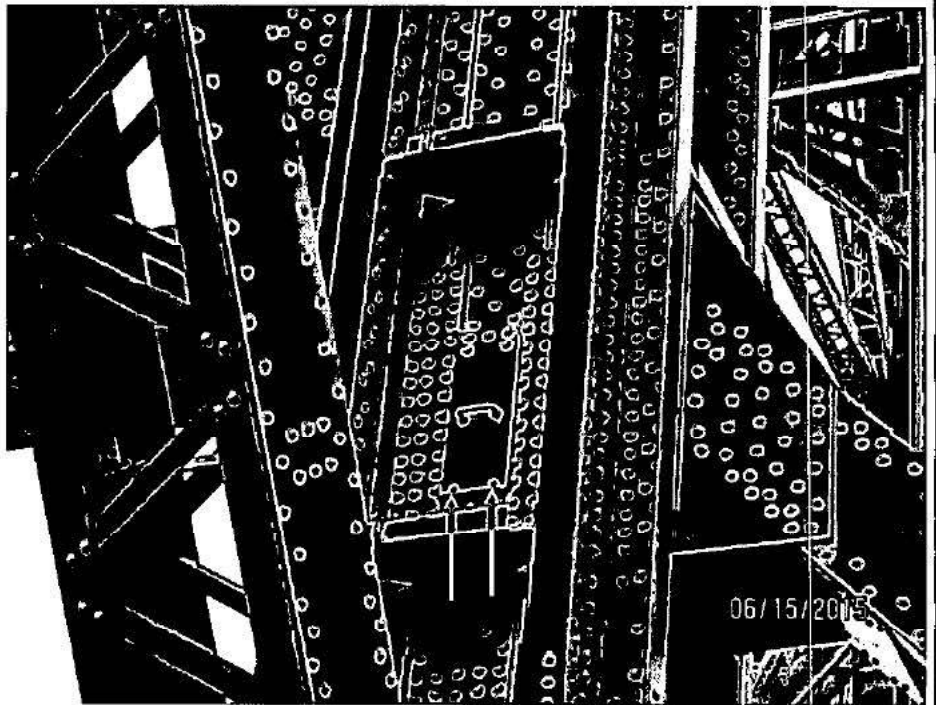
Photo No.: B14

There are areas of pack rust between the vertical connection plates and the tower members at Levels 0 to 3 (see Photo B14).

Location: New Jersey Tower, south leg between levels 0 and 1, between northeast and southeast exterior column, looking southwest.

Description: Pack rust between the vertical connection plate and diagonal tower member.

(Routine Repair 9)

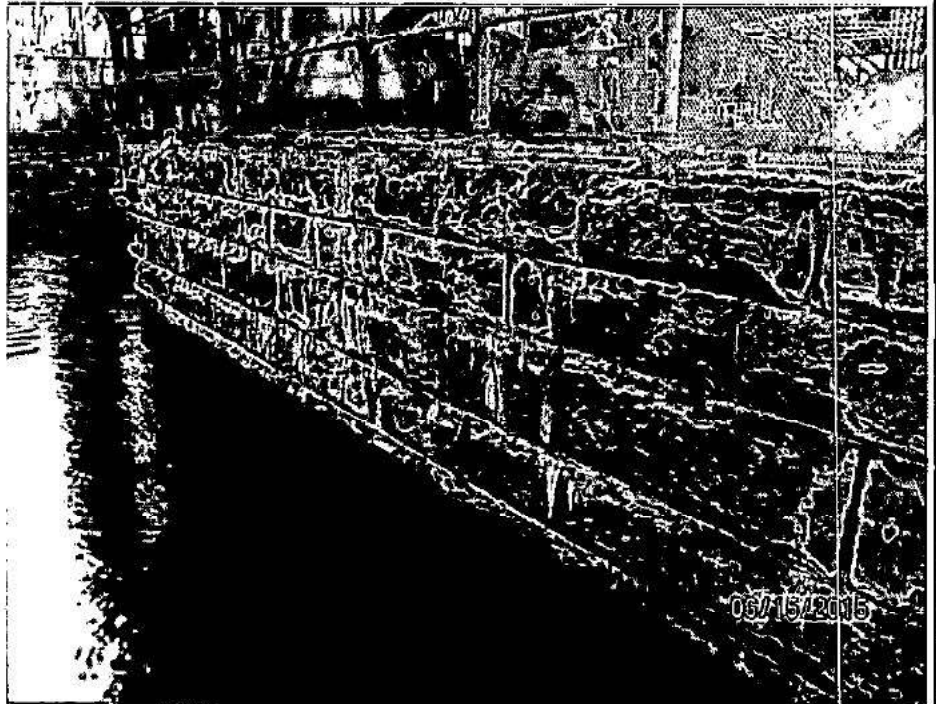
Photo No.: B16

Location: New York Tower, north leg at Level 0, southwest interior column, looking southwest.

Description: Missing handhole cover for the electrical conduit.

(Routine Repair 11)

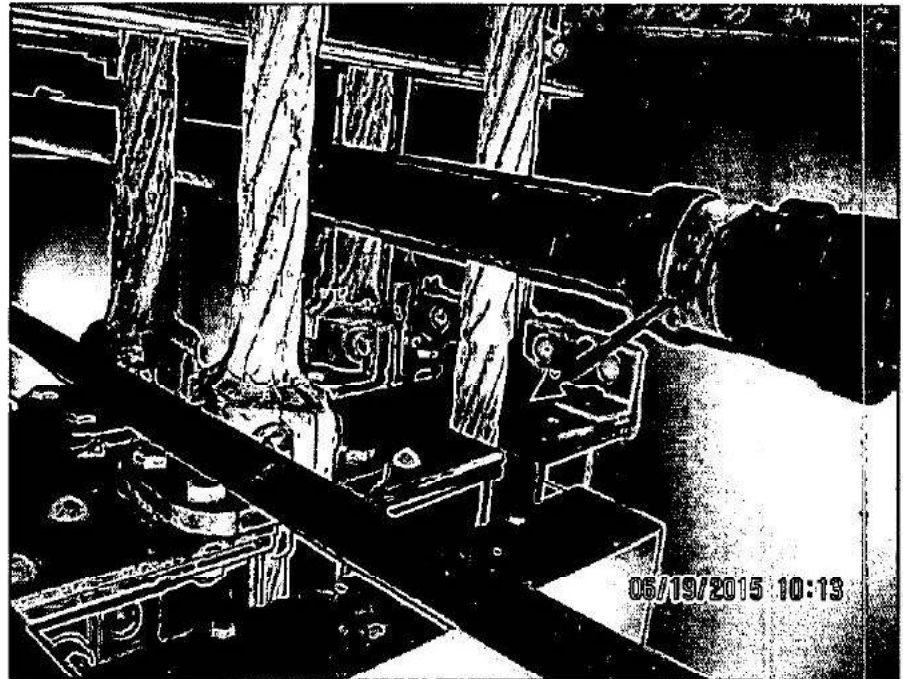
Photo No.: C5

Location: Panel Point 20E, Cable D, northeast Suspenders Rope 14, looking northwest.

Description: Missing collar at the top flange of the floorbeam.

(PRIORITY REPAIR 5)

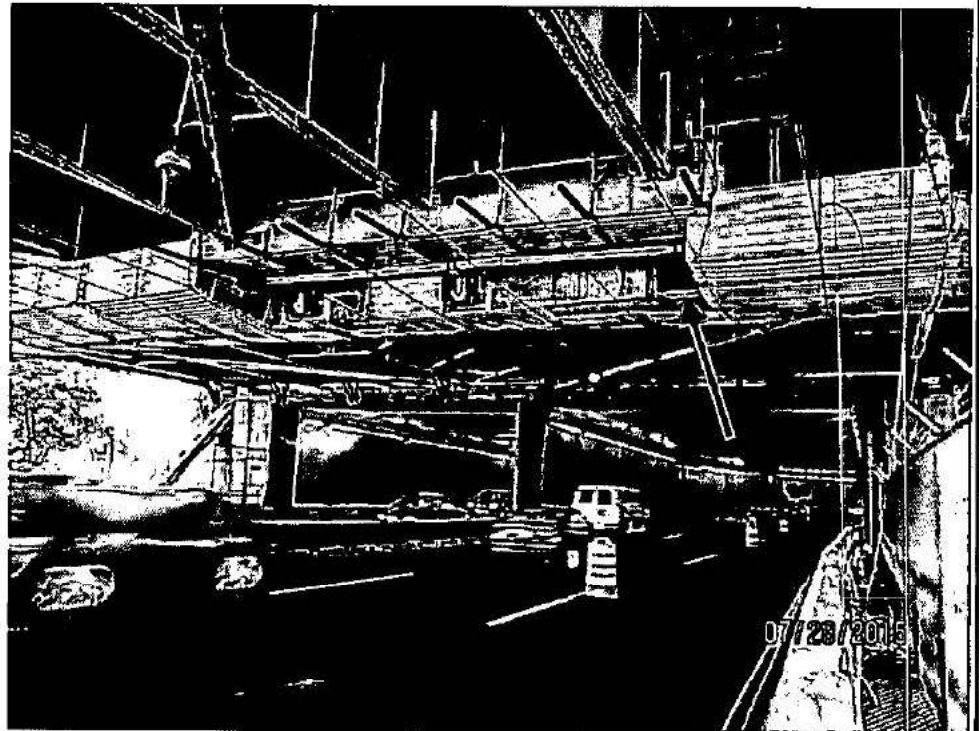
Photo No.: D7

Bent bracing members between light fixture arms at the sign structure.

(Routine Repair No. 8)

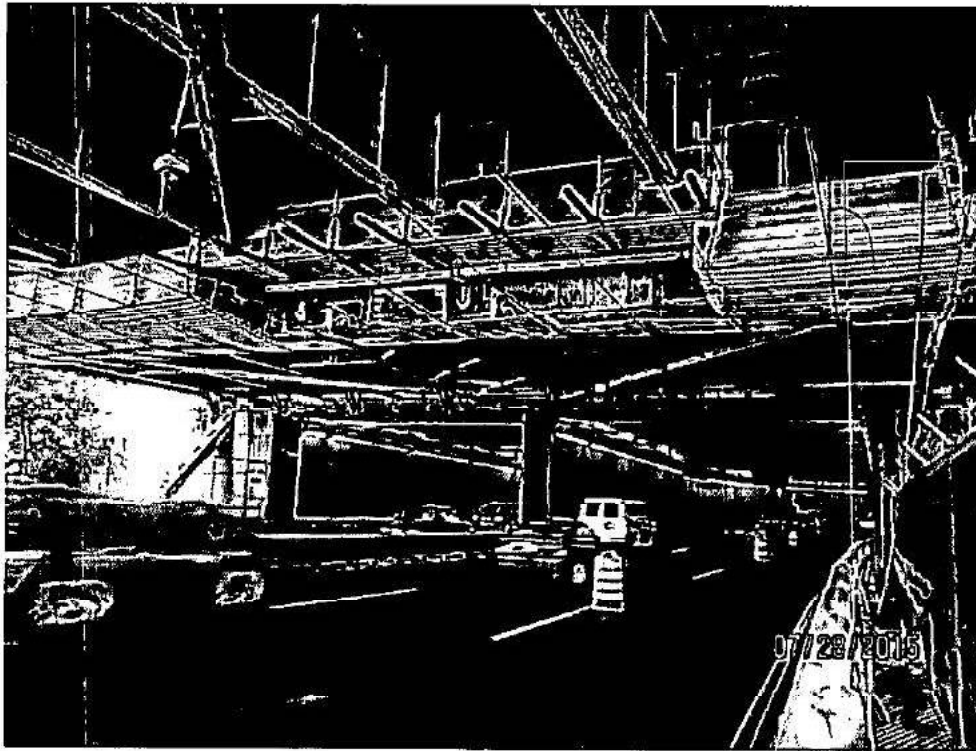
Sign No.	Type	Roadway	Panel Point	Number of Panels	Sign Text	Overall Condition	Repair Recommendation	Repair Category
L1	SABR	WESTBOUND	3W	3	"ELECTRONIC LANE STATUS INDICATOR SIGNALS"	FAIR	R7: Replace the non-functioning (1 of 3) signal at the electronic lane status indicator signals (see Photo D6).	ROUTINE
S35	PS	MEDIAN (WB)	5W-6W	1	TRAFFIC MAY BE STOPPED AHEAD "SUDDEN STOP SYMBOL" SLOW DOWN	FAIR	R1: Repair the impact damaged sign attached to the sign structure (see Photo D1). R5: Replace broken (1 of 6) U-bolts which attach the sign panel to the sign structure (see Photo D1).	ROUTINE
S36	PS	WESTBOUND	6W-7W	1	G W BRIDGE HIGHWAY ADVISORY AND EMERGENCY (877) PA-ROADS	GOOD	NONE	NONE
S19	SABR	EASTBOUND	8W	1	SPEED LIMIT 45	GOOD	NONE	NONE
140	SABR	EASTBOUND	9W	1	"ROUTE 9A" H HUDSON PKWY KEEP LEFT	GOOD	NONE	NONE
S35A	PS	MEDIAN (EB)	9W	1	"ROUTE 9A" H HUDSON PKWY KEEP LEFT	GOOD	NONE	NONE

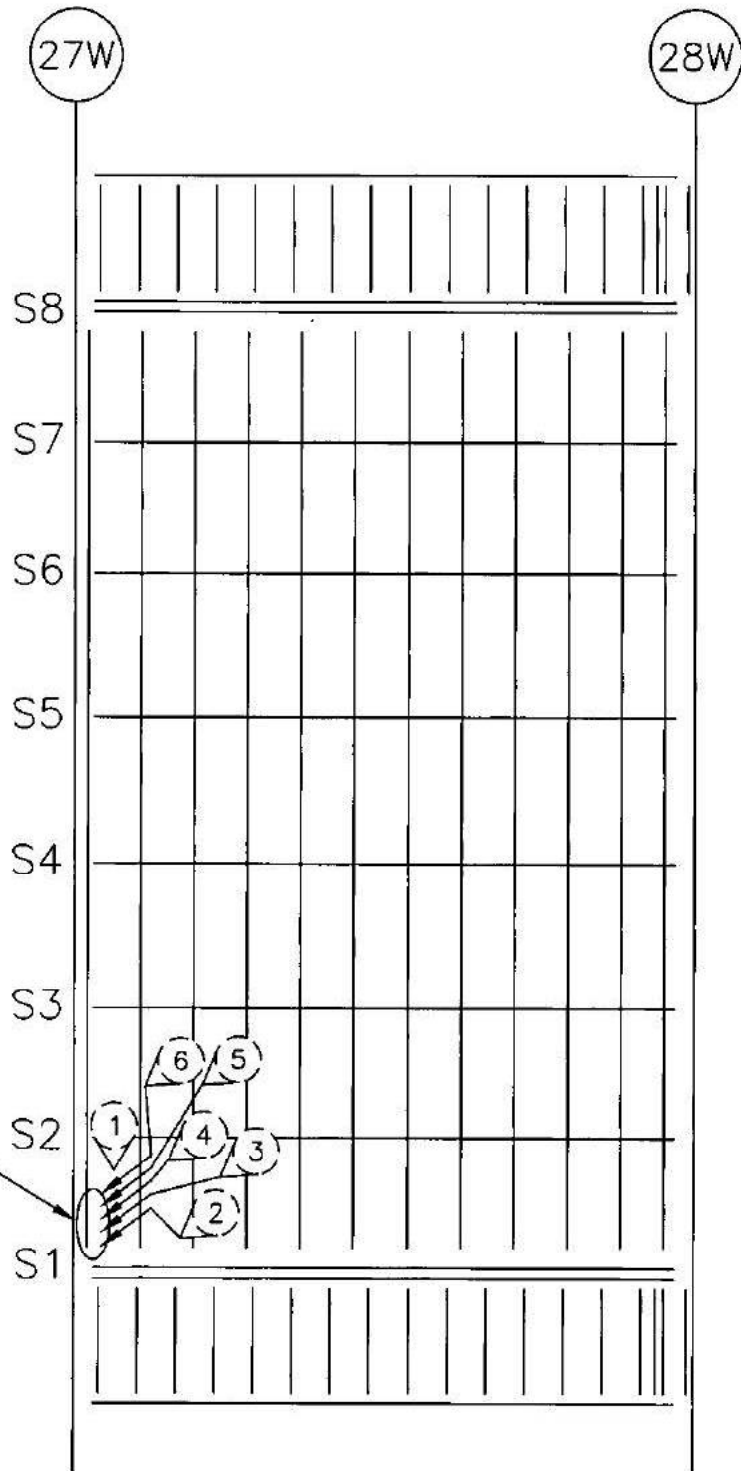
SEVERELY DETERIORATED
AND CRACKED WEB OF
RIBS R1 THRU R5.
