Port Authority Facility Condition Survey Program

George Washington Bridge
2015 Inspection Report of
Main Span Upper Level

Volume 1 of 2

January 2016

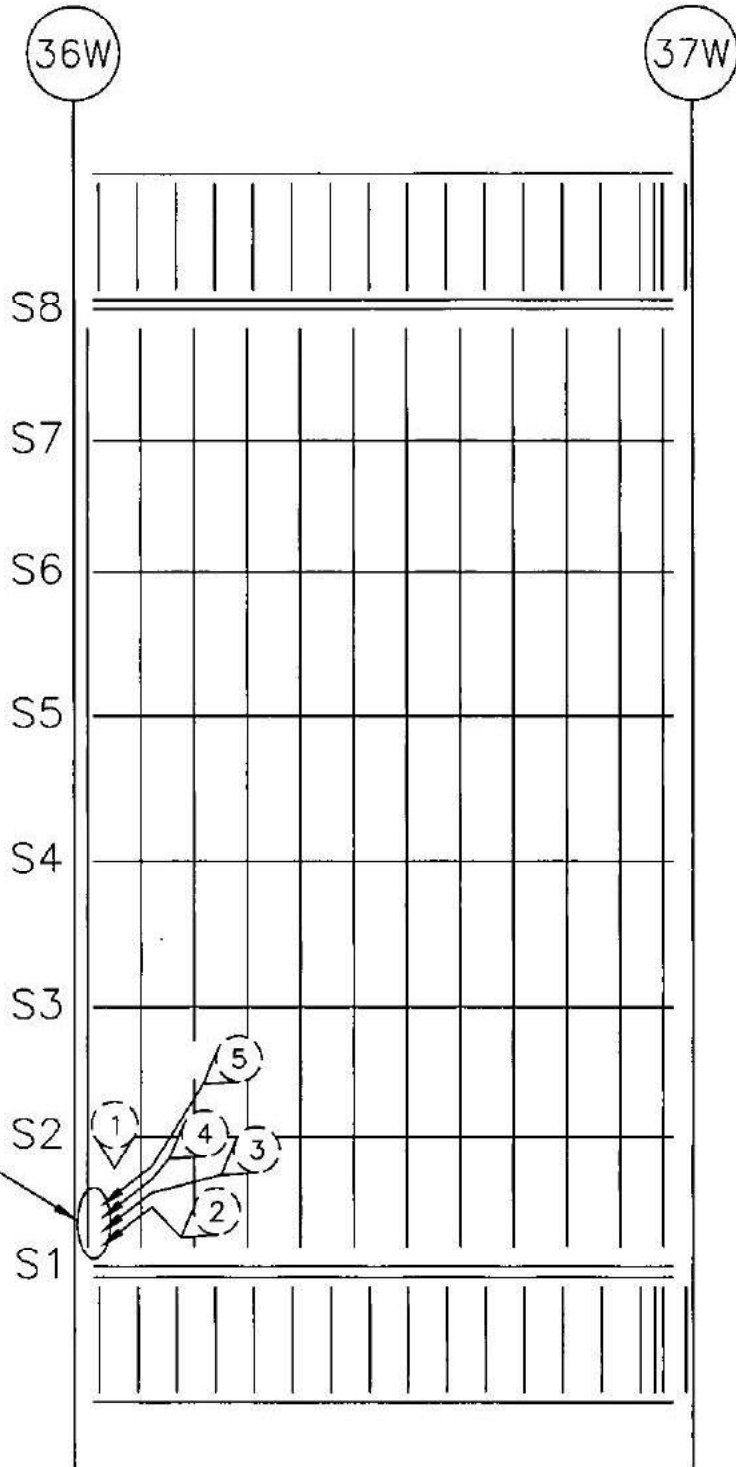
SEVERELY DETERIORATED
AND CRACKED WEB OF
RIBS R1 THRU R4.

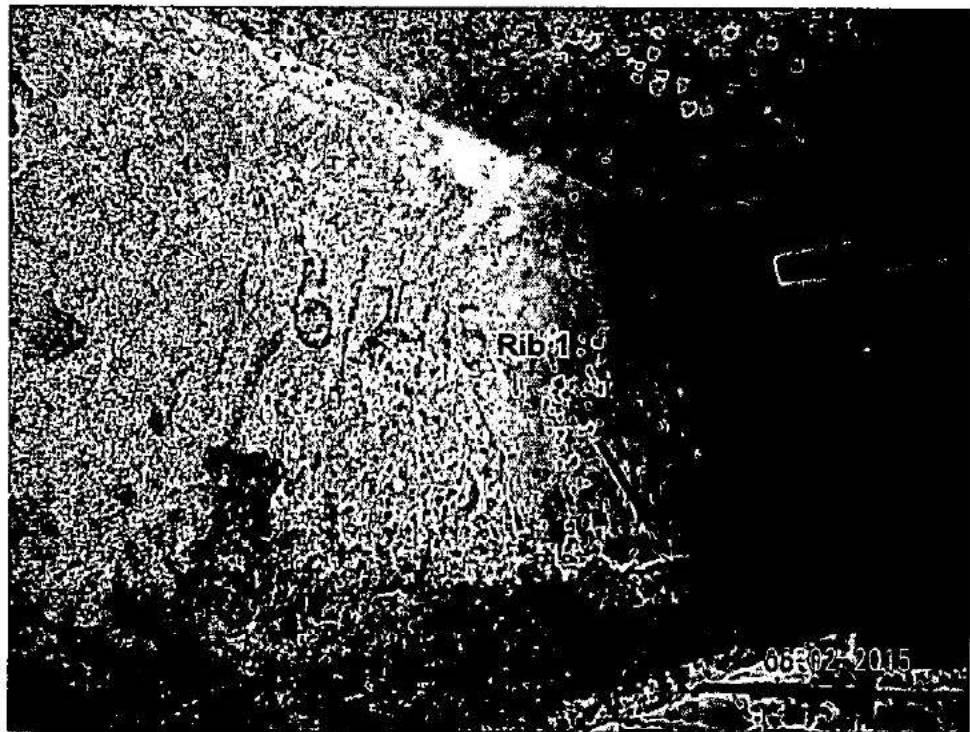
Photo No.: 3

Severely deteriorated deck rib with 7" long crack at the bottom of the web.

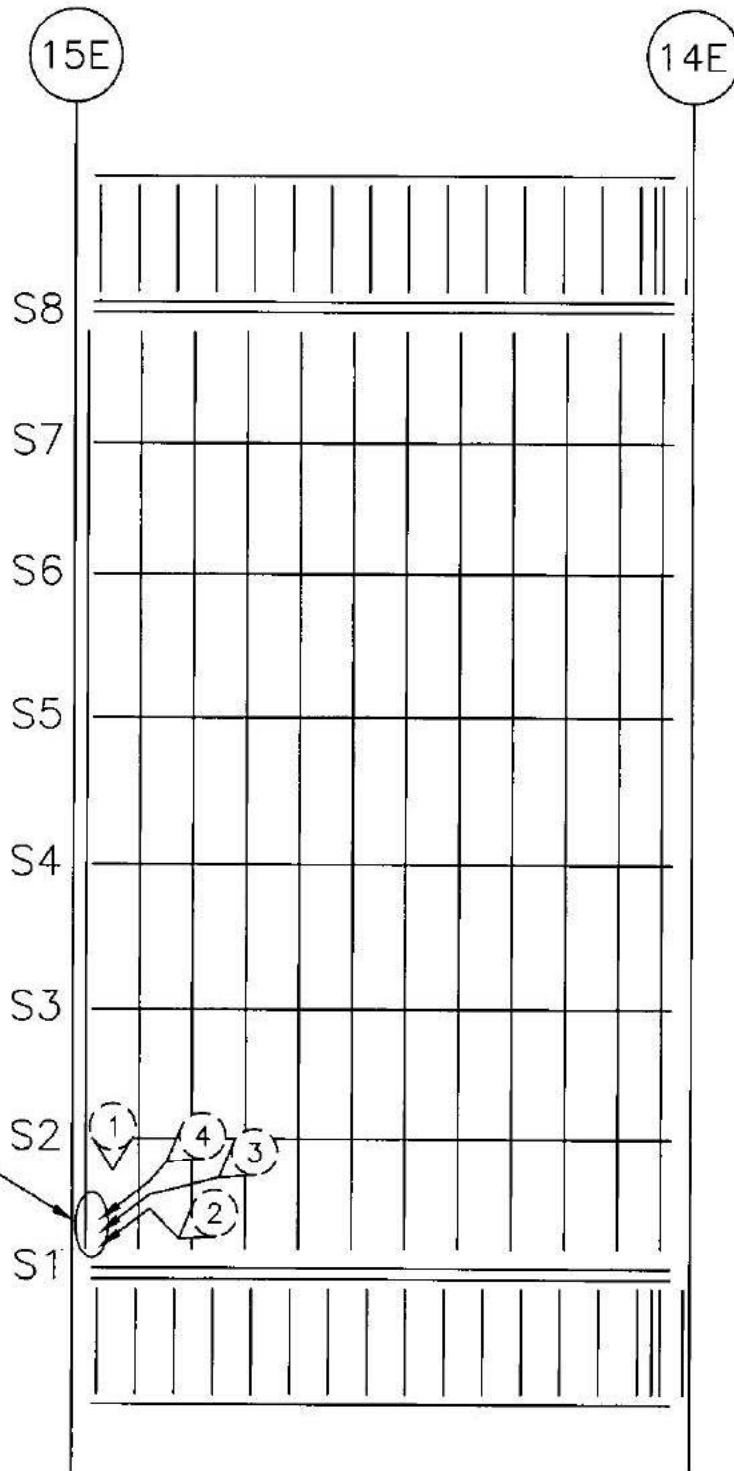
- Near Panel Point 15E (East side), Ribs 1 thru 3 exhibit severely corroded web bottom with up to 14 1/2" long cracks between Secondary Floorbeams SFB1 and SFB2.

SEVERELY DETERIORATED
AND CRACKED WEB OF
RIBS R1 THRU R3.

It is recommended to drill a 3/4" hole at the end of each crack as illustrated on QAD-1506-02 and repair selected severely deteriorated and cracked ribs on an immediate basis (See attached QAD-1506-01 & QAD-1506-02).

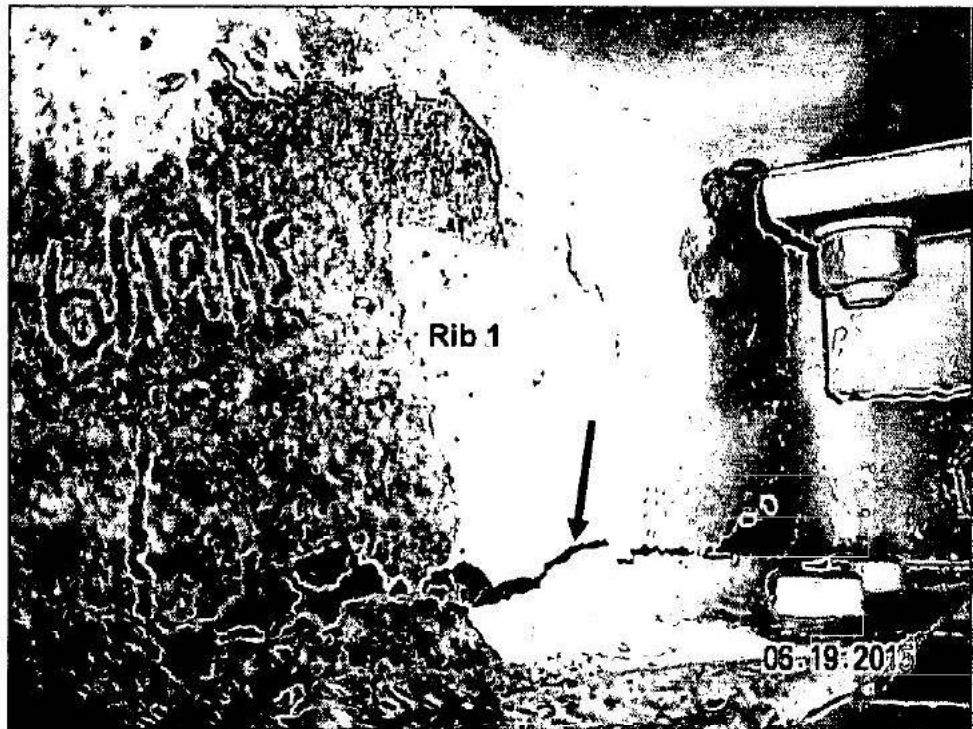
Photo No.: 3

Severely deteriorated deck rib with 13 1/2" long crack at the bottom of the web.

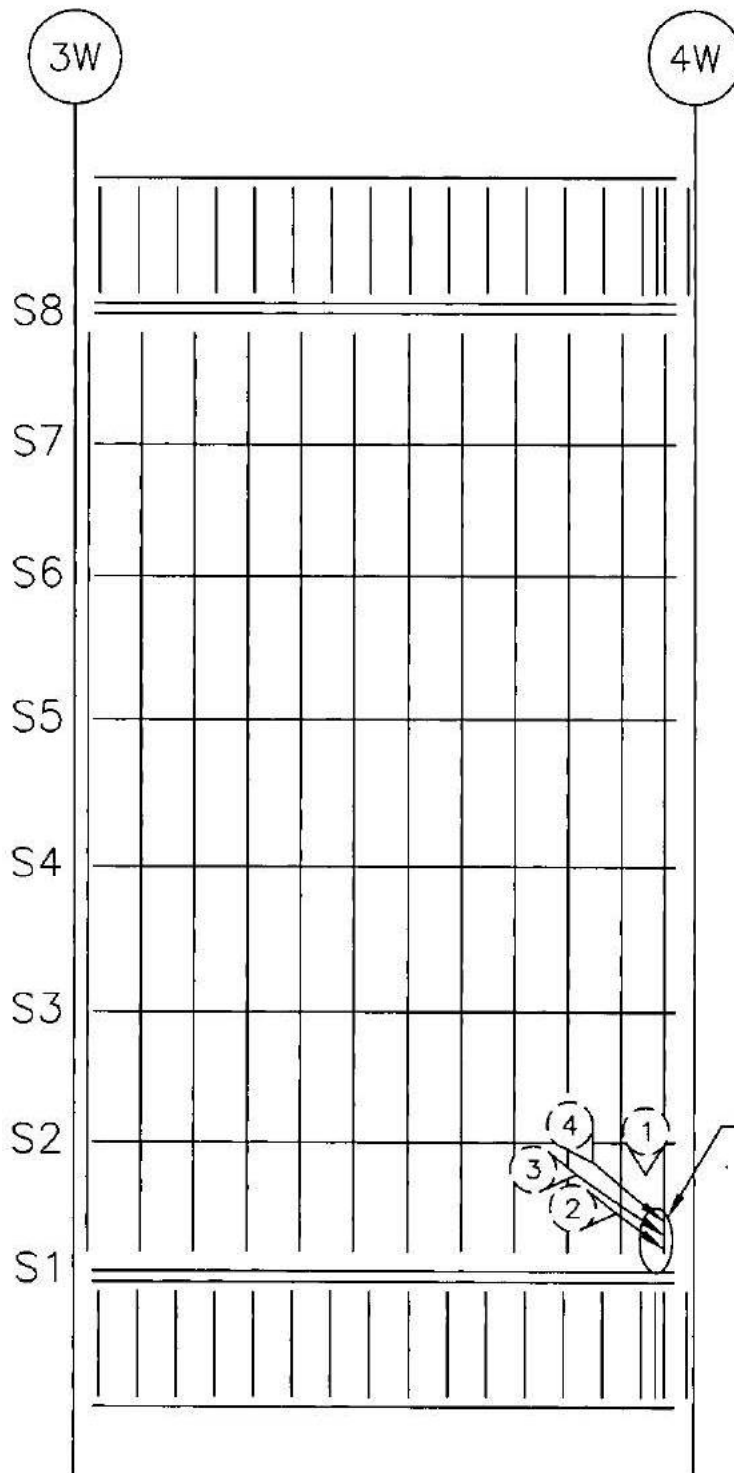
- Near Panel Point 4W (West Side), Ribs 1 thru 3 exhibit severely corroded web bottom with up to 30" long cracks between Secondary Floorbeams SFB11 and SFB12.

SEVERELY
DETERIORATED AND
CRACKED WEB OF
RIBS R1 THRU R3.

It is recommended to drill a $\frac{3}{4}$ " hole at the end of each crack as illustrated on QAD-1507-02 and repair selected severely deteriorated and cracked ribs on an immediate basis (See attached QAD-1507-01 & QAD-1507-02).

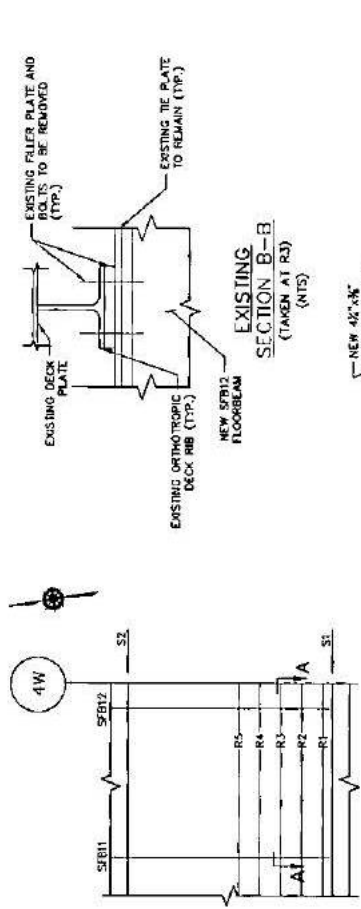
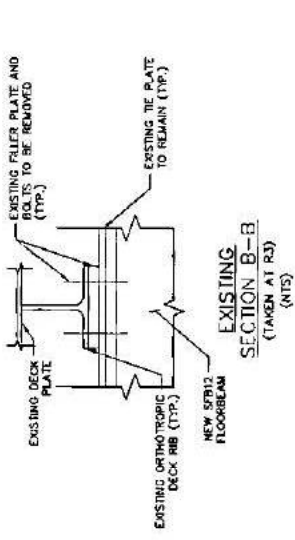
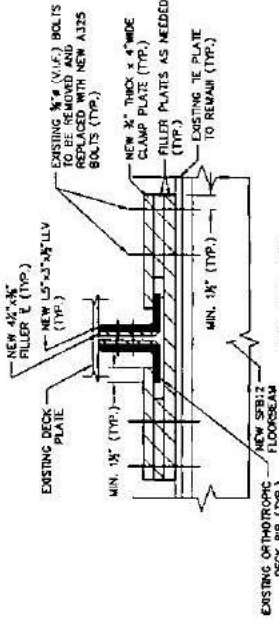
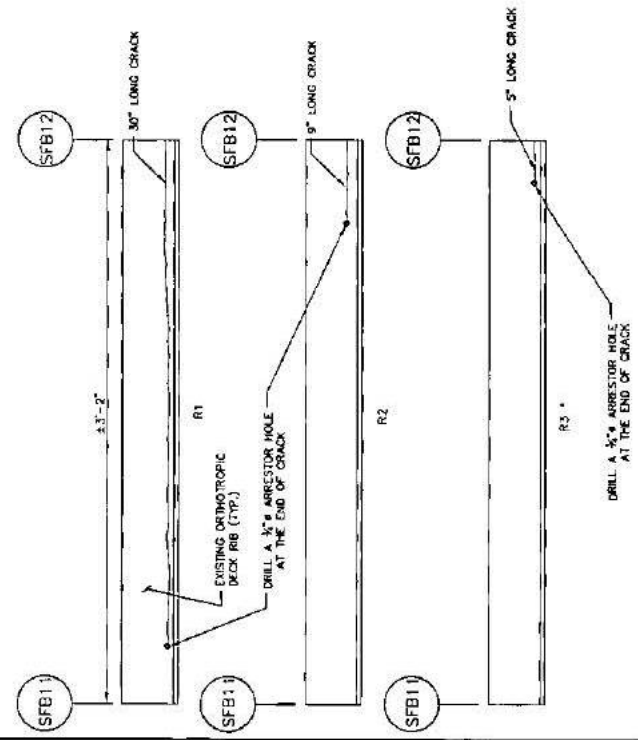
EXISTING CONDITION
(SOUTH ELEVATION OF R1 THRU R3
BETWEEN SFB11 & SFB12 NEAR PP4W)
(NTS)

* - INDICATES LOCATIONS SELECTED FOR REPAIR

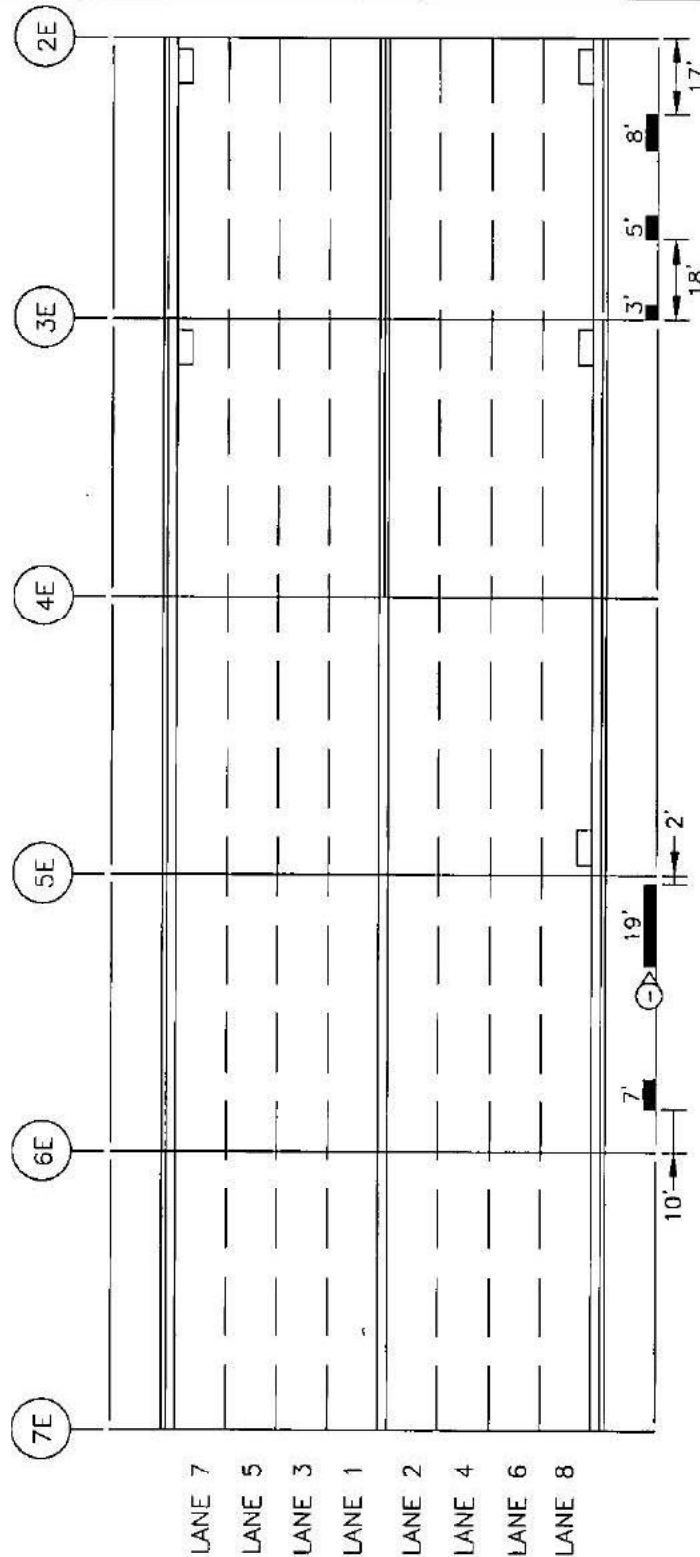
Photo No.: 1

Cracked, delaminated,
and spalled concrete.

It is recommended that the cracked and delaminated concrete be removed on an immediate basis.
